GLADSTONE SCHOOL DISTRICT

Facilities Assessment Report

BRIC ARCHITECTURE, INC. JULY 2024

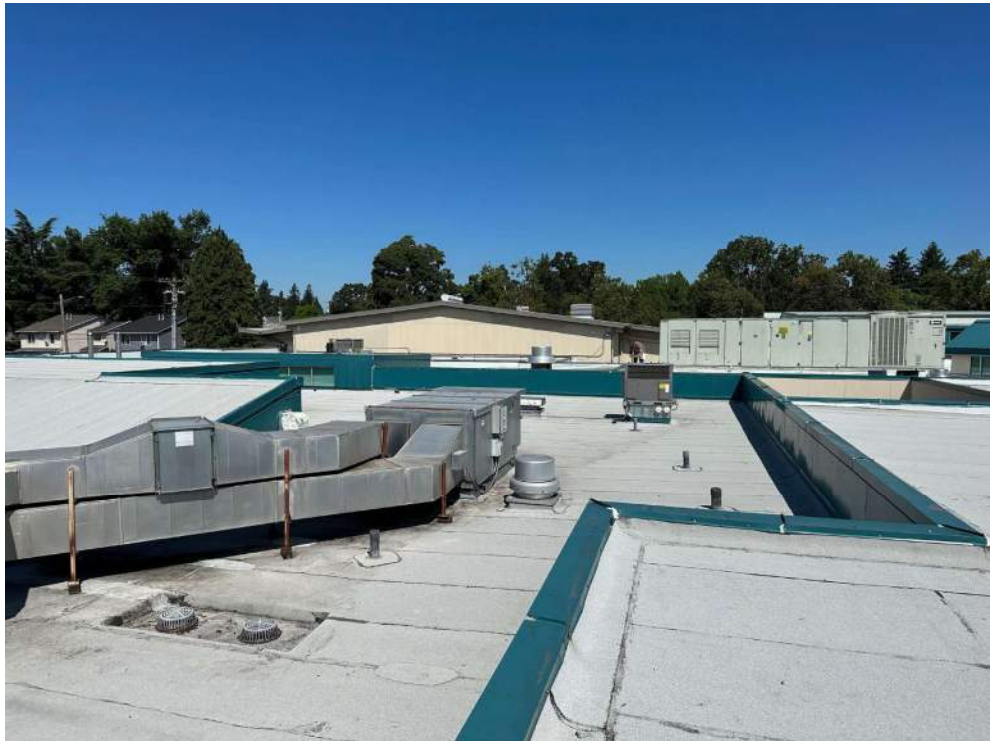
DUCTWORK WITH PATCHED LEAKS BELOW IN 2019 REFURBISHED ROOF AREA

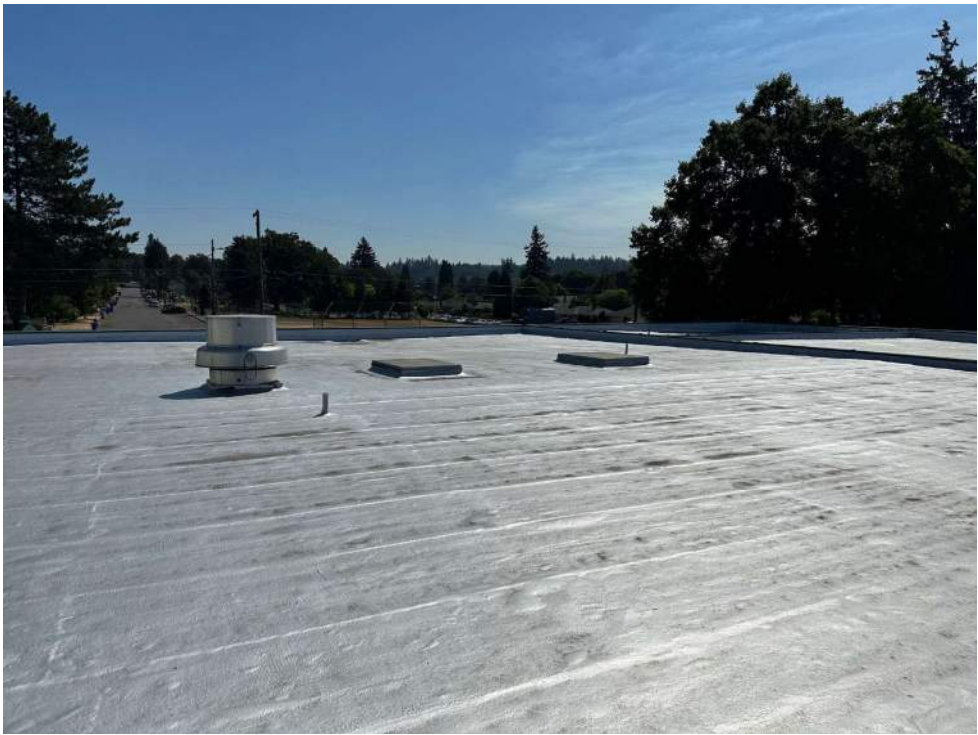
BLISTERS @ ALUMINUM EMULSION RESTORATION IN 2020

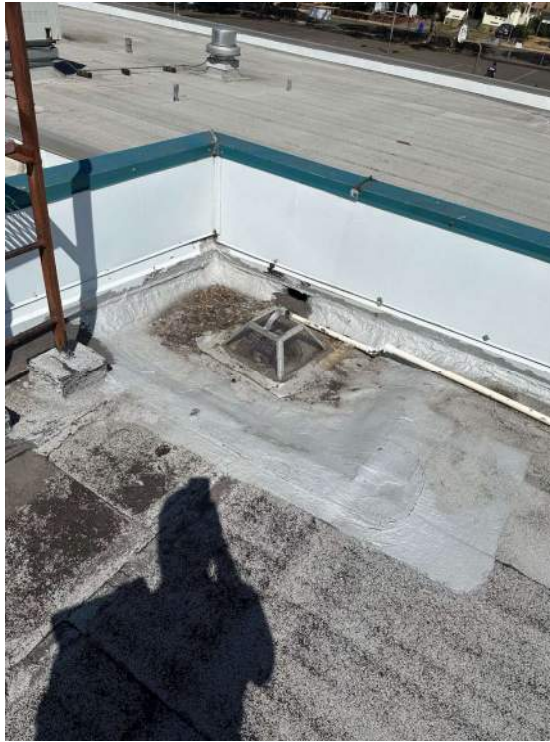
DRAIN PATCHING DUE TO LEAKS

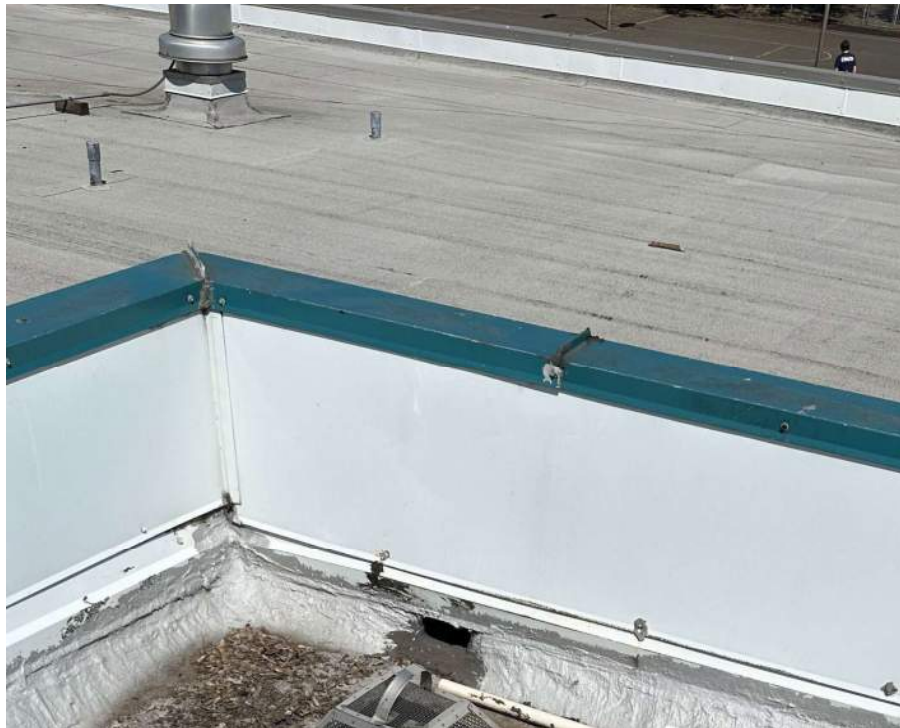
SHEET METAL WORKMANSHIP POOR – RELIANT UPON SEALANT

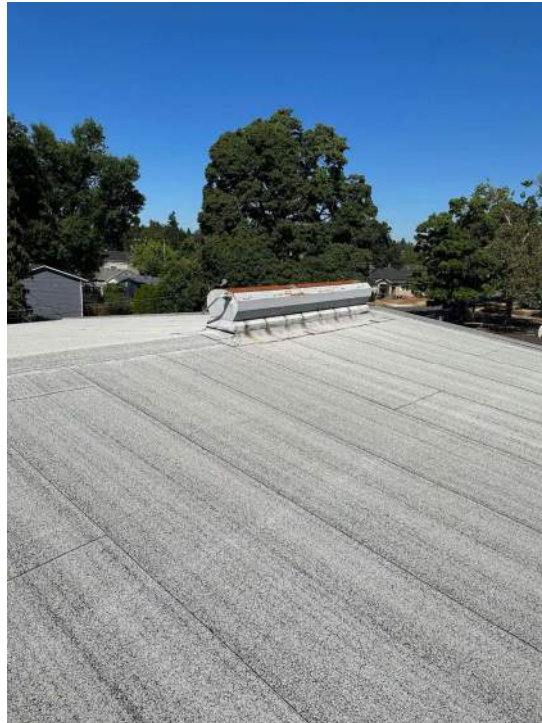
OLDER BUR HAS SIGNIFICANT GRANULE LOSS ON CAP SHEET

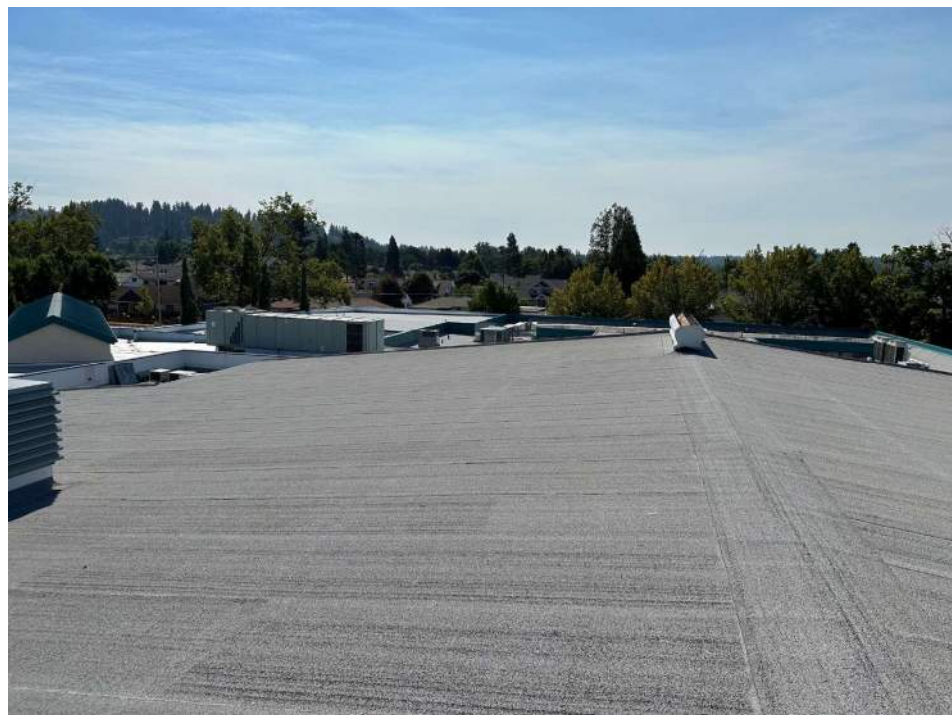
OLDER BUR HAS ALIGATORING AND GRANULE LOSS

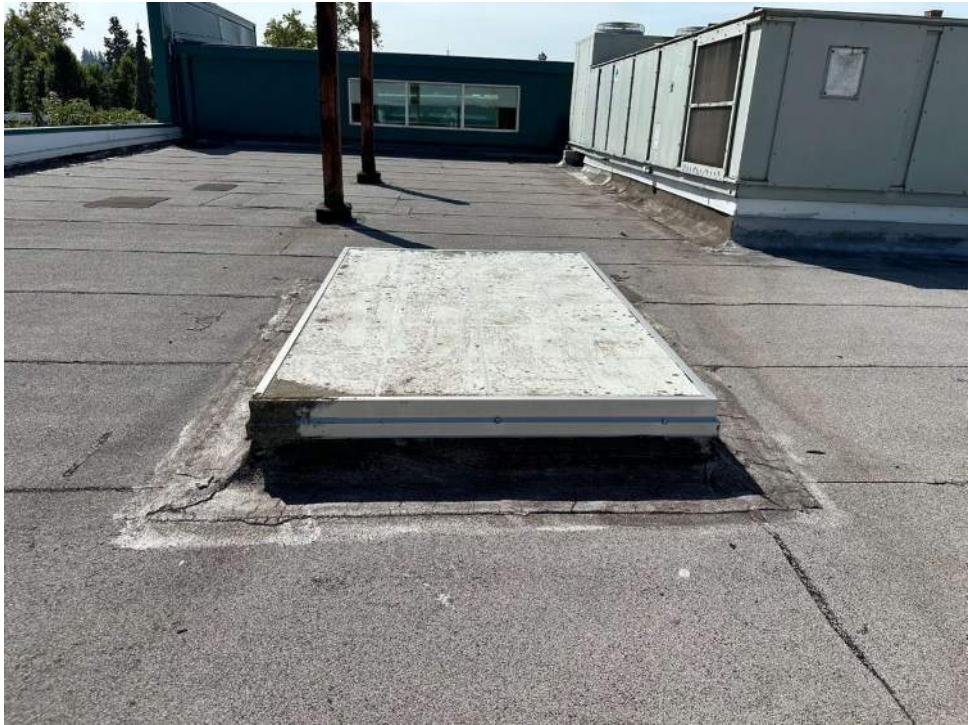
KALWALL SKYLIGHTS WITH UV DEGRADATION

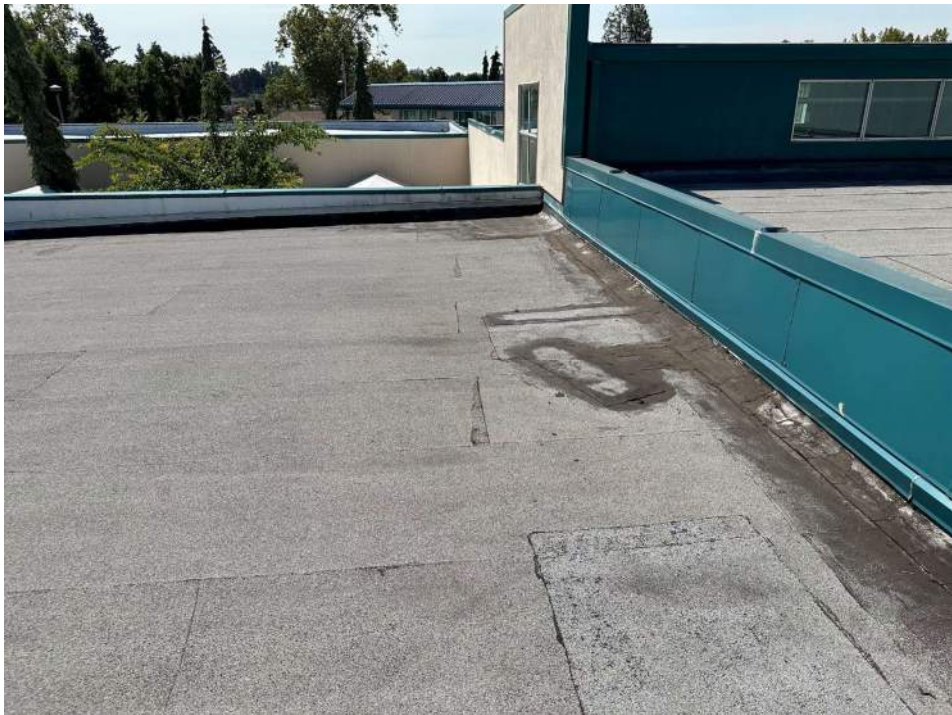
OLDER BUR AREAS WEARING OUT REQUIRING PATCHING

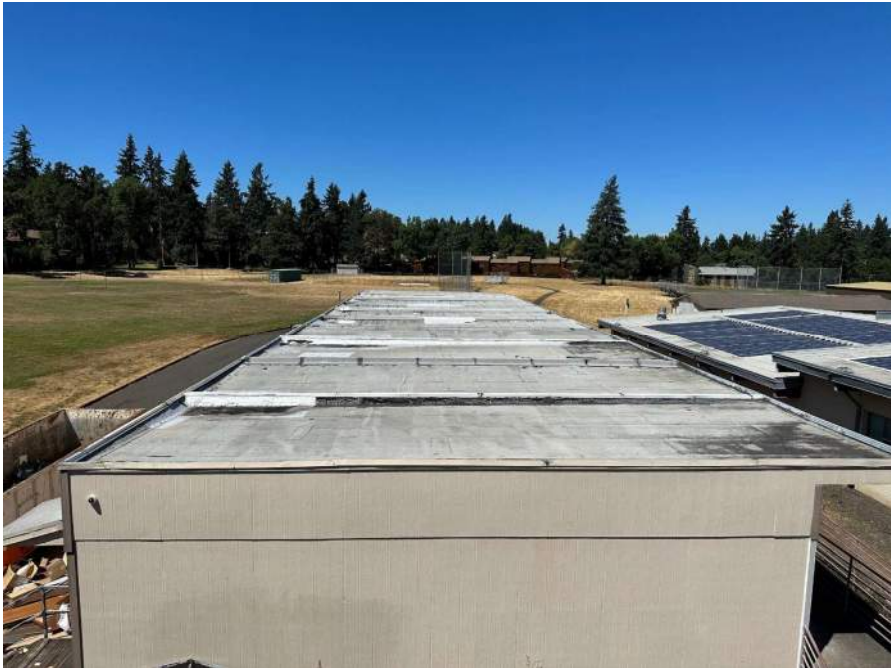
OLDER MODULAR UNITS TO BE REPLACED

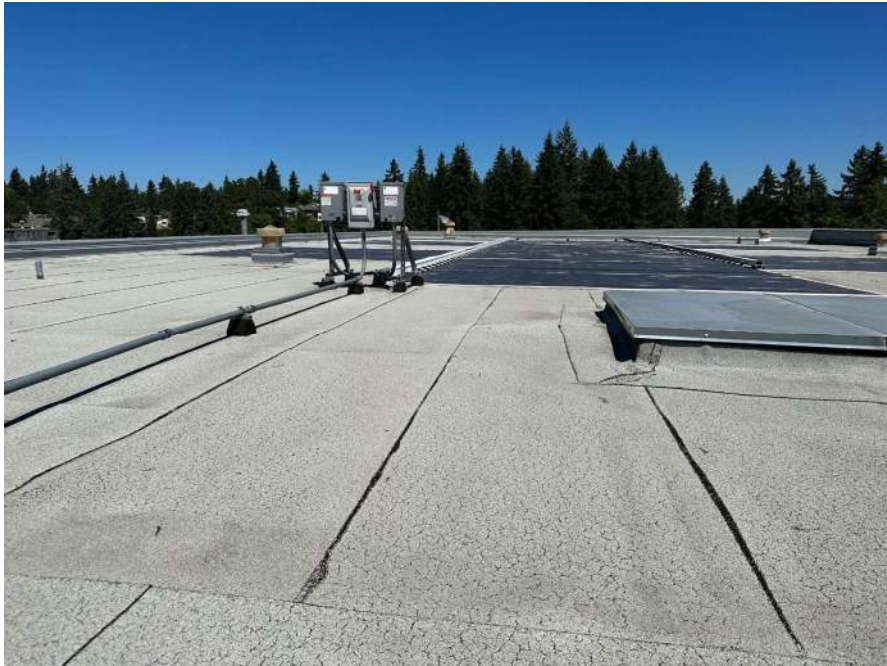
OLDER BUR CAP SHEET IS ALIGATORING AND BLISTERING

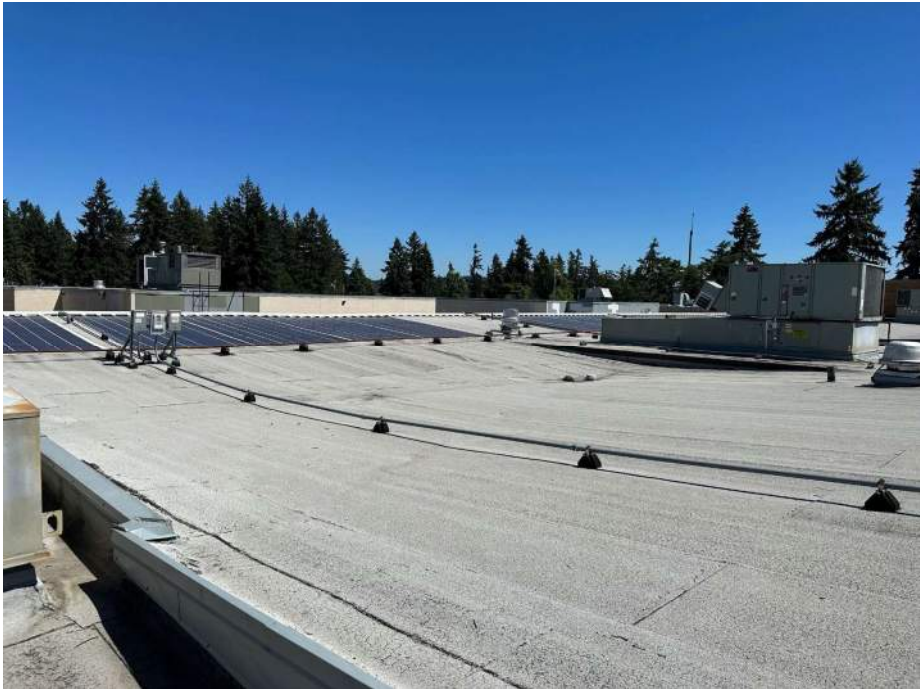
OLDER BUR PONDING ISSUES

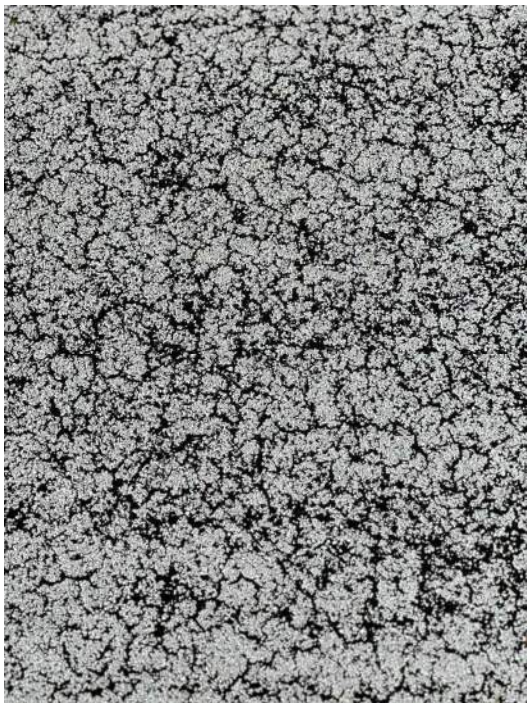
ALIGATORING IN CAP SHEET IN OLDER BUR

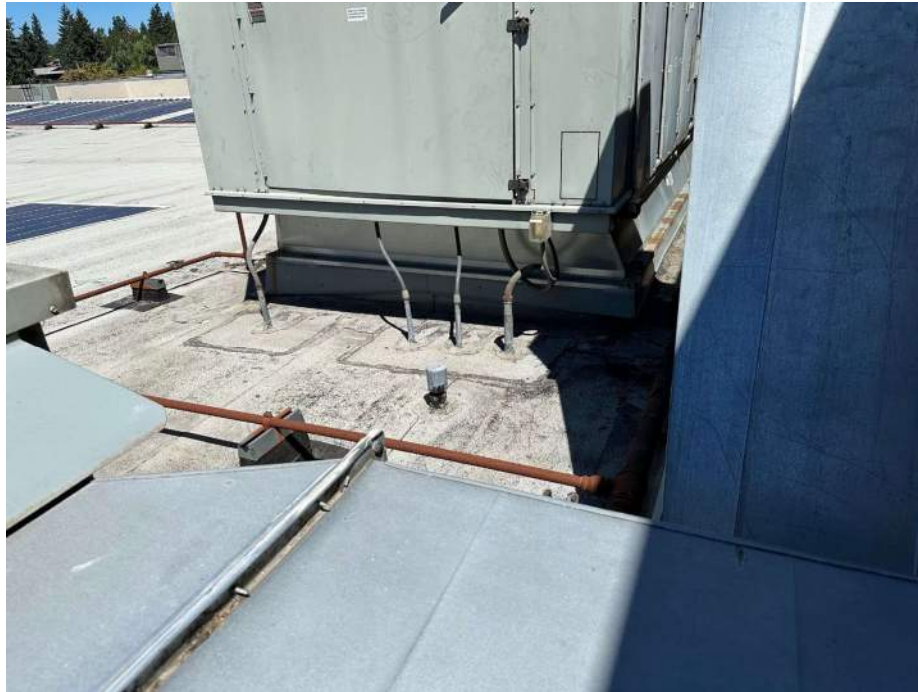
PATCHES AT OLDER BUR

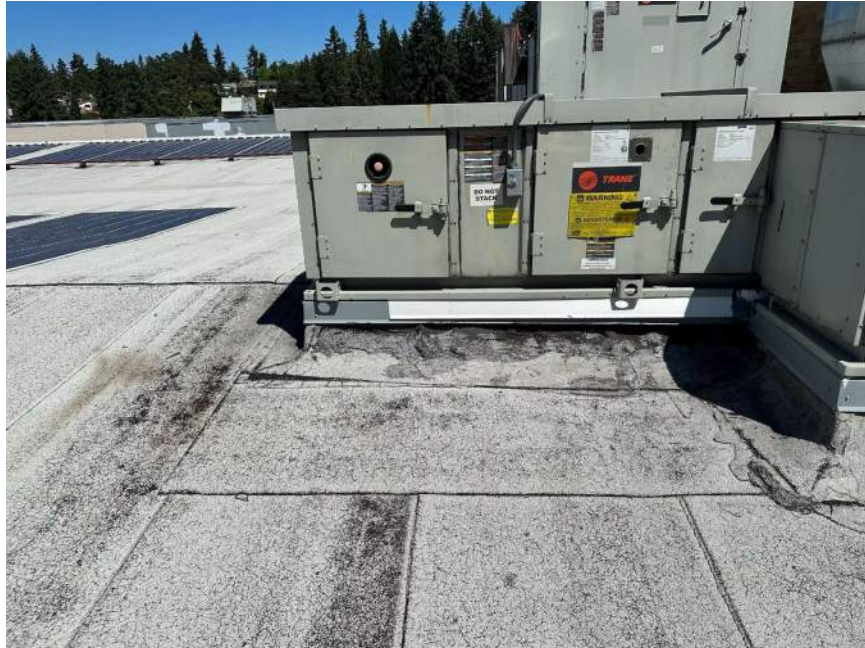
PATCHES AT OLDER BUR CURBS & GRANULE LOSS

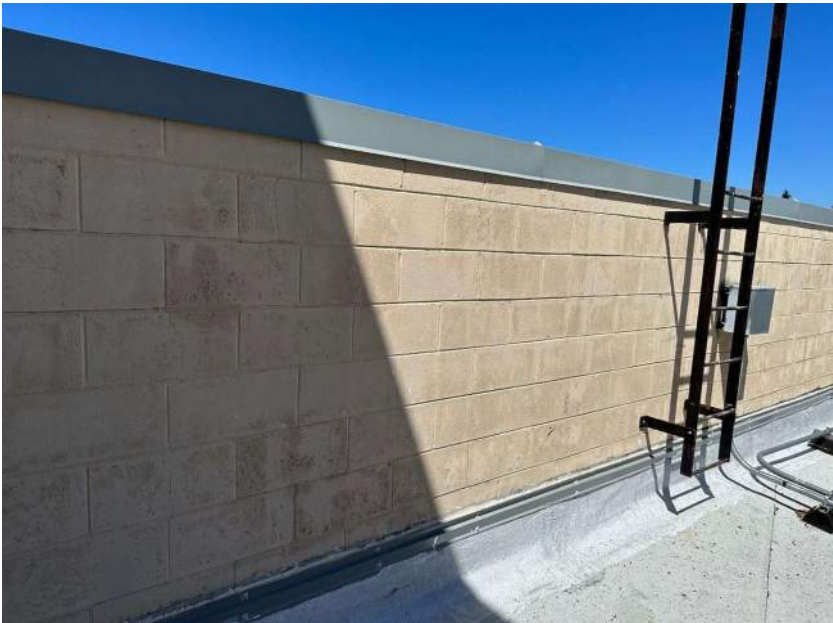
CMU WALL NEEDS ELASTOMERIC PAINT TO SEAL FROM WATER INTRUSION

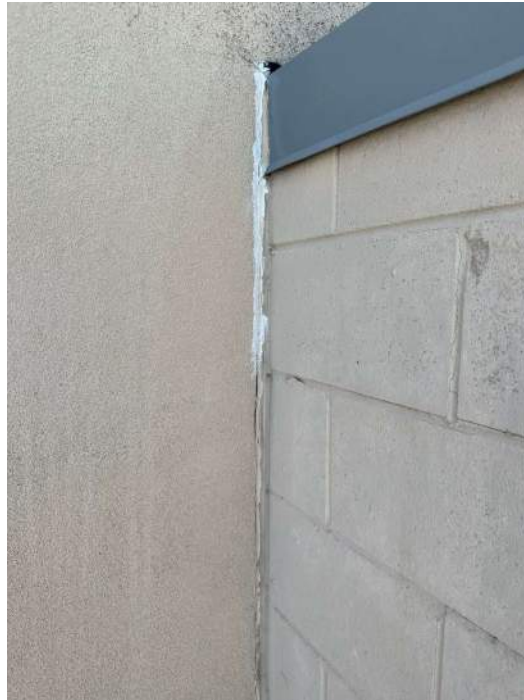
EFIS TO CMU JOINT REQUIRES NEW SEALANT

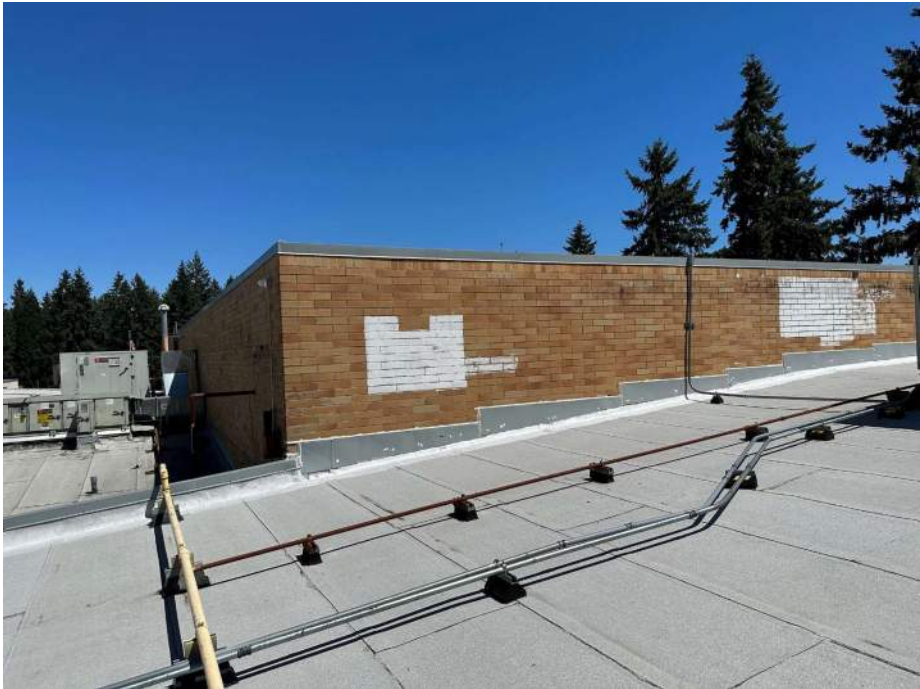
EXPOSED BRICK SHOULD BE SEALED

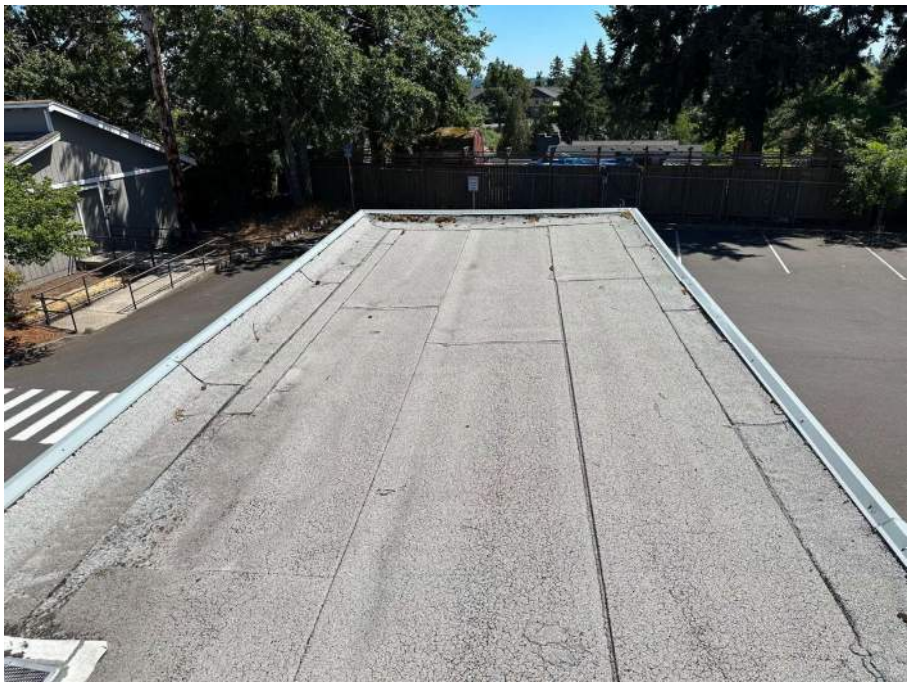
OLDER BUR WITH MOSS AND PONDING

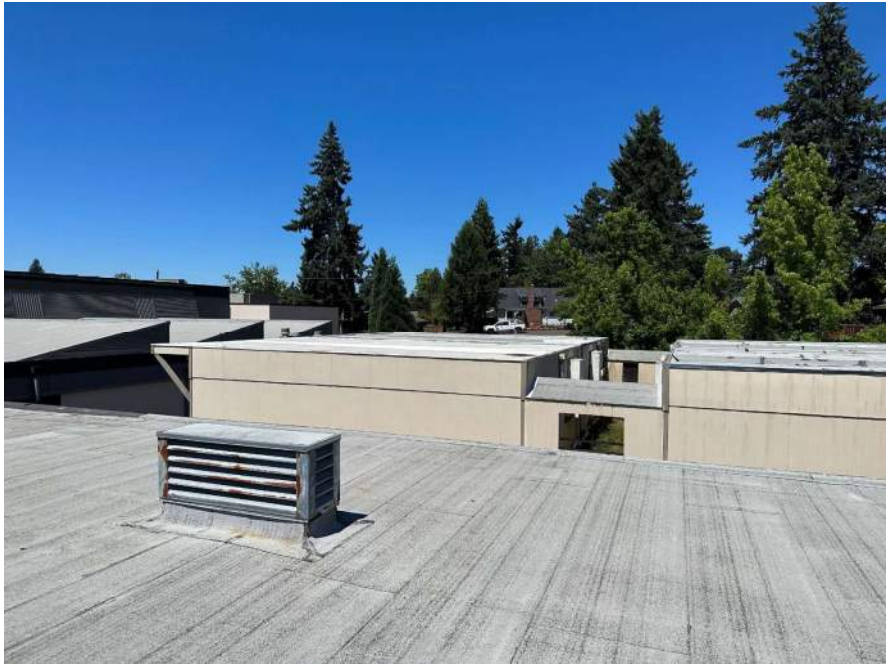
TYPICAL WORN OUT BUR CAP SHEET

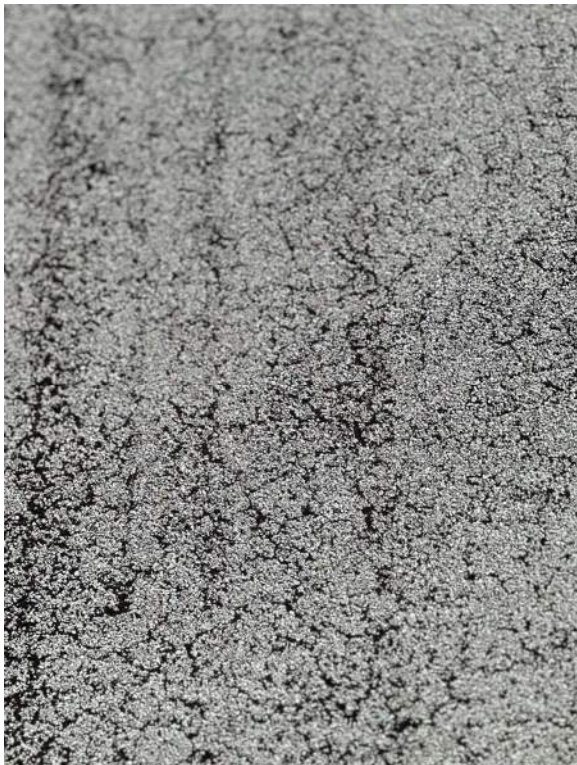
ALLIGATORING IN CAP SHEET

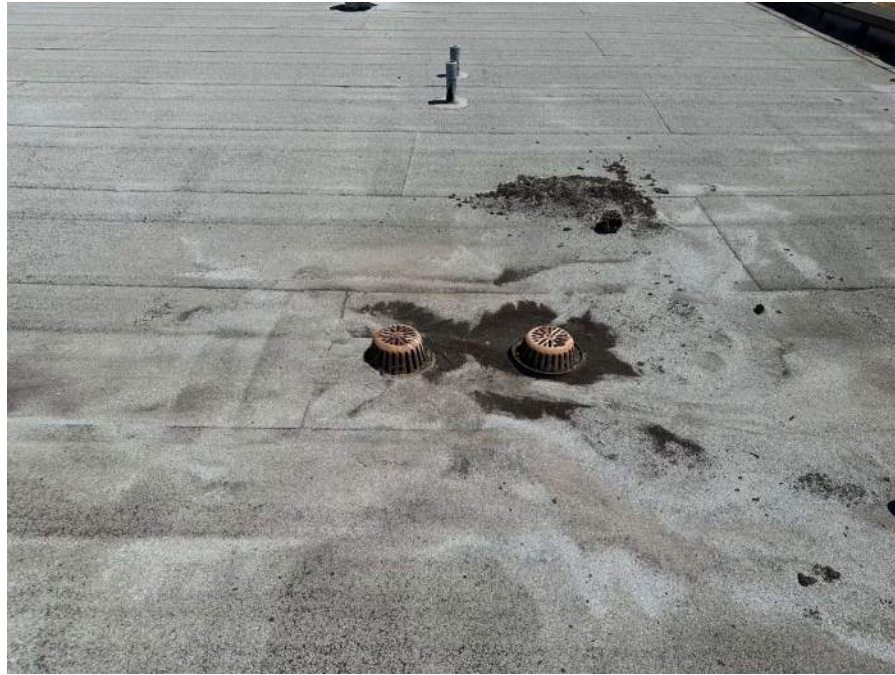
PONDING & BLISTERING @ DRAINS

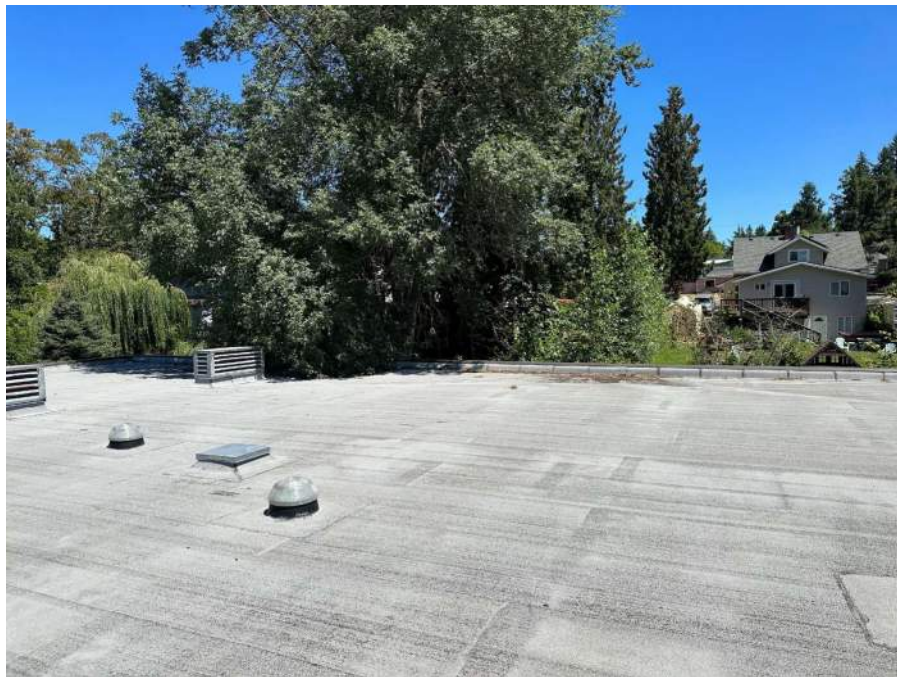
TREES DROPPING LEAVES CAUSING PREMATURE WEAR ON CAP SHEET

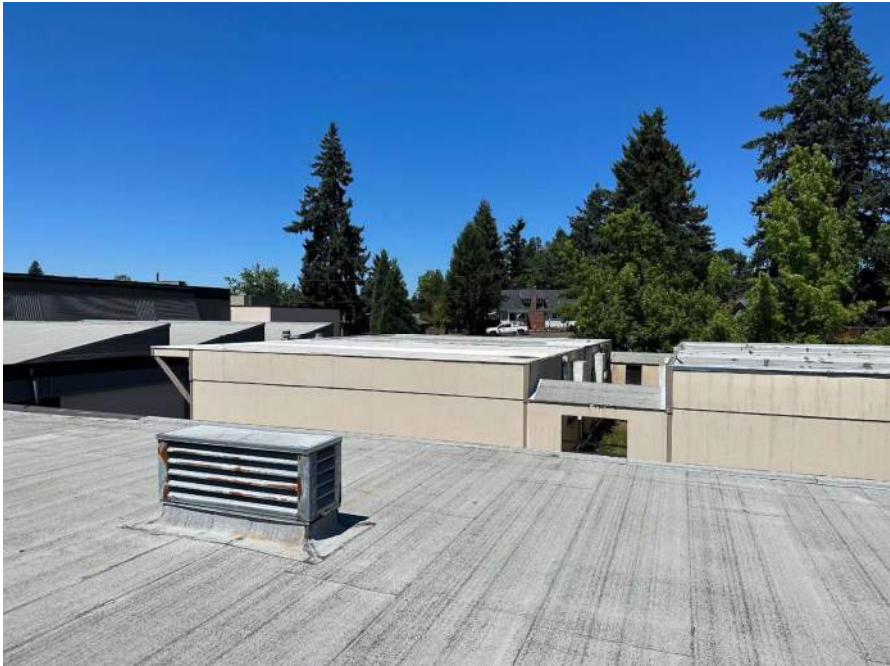
WORN CAP SHEET AND RUSTED VENTS

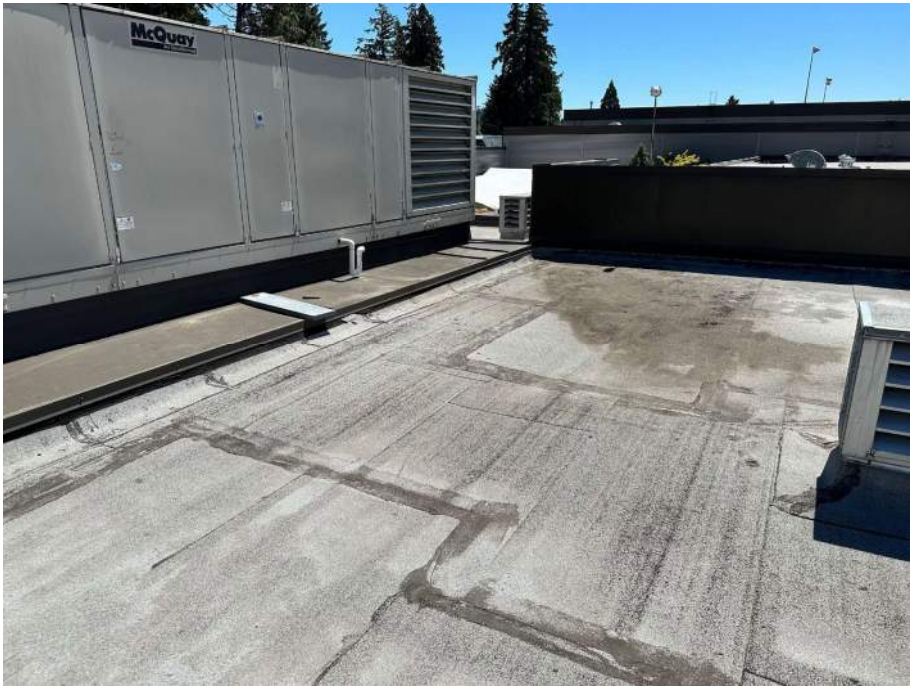
PONDING AND PATCHING

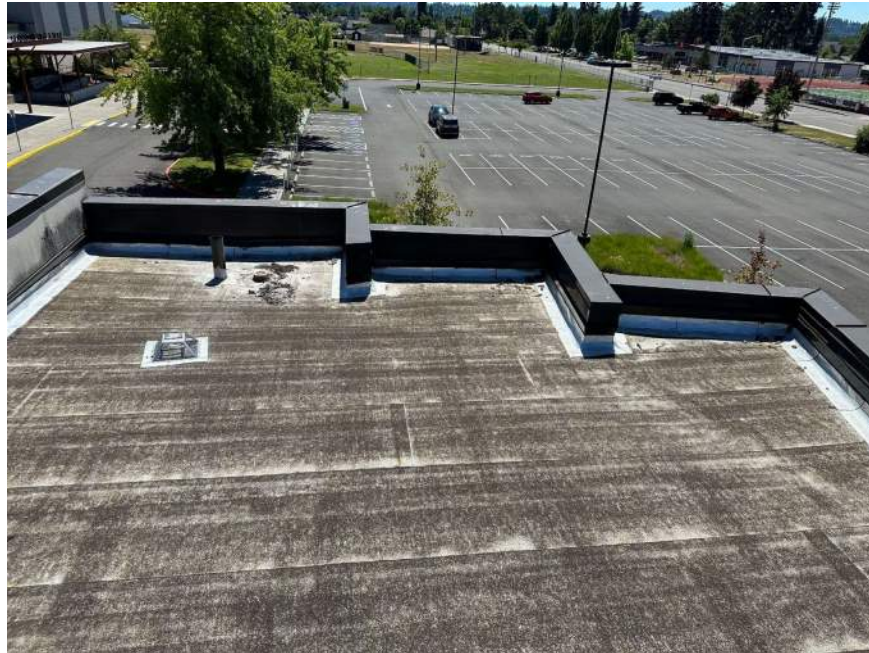
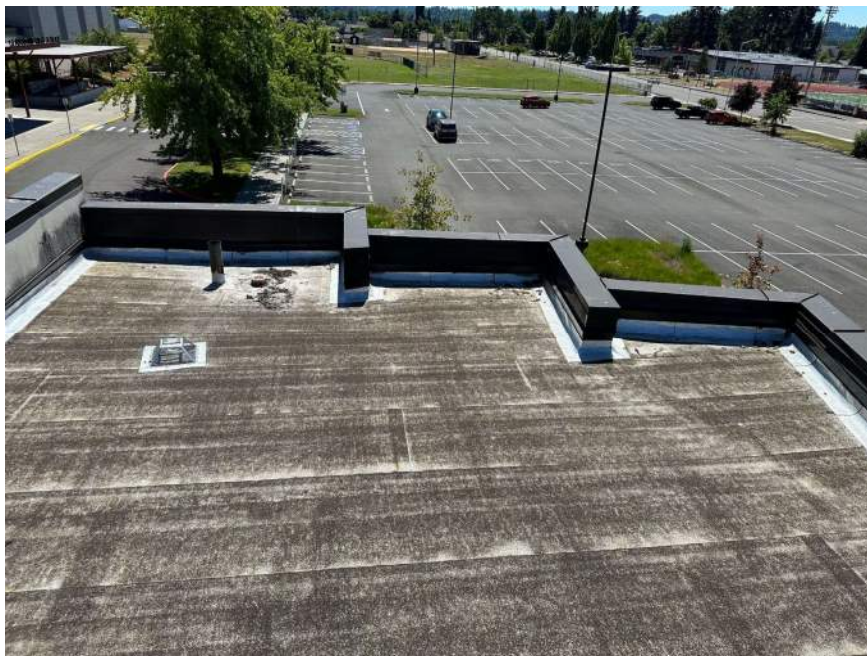
COMPLETELY WORN OUT CAP SHEET IN NEED OF IMMEDIATE REPLACEMENT OR COATING

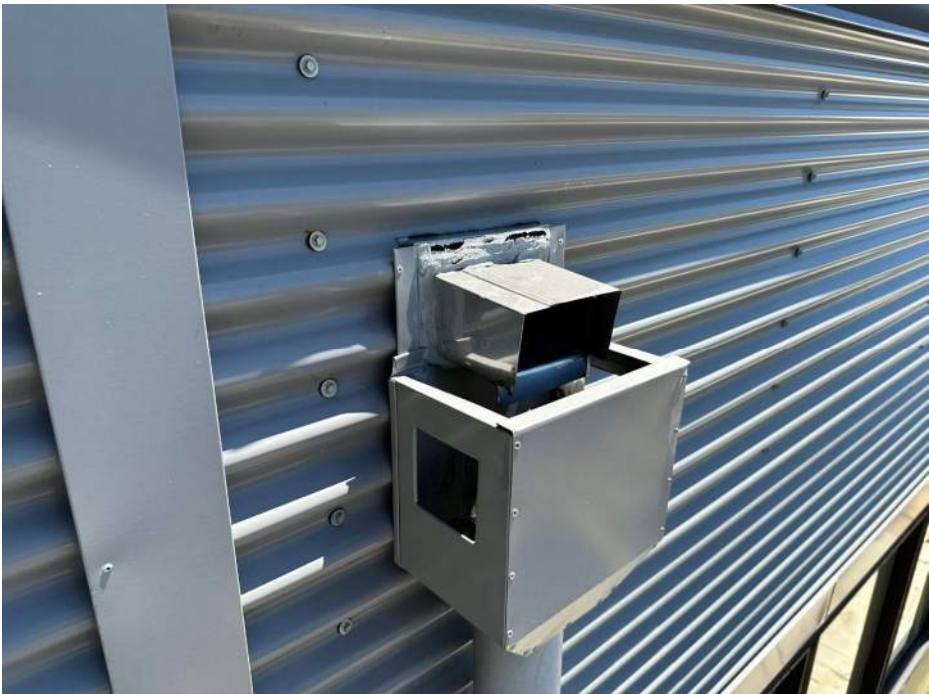
FAILED SEALANT AT SCUPPERS

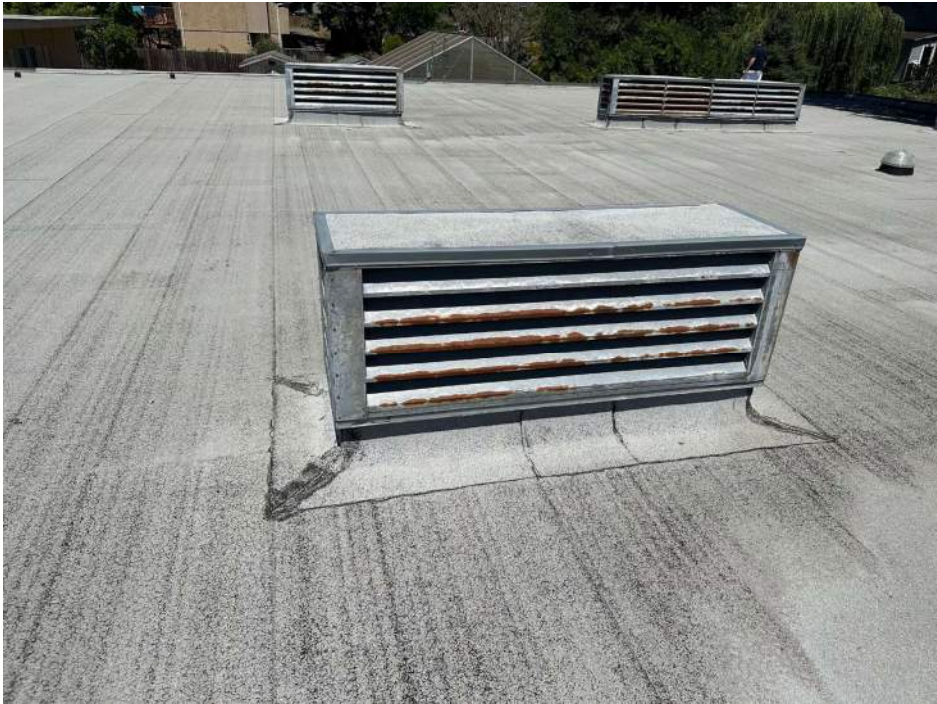
RUSTED VENT CAP

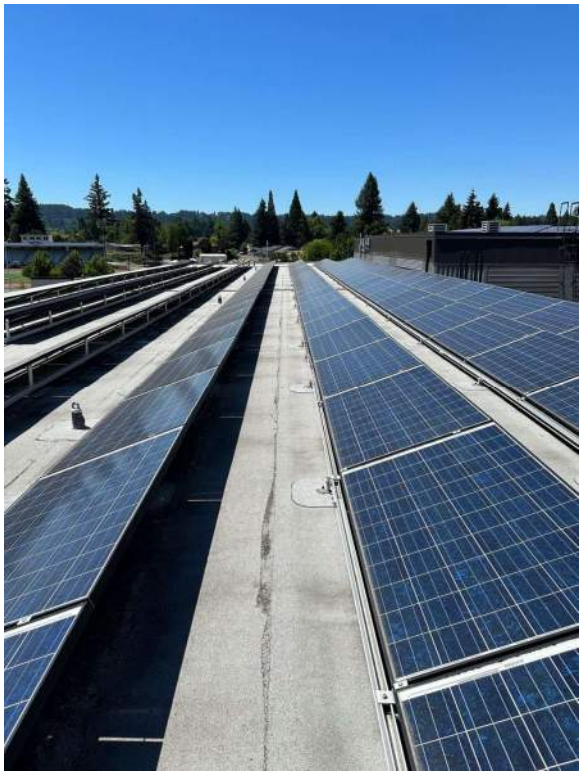
SOLAR PANELS WITH MULTIPLE PENETRATIONS

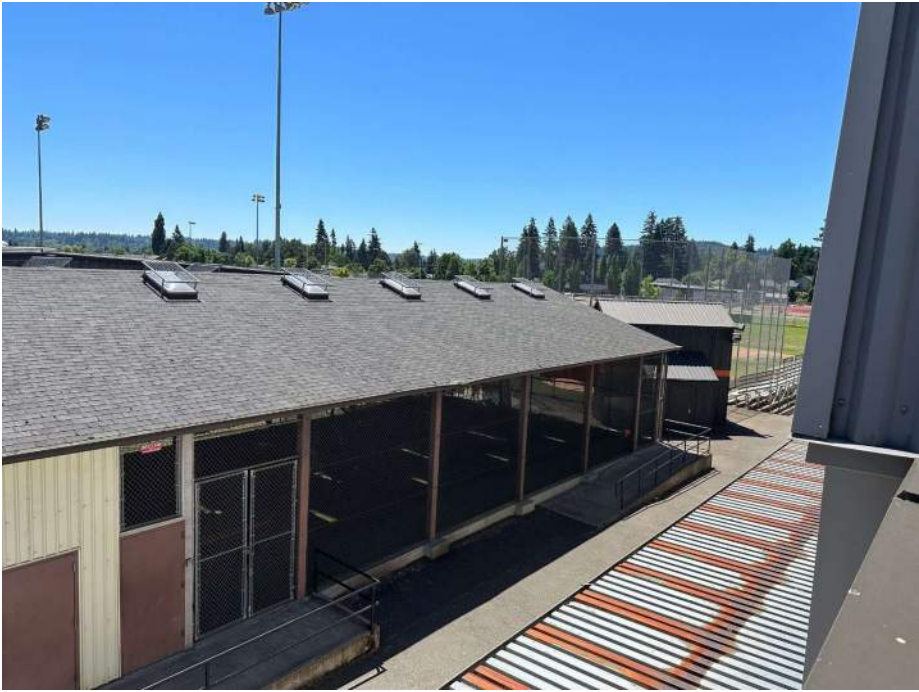
WORN OUT SHINGLES AND DAMAGED GUTTER

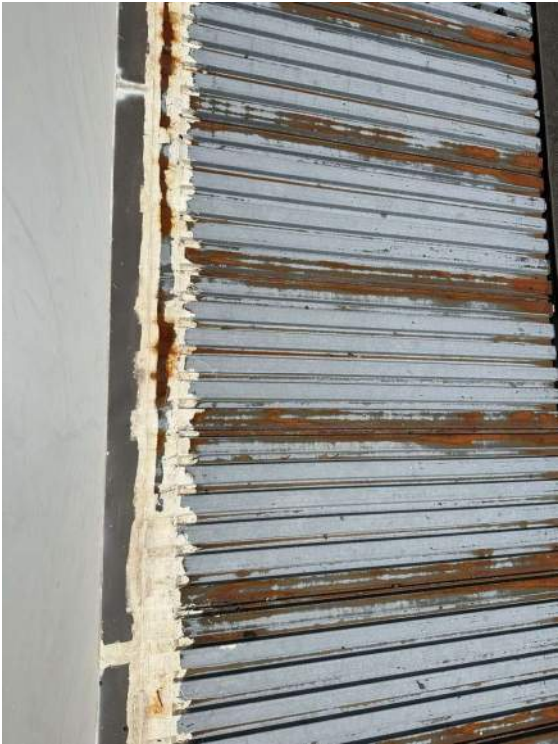
RUSTED STEEL CANOPY ROOF

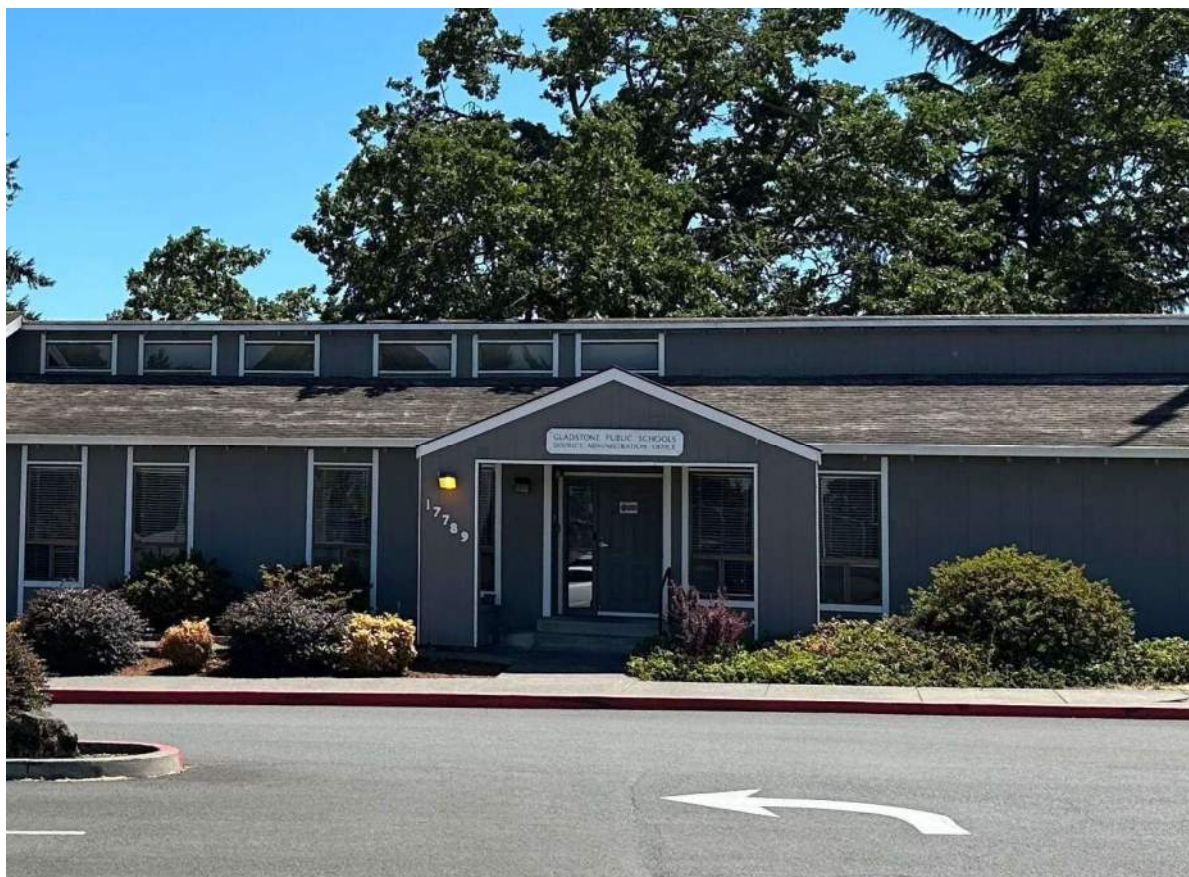
LOW SLOPE HAS CAUSED PREMATURE DETERIORATION, GRANULE LOSS AND BAKING

- Budget for shingle replacement in 1-3 years over ice and water shield.
- Replace all rake boards and consider fascia boards all wrapped in SAHT vapor barrier and 24 ga. Metal at the time of re-roofing.
- Review attic ventilation and insulation levels to increase shingle life cycle.

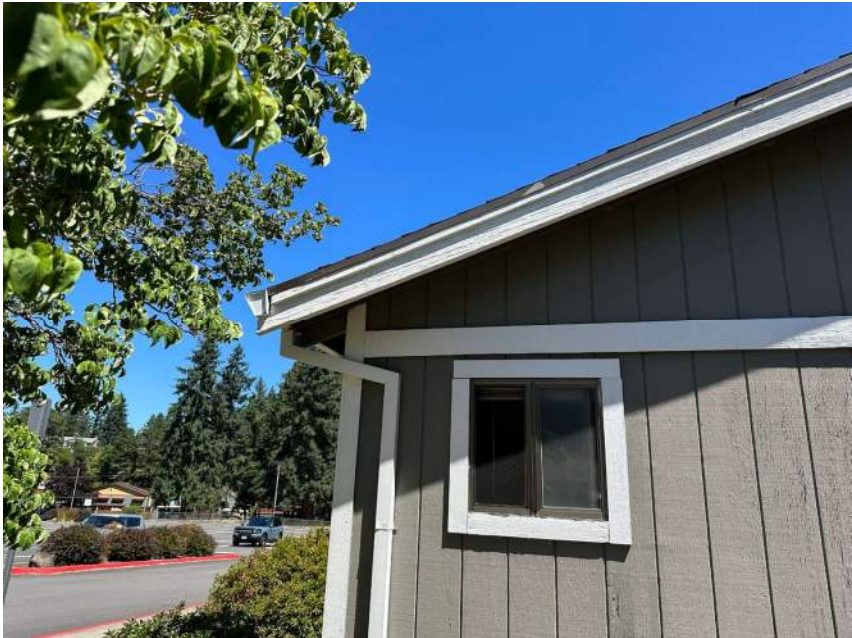
RAKES SHOULD BE REPLACED AND COVERED WITH METAL

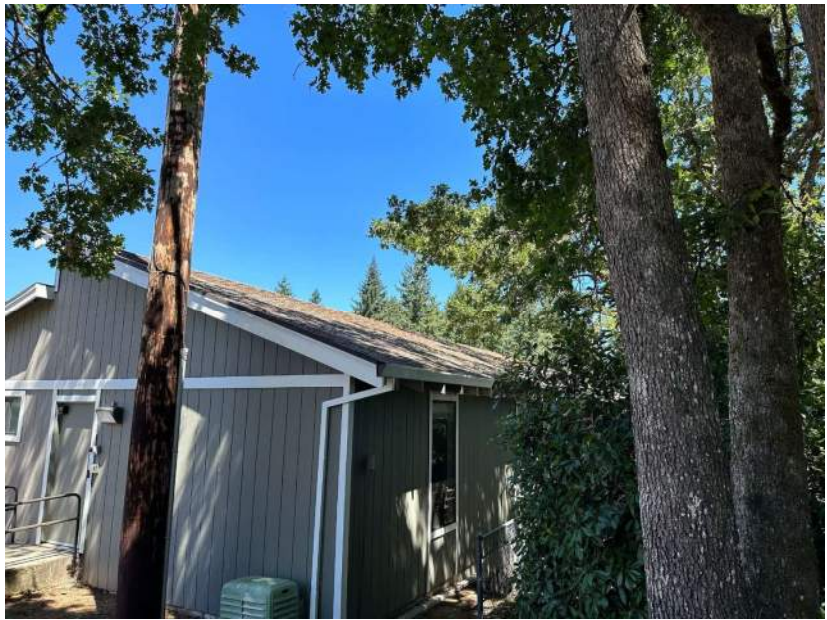
SHINGLES SHOULD BE REPLACED OVER ICE AND WATER SHIELD DUE TO LOW SLOPE

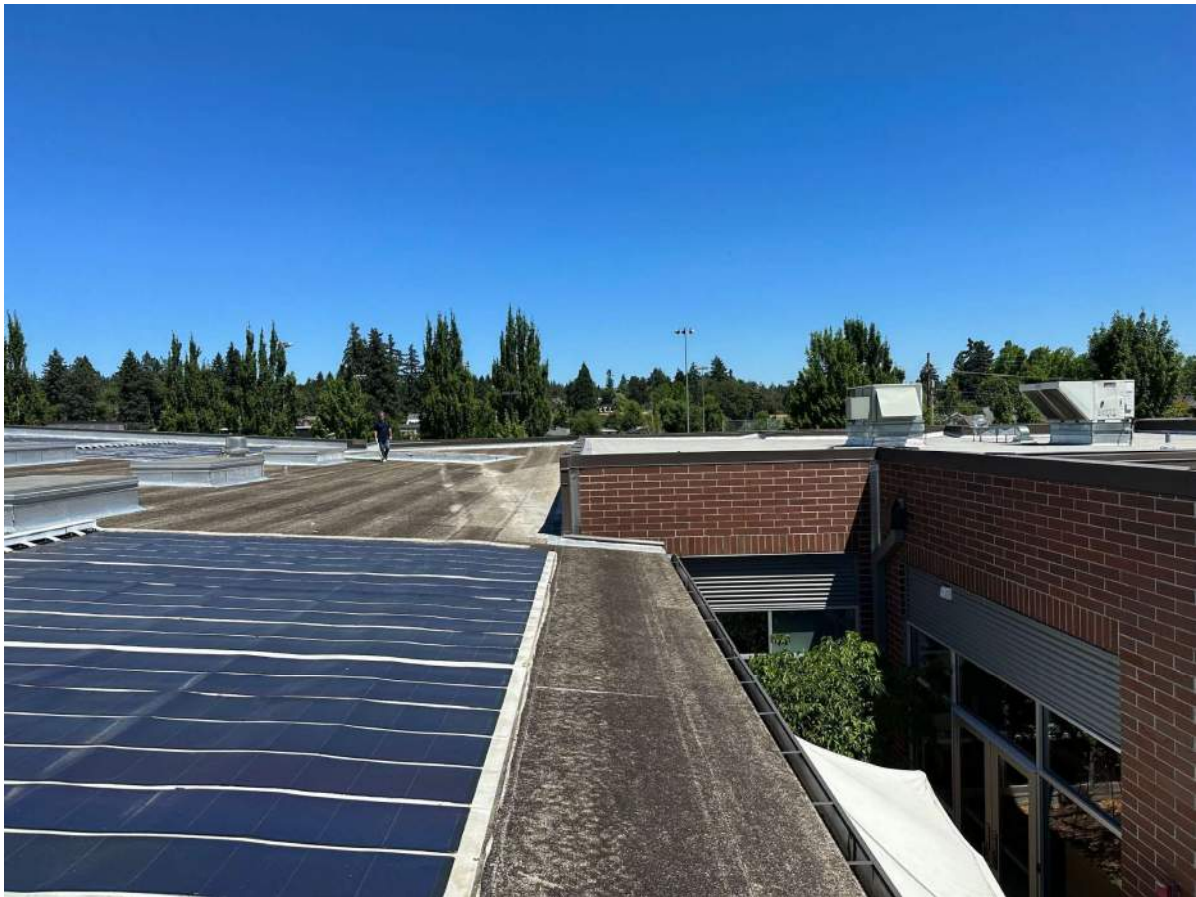
CAP SHEET IS COMPELTELY WORN WITH NO GRANULES TO PROTECT FROM UV

- Budget to replace entire roof next year.
- Consider a moisture study to identify wet insulation and potential dry rot prior to roofing.
- Determine impacts of rollout solar panels on re-roofing.
- Review insulation and ventilation conditions prior to re-roofing.

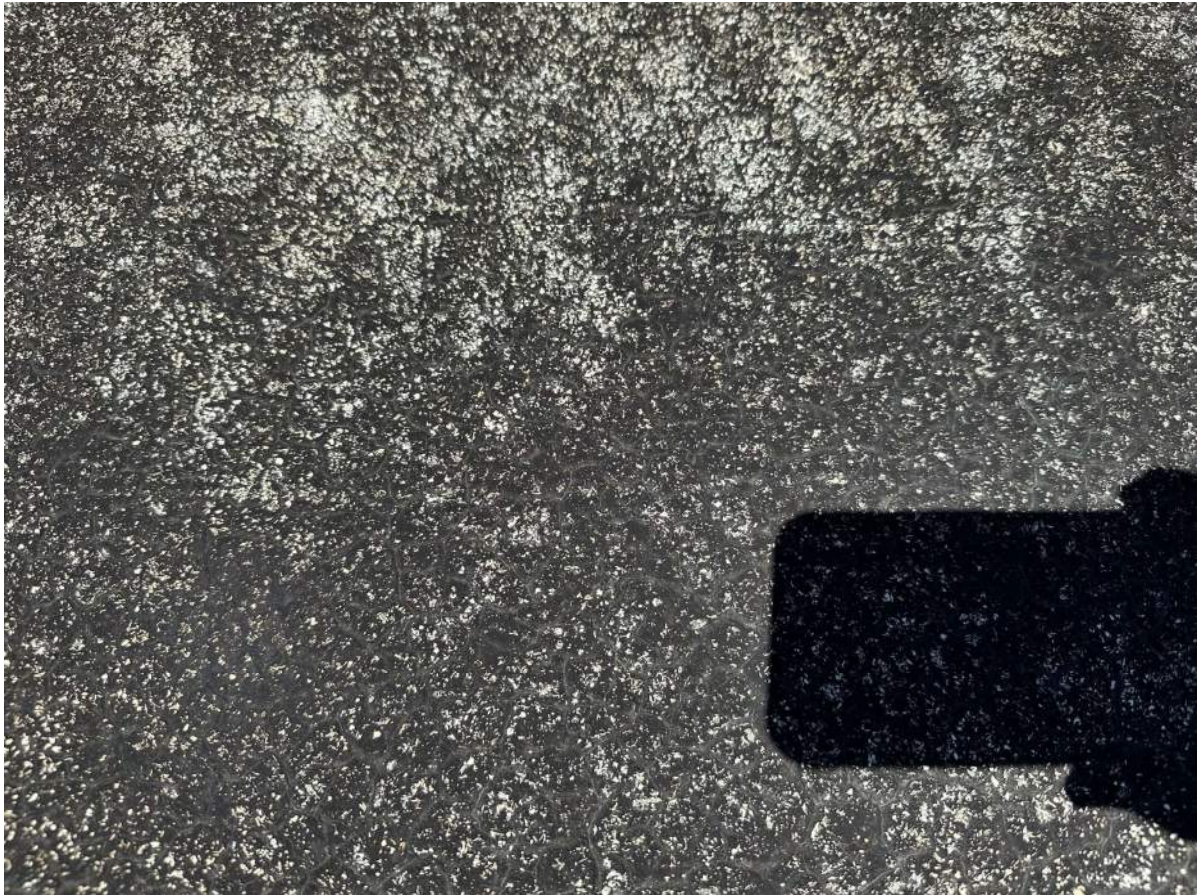
NEARLY ALL GRANULES ARE GONE EXPOSING BASE SHEETS TO UV
