GLADSTONE SCHOOL DISTRICT

Facilities Assessment Report

BRIC ARCHITECTURE, INC. JULY 2024

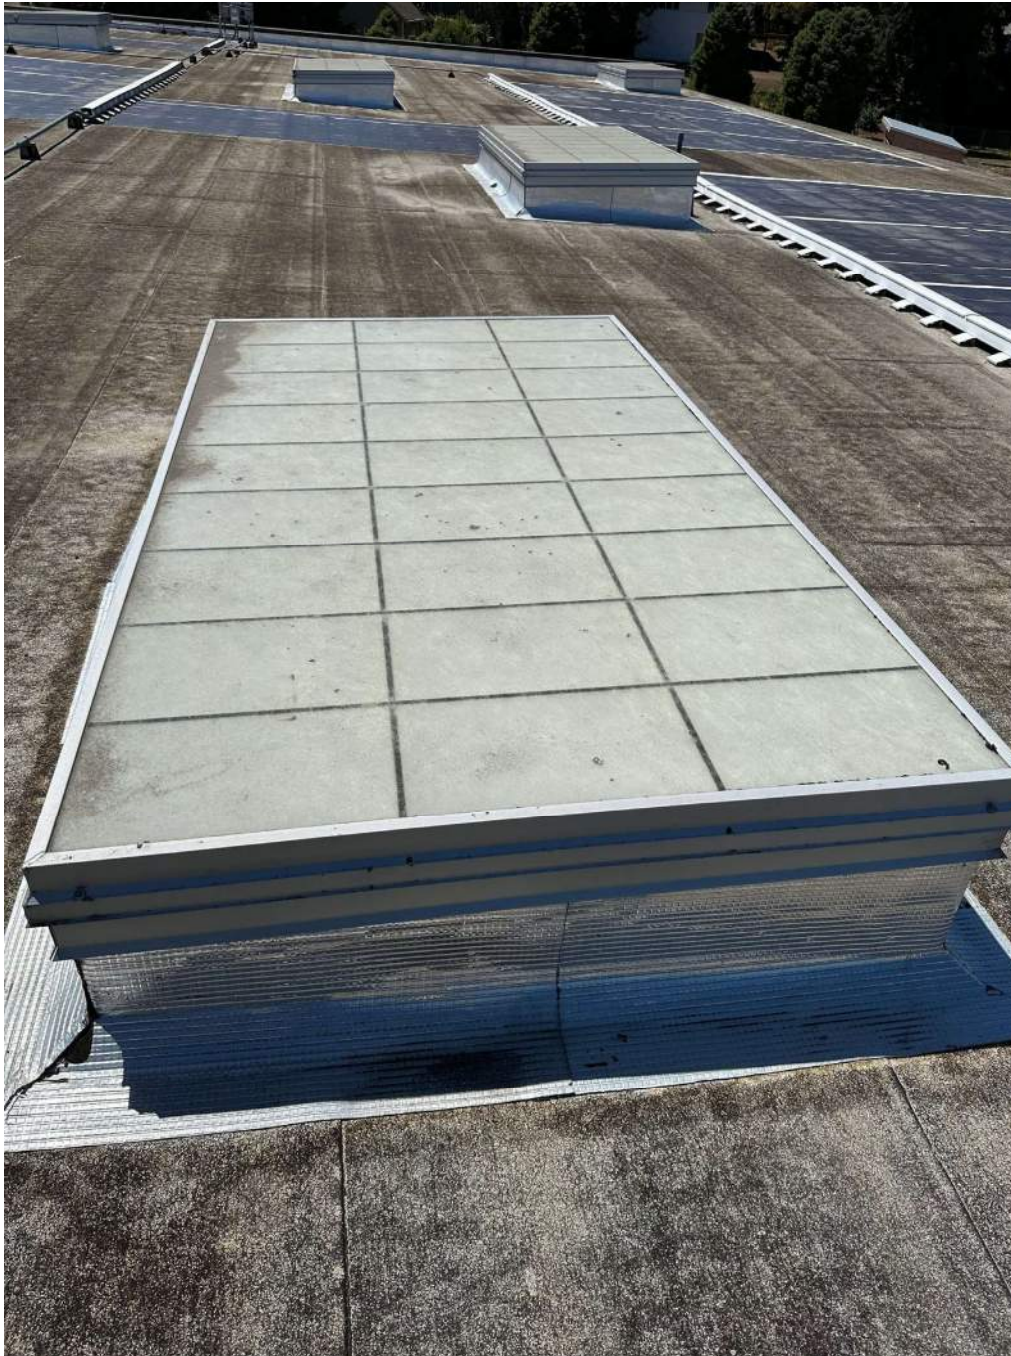
SKYLIGHT CURB LEAKS AND UV DEGRADATION

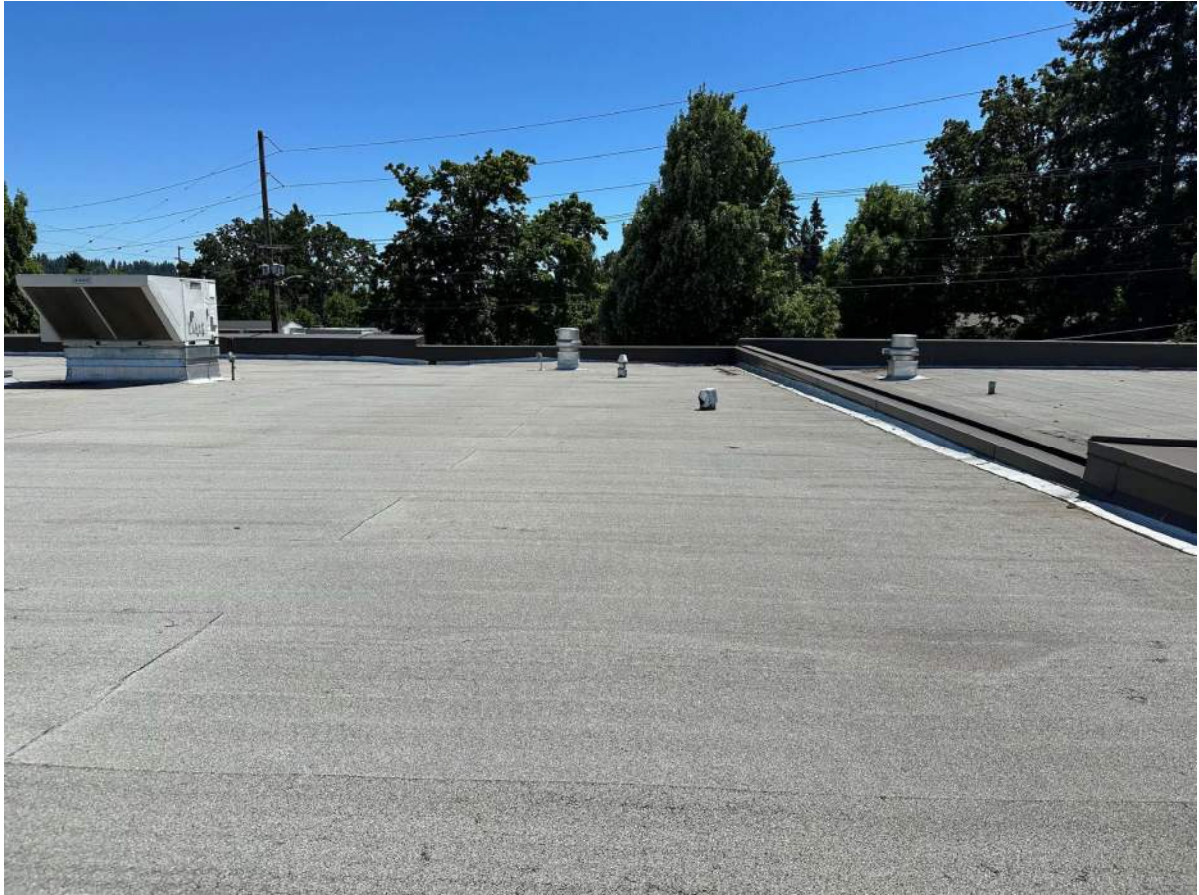
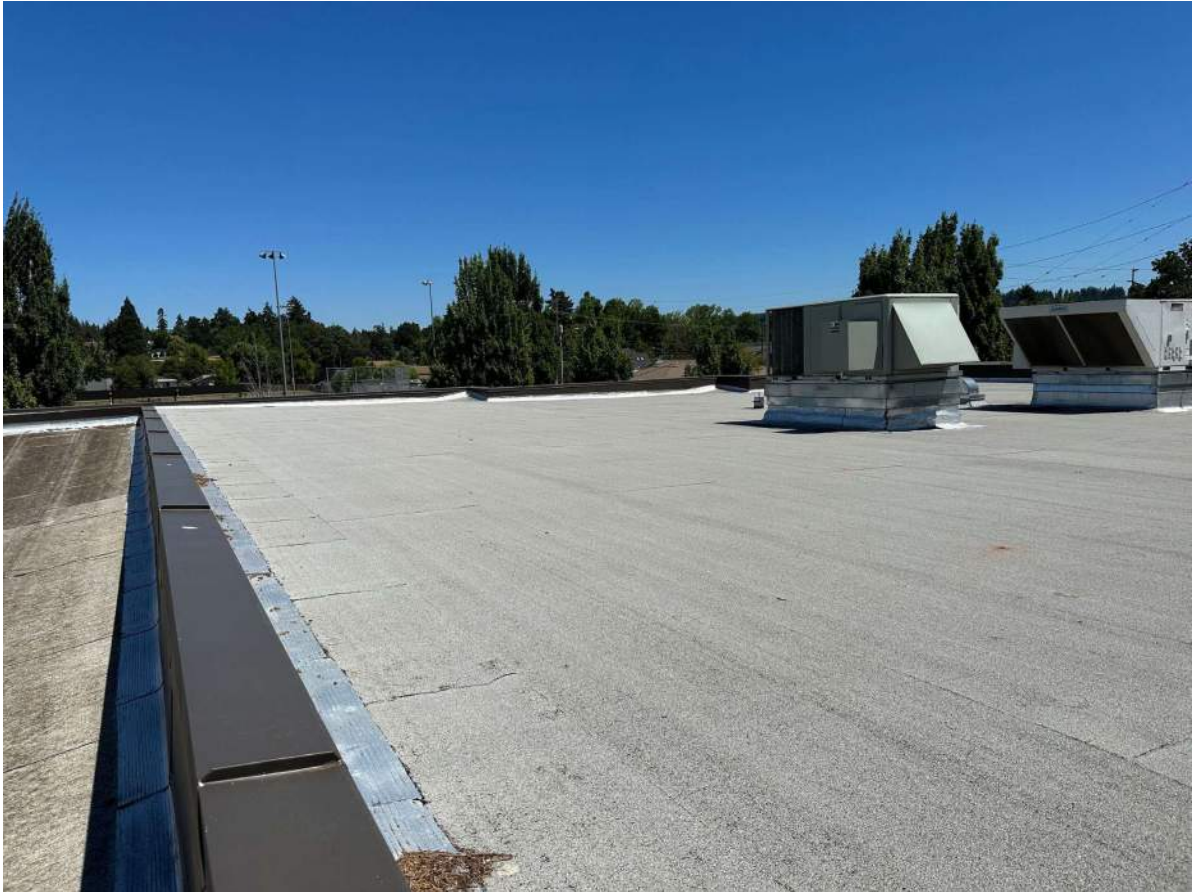
NEWER BUR WITH EDGE REINFORCING – BEGINNING TO WEAR
