School Type by Count

School Type	SqFt
Elementary School	210,625
Middle School	171,828
K-8	31,817
High School	259,720
Total:	673,990

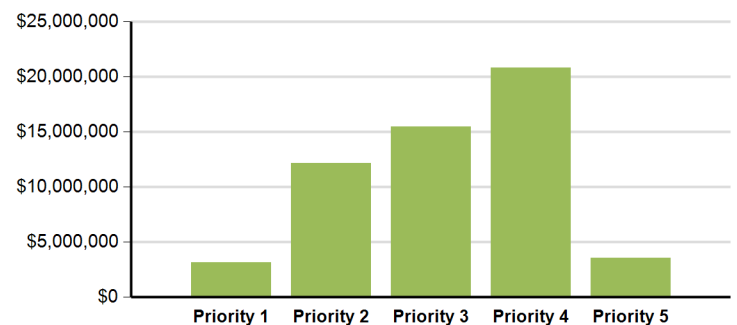
Five Year Need Summary

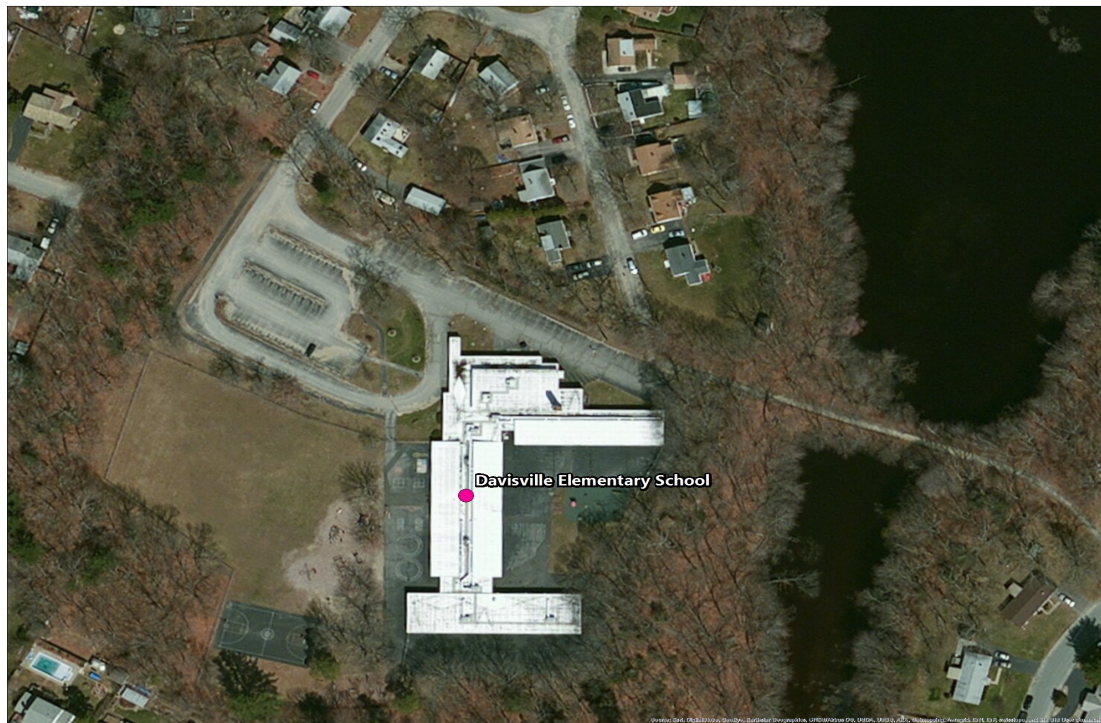
Figure 1: Aerial view of Davisville Academy

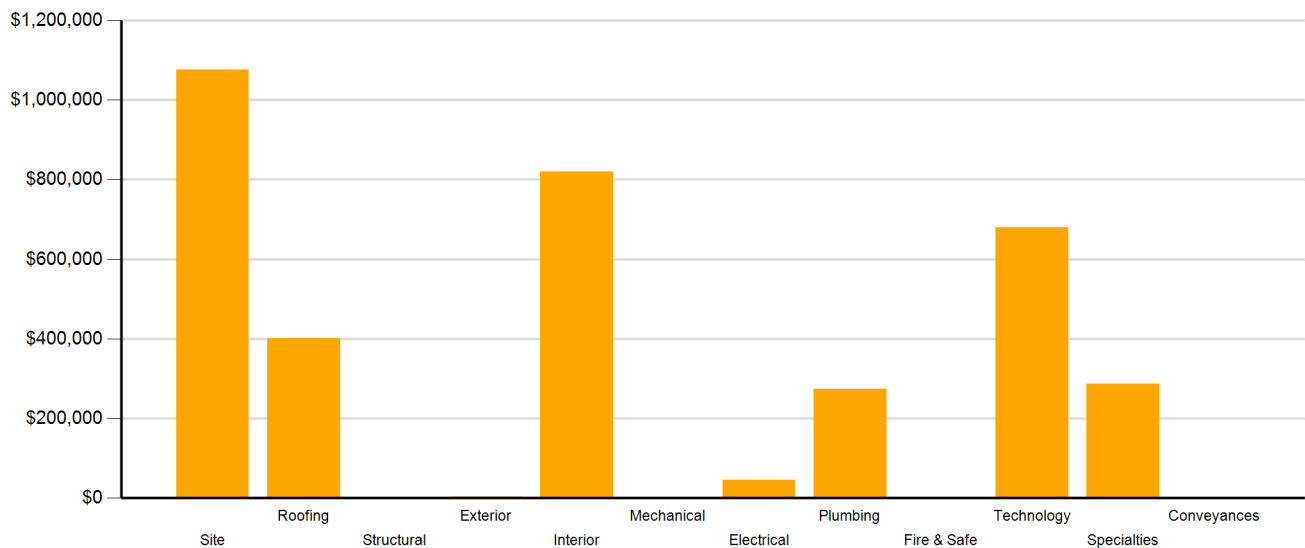
Figure 2: System Deficiencies

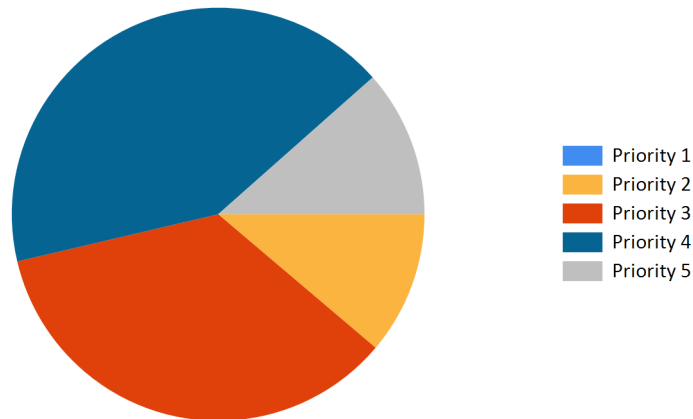
Figure 3: Current deficiencies by priority

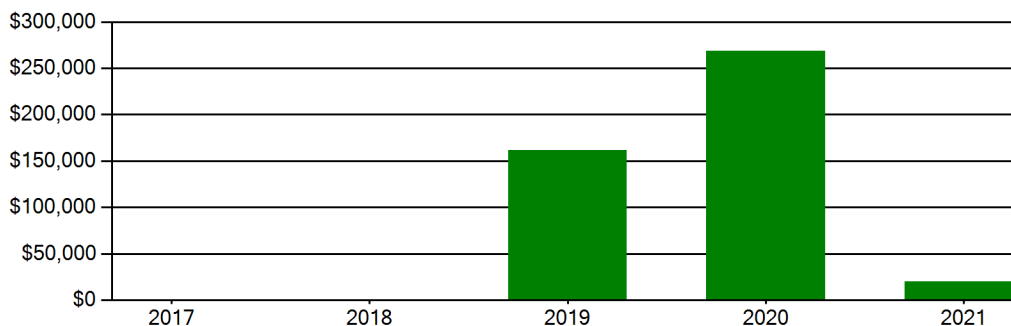
Figure 4: Life Cycle Capital Renewal Forecast

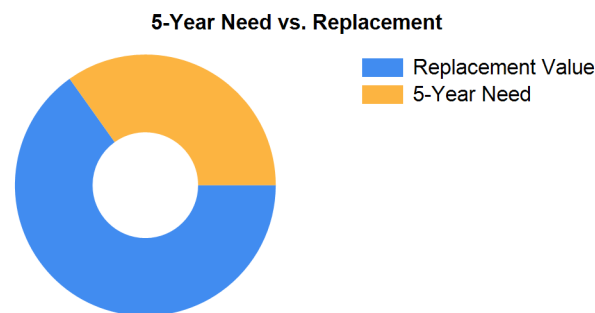
Figure 5: 5-Year FCI

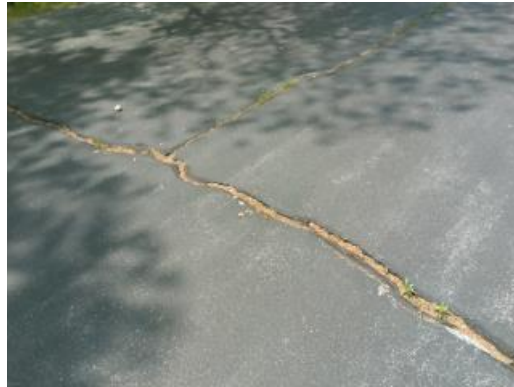
Cracked Asphalt Roadway

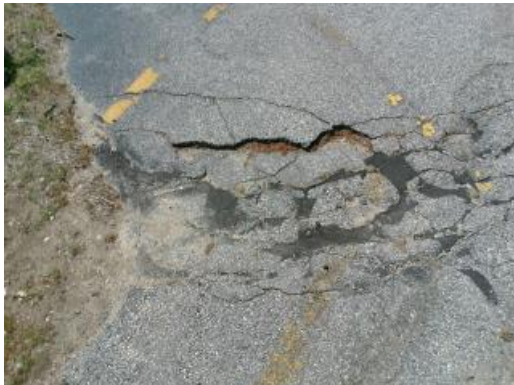
Deteriorated Asphalt Paving

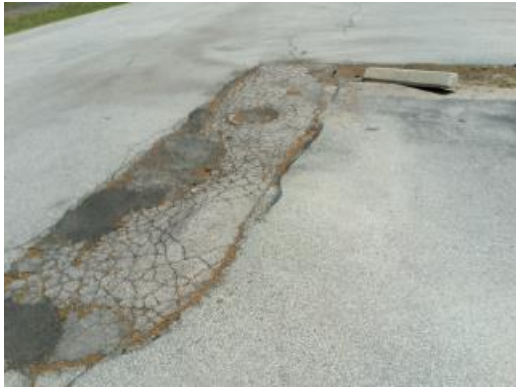
North Kingstown - Davisville Academy

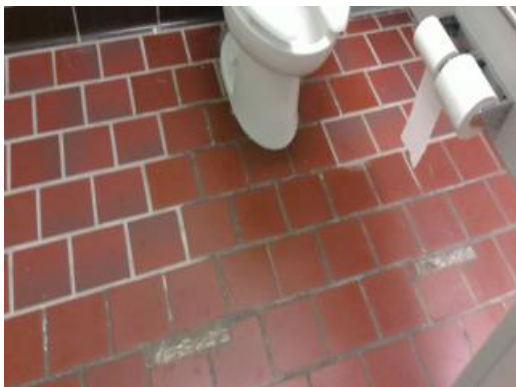
Cracked Ceramic Tile

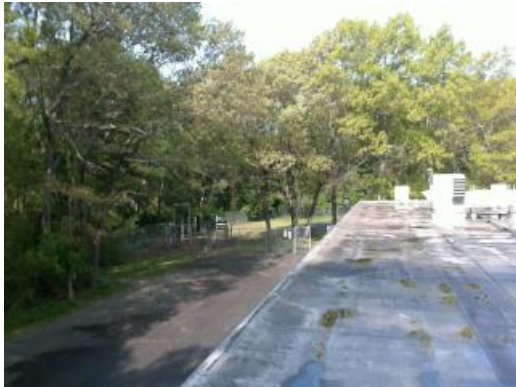
Weathered Roof With Ponding

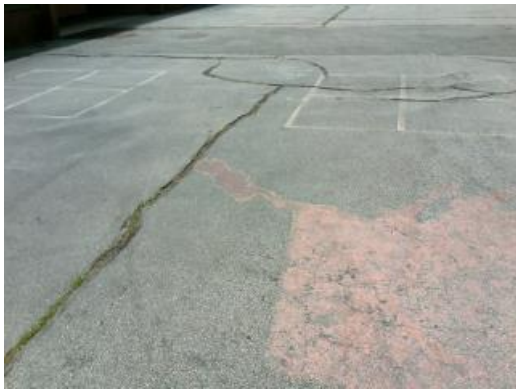
Weathered Asphalt Play Area

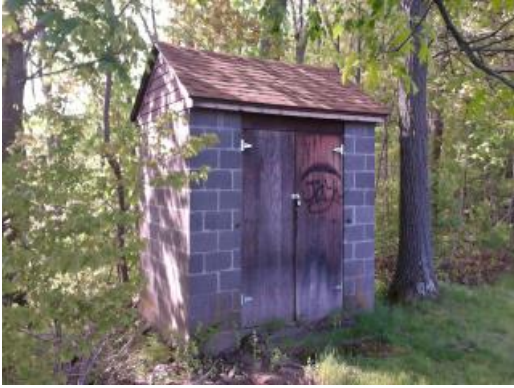
North Kingstown - Davisville Academy

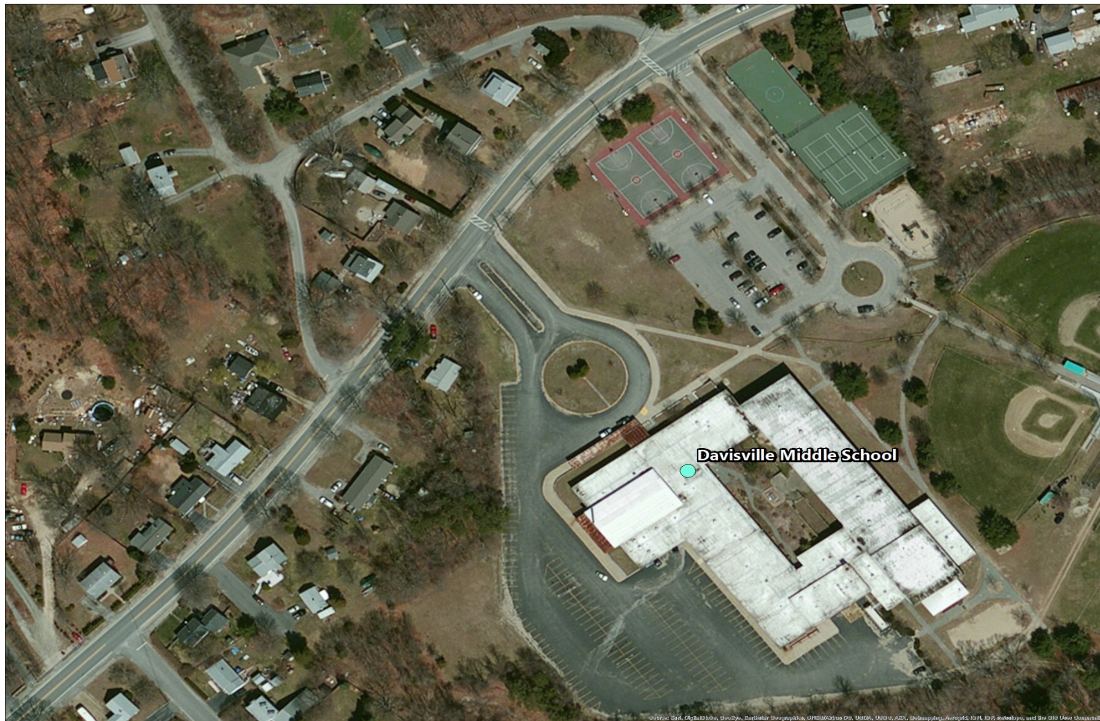
Figure 1: Aerial view of Davisville Middle School

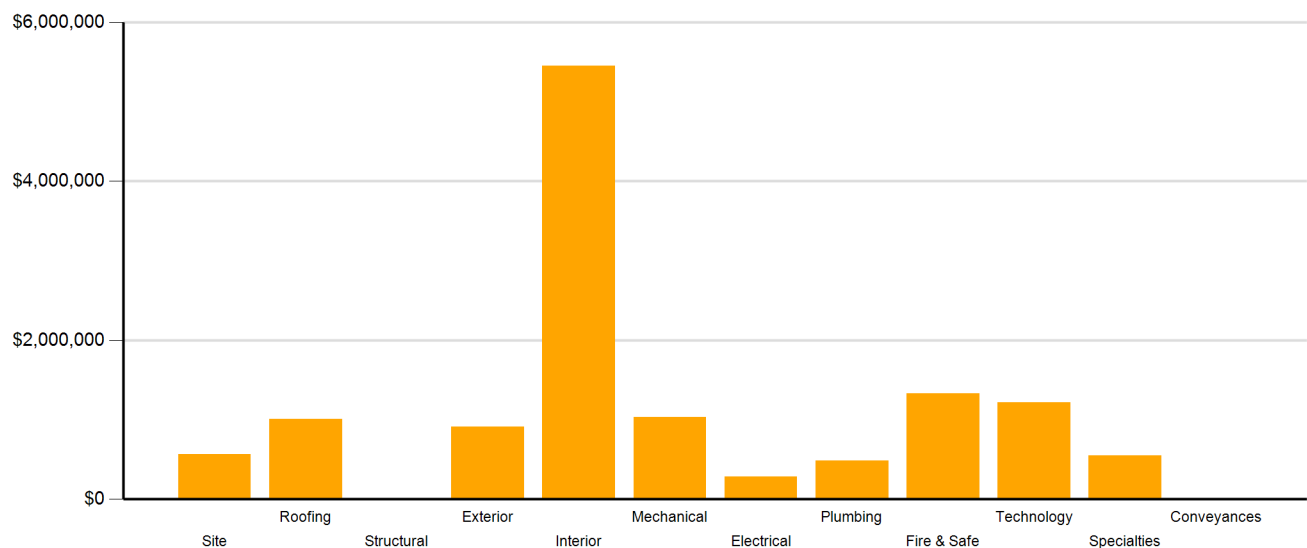
Figure 2: System Deficiencies

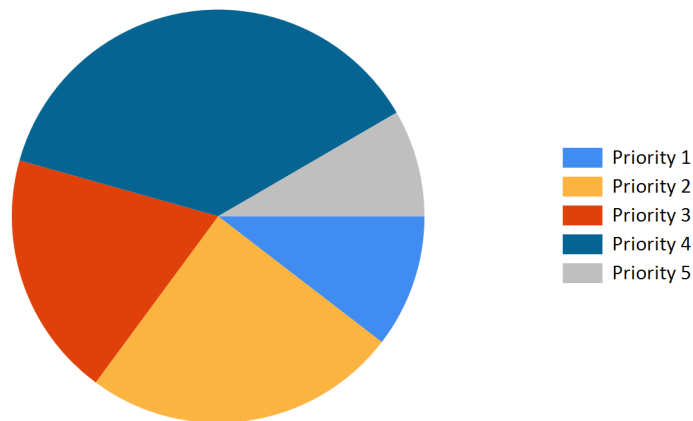
Figure 3: Current deficiencies by priority

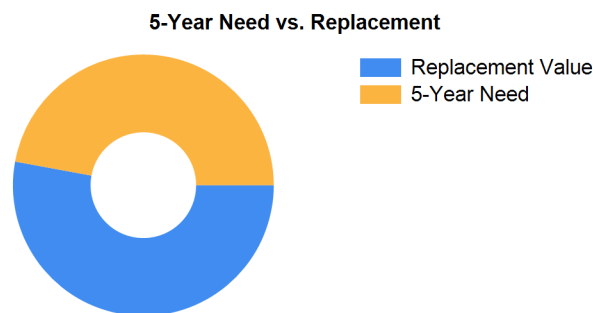
Figure 5: 5-Year FCI

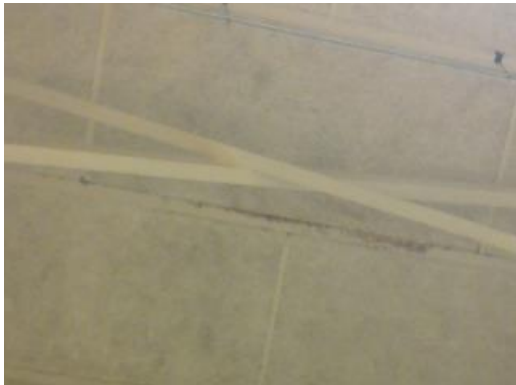
Damaged Tectum Ceiling in Gymnasium

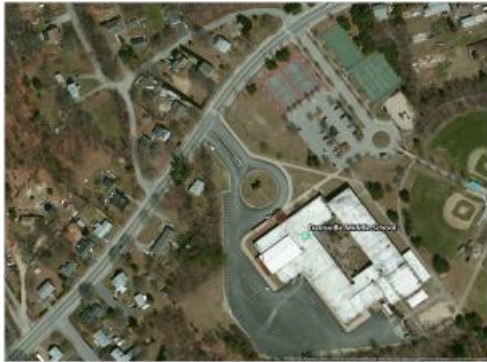
North Kingstown - Davisville Middle School

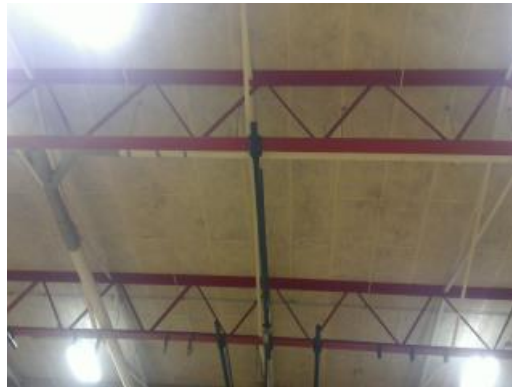
Stained Tectum Ceiling in Gymnasium

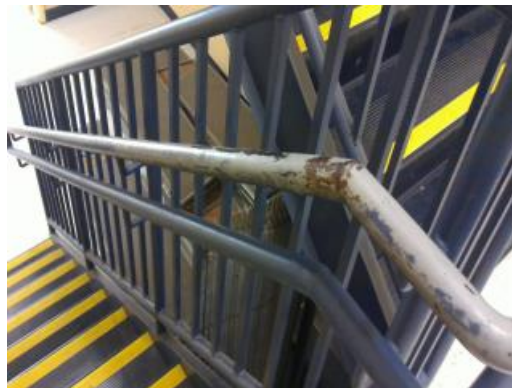
Worn Paint at Interior Stairwells

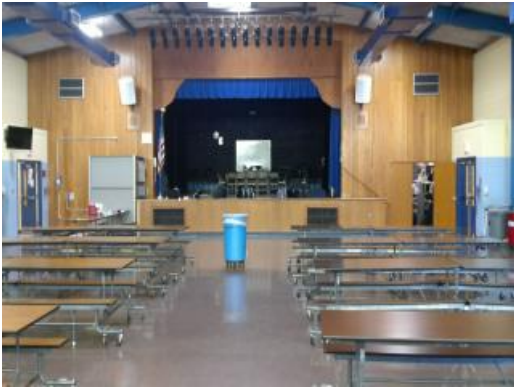
North Kingstown - Davisville Middle School

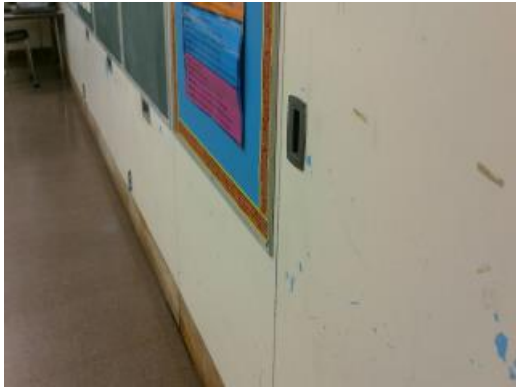
Damaged Moveable Classroom Partitions

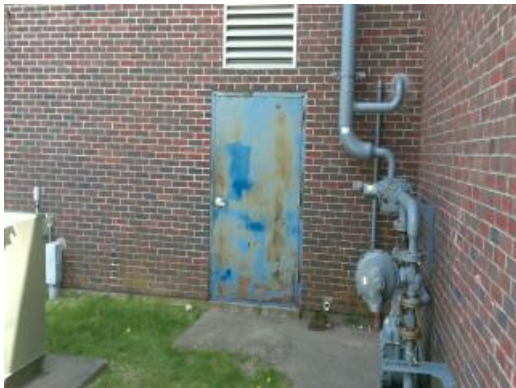
Corroding Exterior Door at Rear of Building

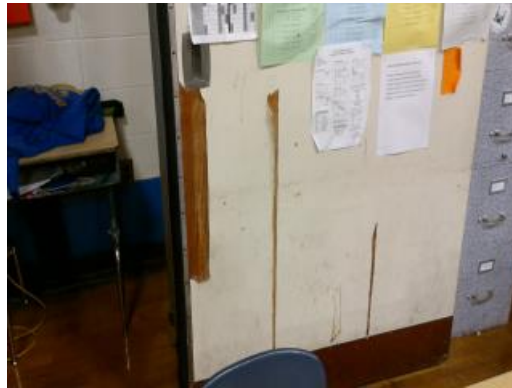
Damaged Moveable Gym Partition

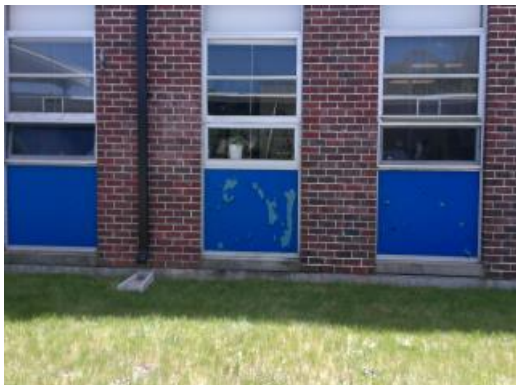
Typical Exterior Windows

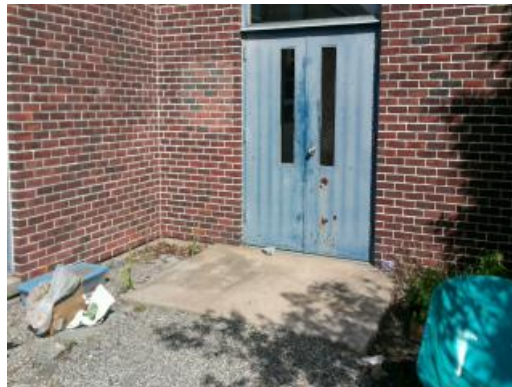
Corroding Exterior Door at Courtyard

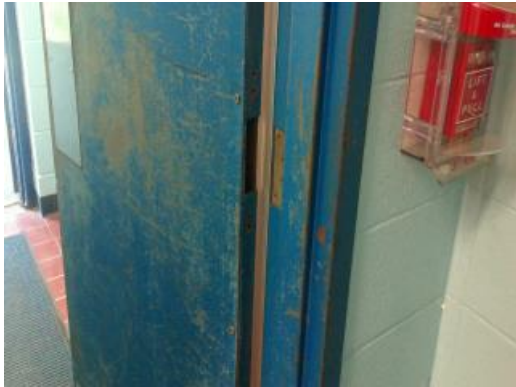
Repaint Interior Doors

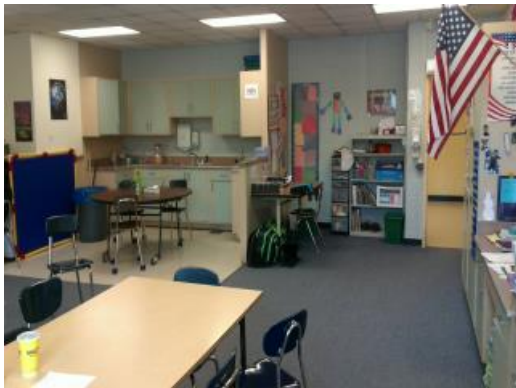
Worn Carpet at Classrooms

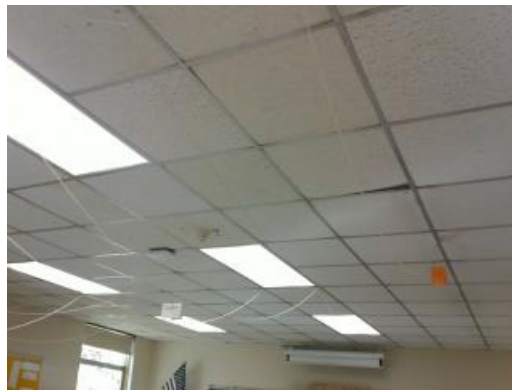
Aged and Damaged Ceiling Tile at Classroom

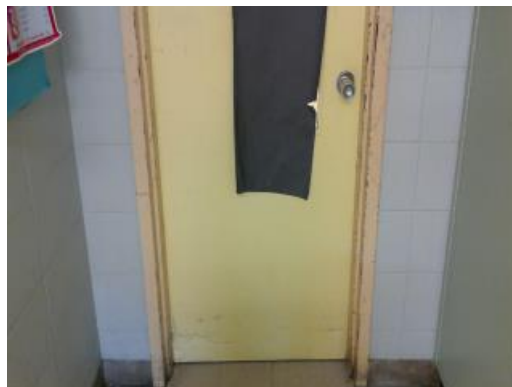
Paint Peeling at Classrooms

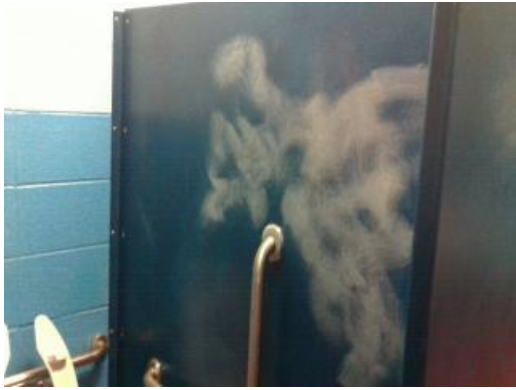
Damaged Toilet Partitions

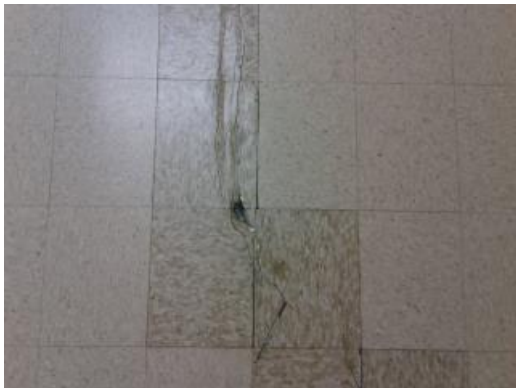
Cracked Flooring Outside Wood Shop

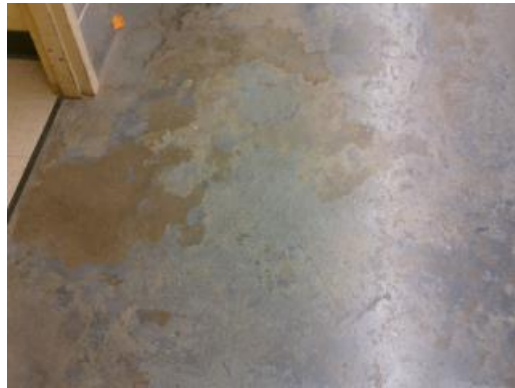
Refinish Concrete Flooring

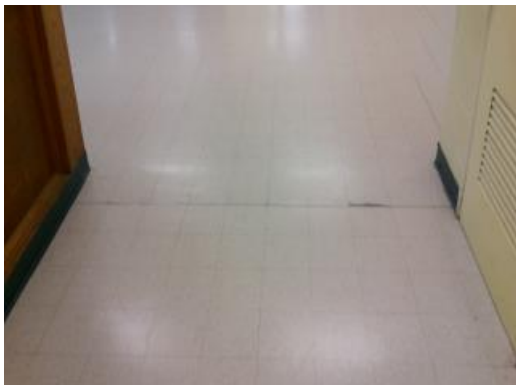
Cracked Flooring at Administrative Offices

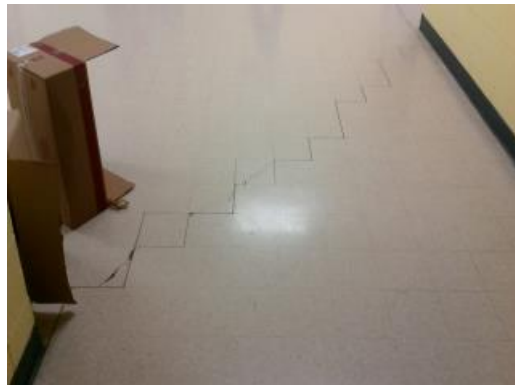
Cracked Flooring Outside of Cafeteria

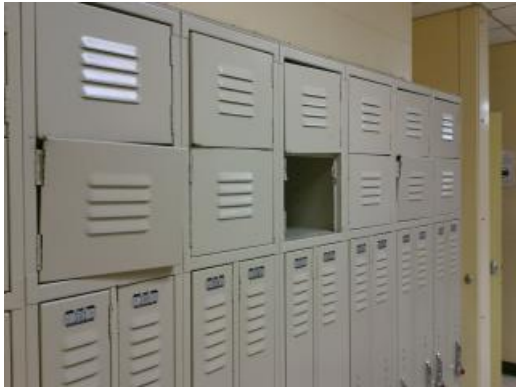
Lockers with Safety Concern at First Floor and Basement

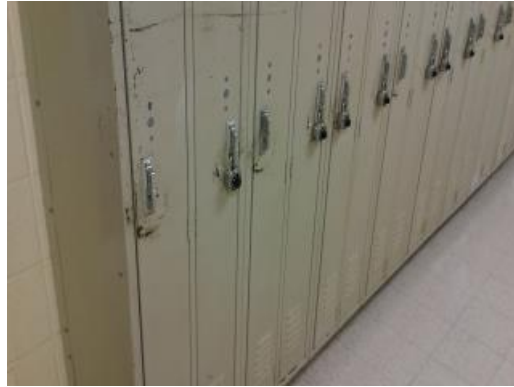
Corroded Lockers at Basement

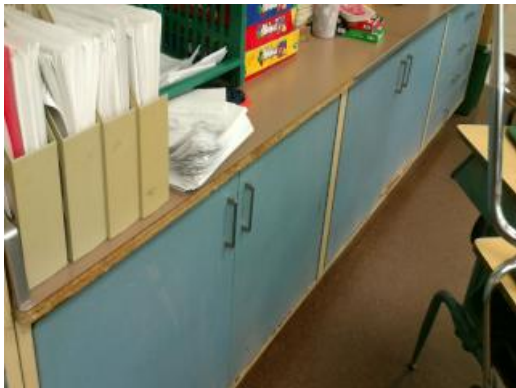
Typical Classroom Cabinets

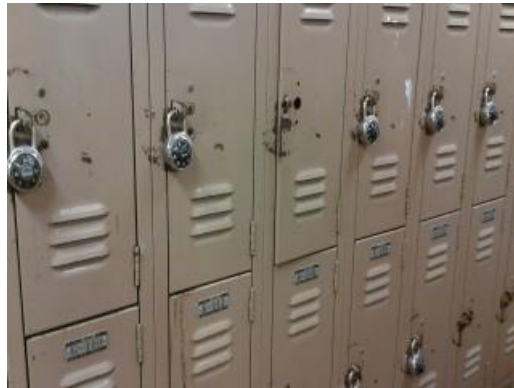
Corroded Lockers at Girls Locker Room

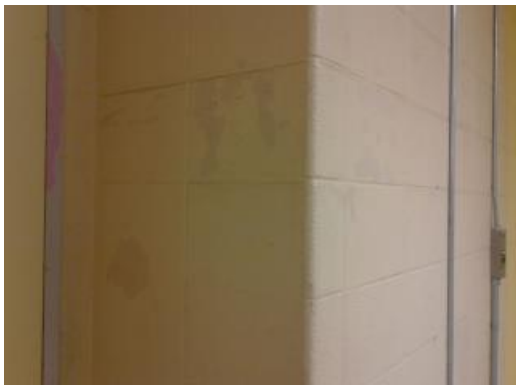
Peeling Paint in Hallways

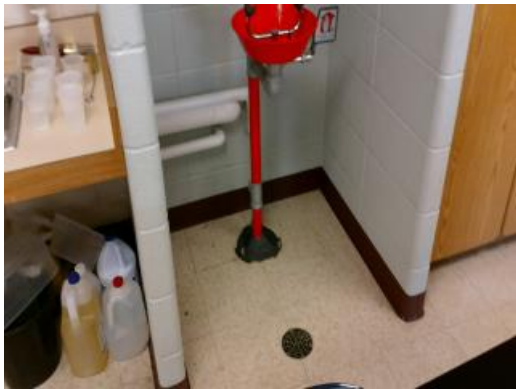
Science Room Emergency Shower

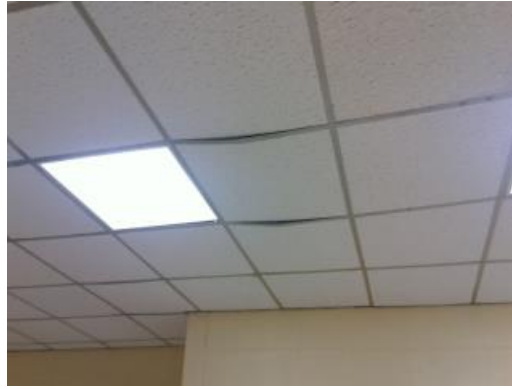
Damaged Ceiling Grid at Hallway

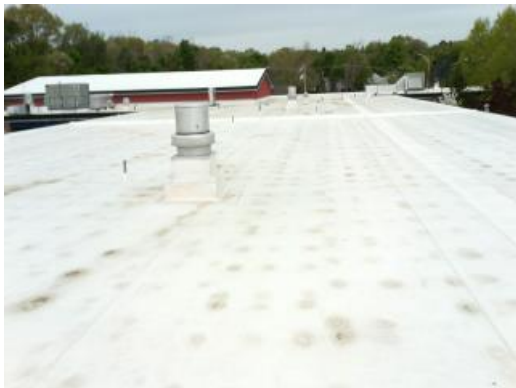
Typical Roof Condition

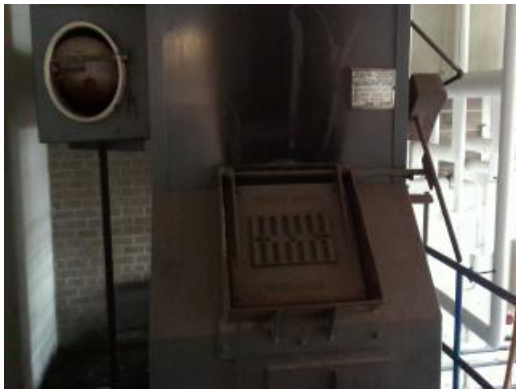
North Kingstown - Davisville Middle School

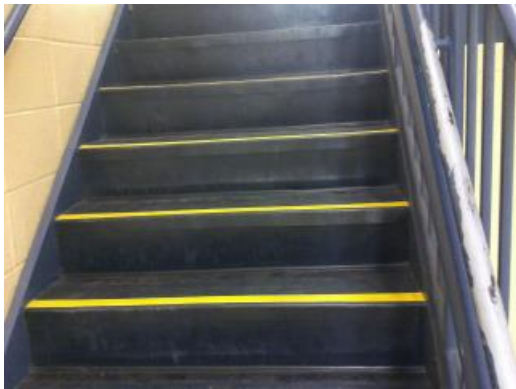
North Kingstown - Davisville Middle School

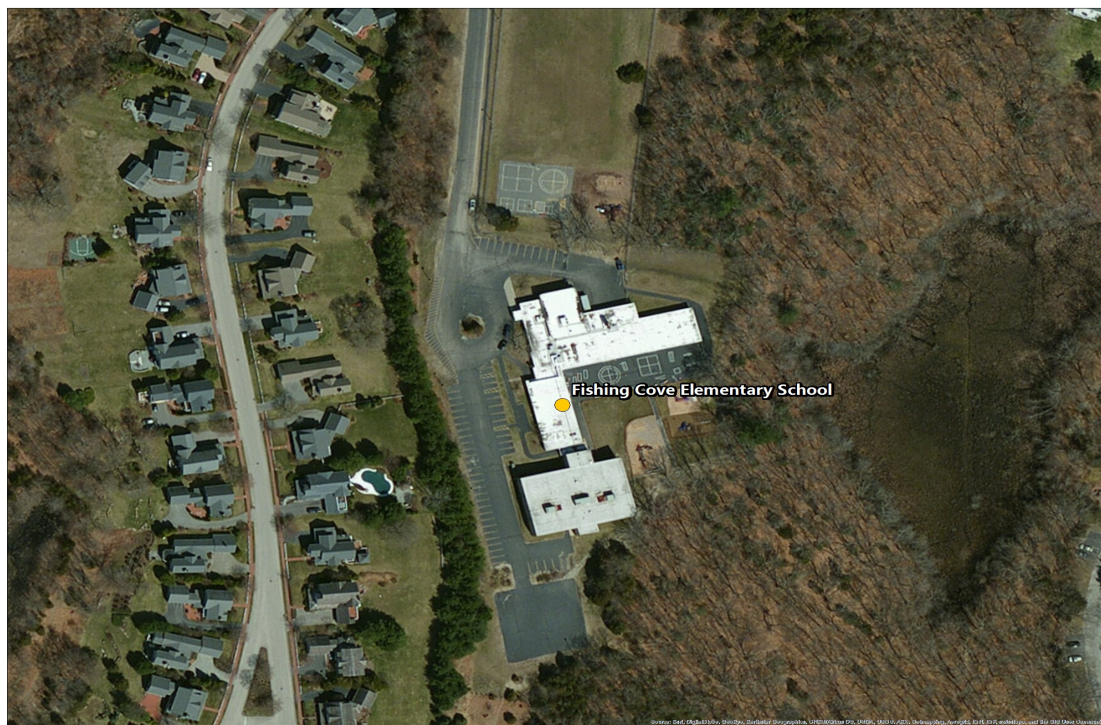
Figure 1: Aerial view of Fishing Cove Elementary School

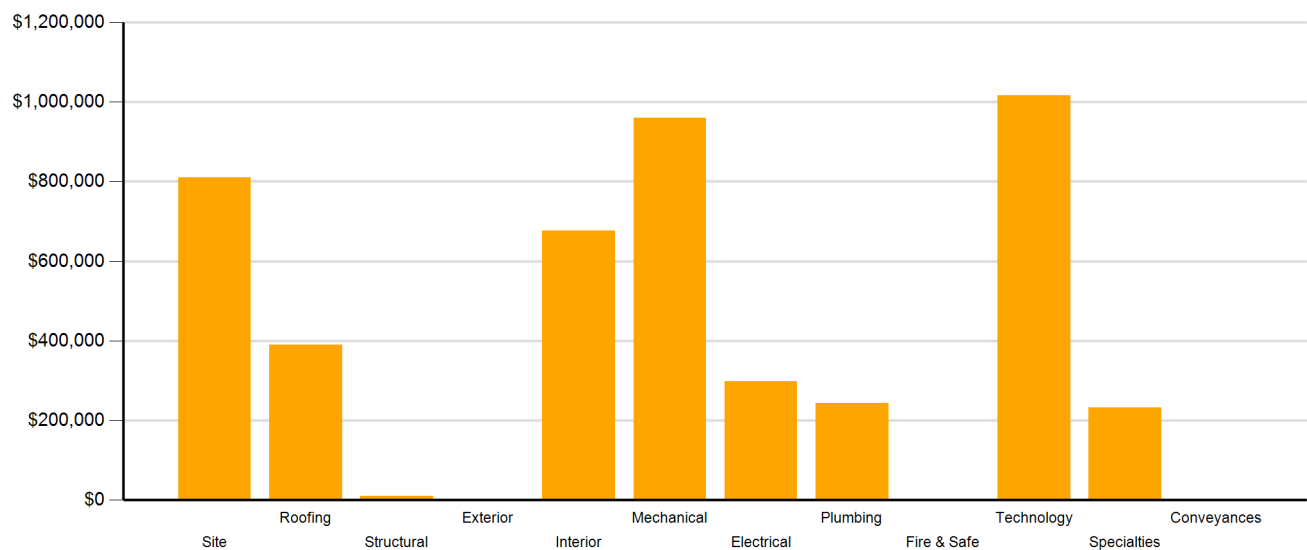
Figure 2: System Deficiencies

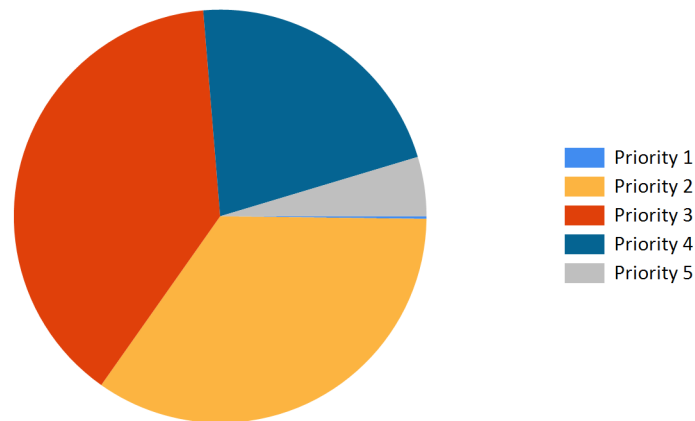
Figure 3: Current deficiencies by priority

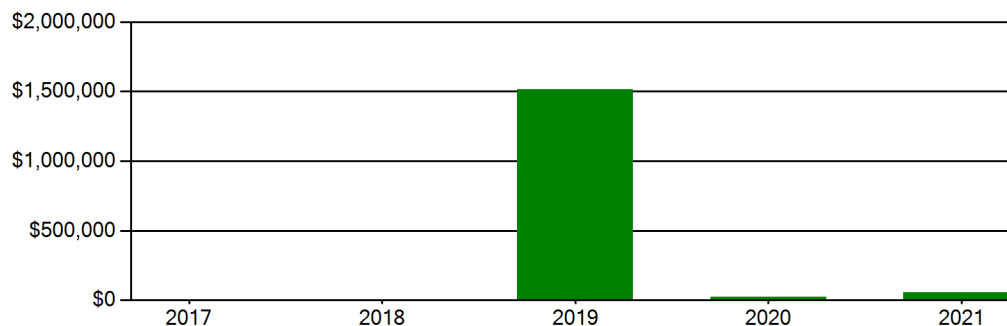
Figure 4: Life Cycle Capital Renewal Forecast

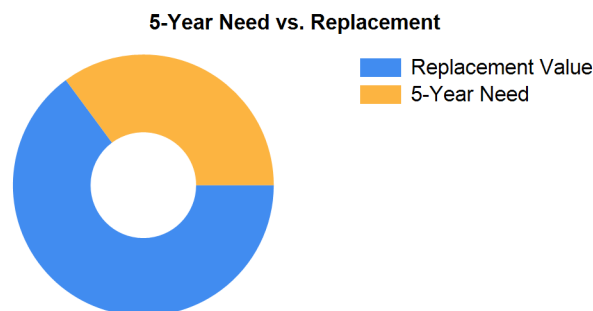
Figure 5: 5-Year FCI

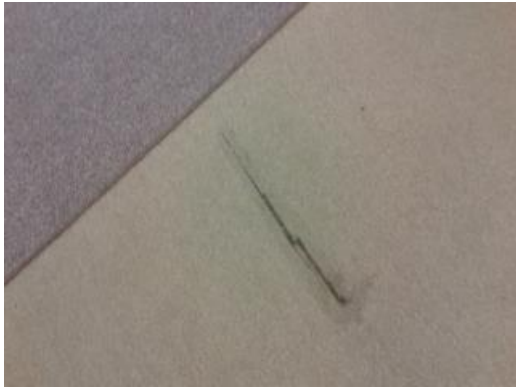
Worn And Tearing Carpet

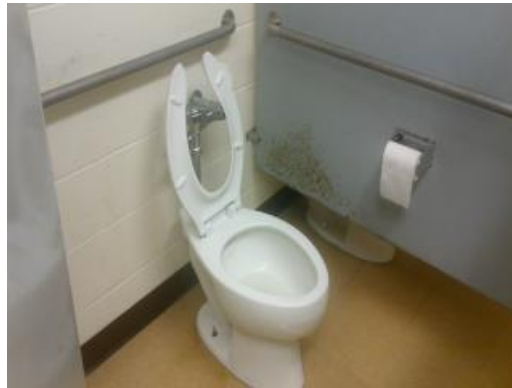
Rusted Toilet Partition

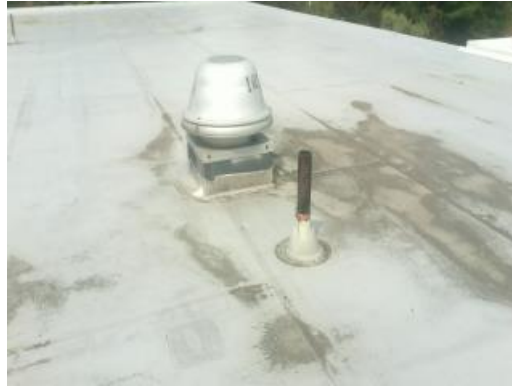
Evidence Of Ponding On Roof

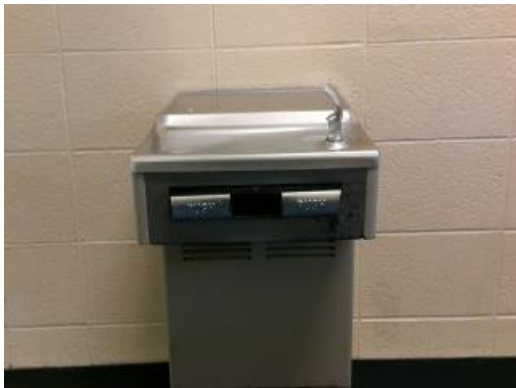
Damaged Drinking Fountain

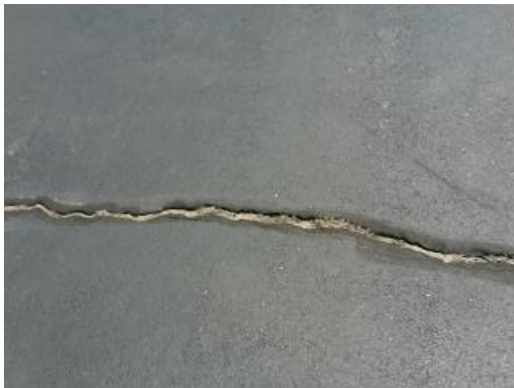
Cracked Asphalt Walkway

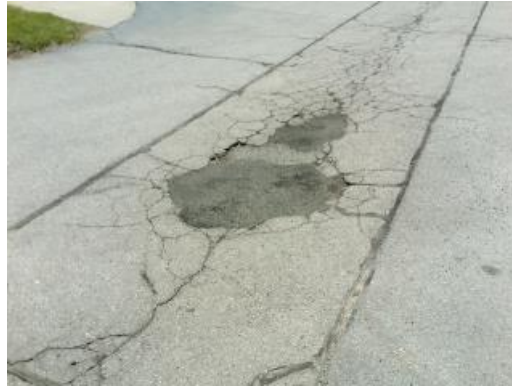
Alligatored Asphalt Pavement

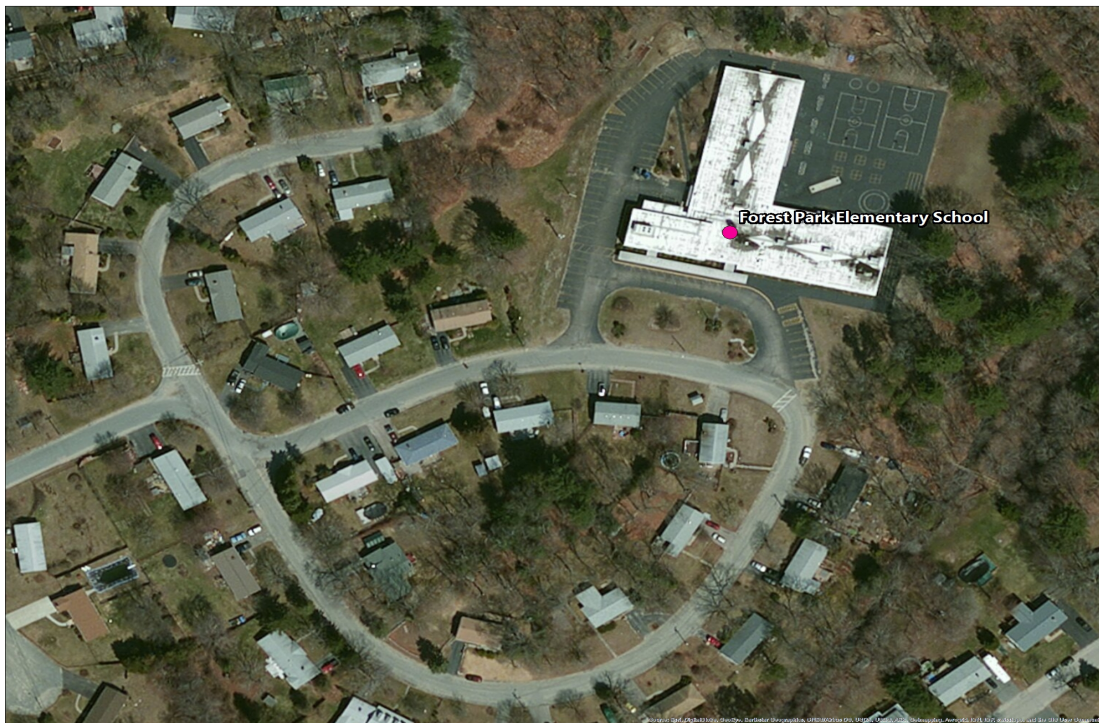
Figure 1: Aerial view of Forest Park Elementary School

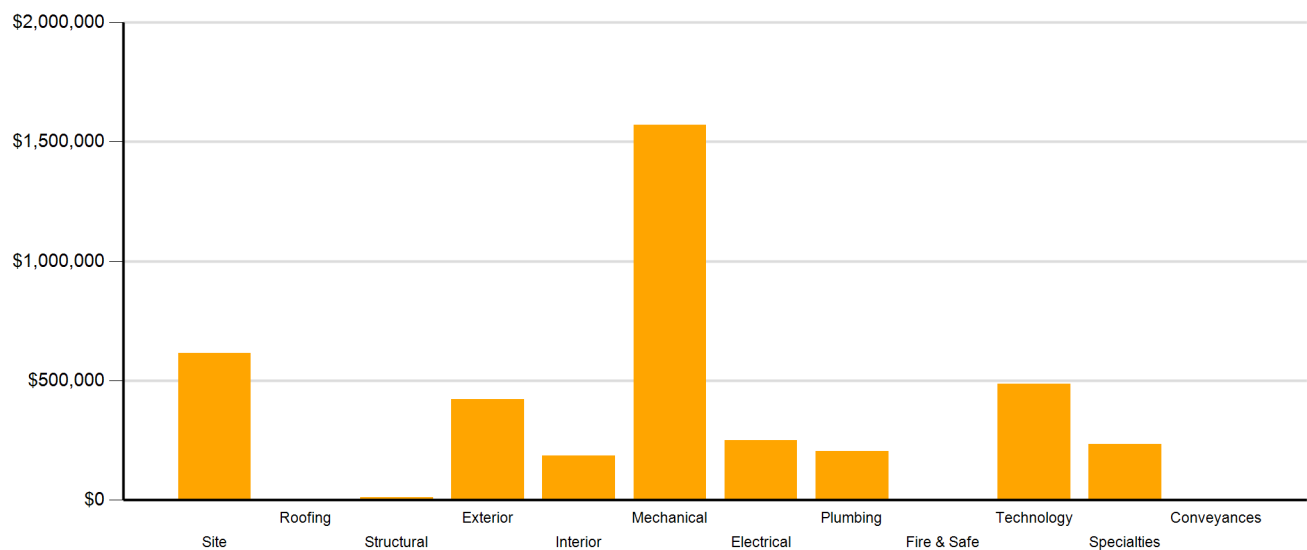
Figure 2: System Deficiencies

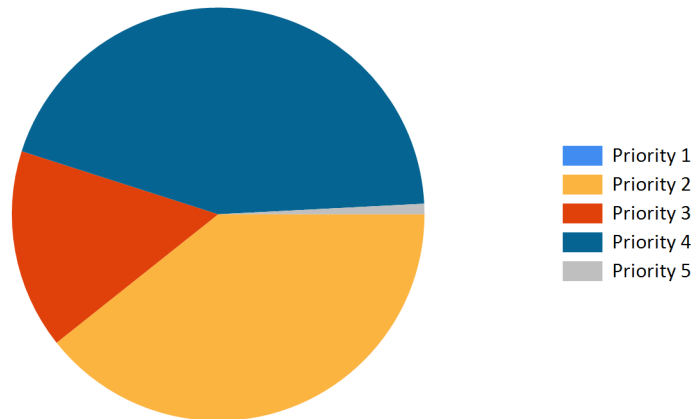
Figure 3: Current deficiencies by priority

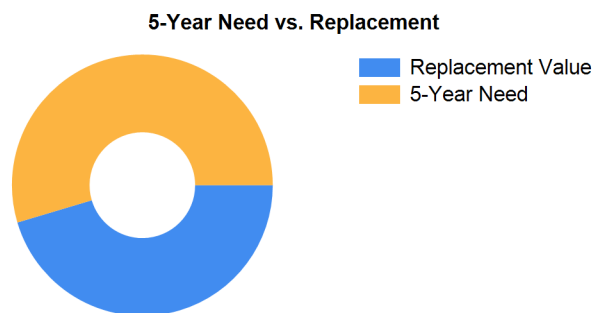
Figure 5: 5-Year FCI

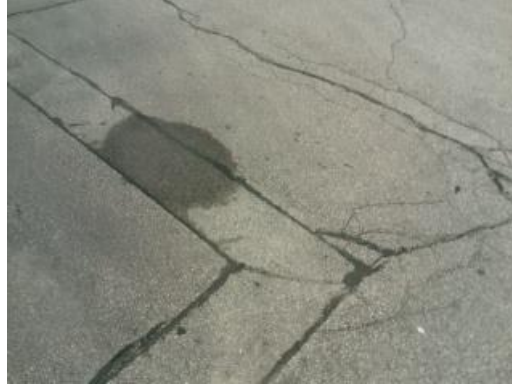
Typical Cracked Asphalt

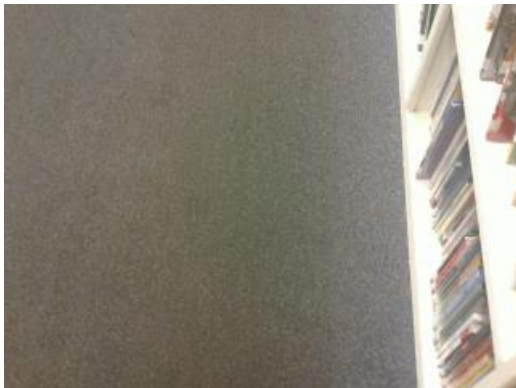
Worn And Stained Carpet

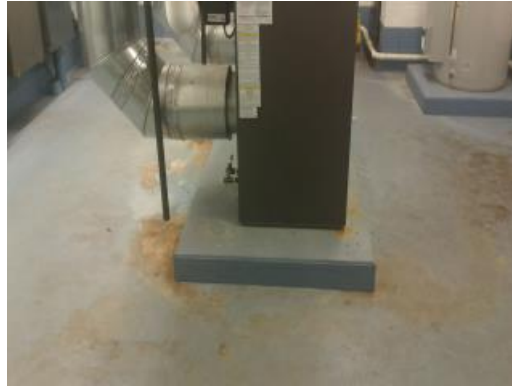
Worn Concrete Flooring

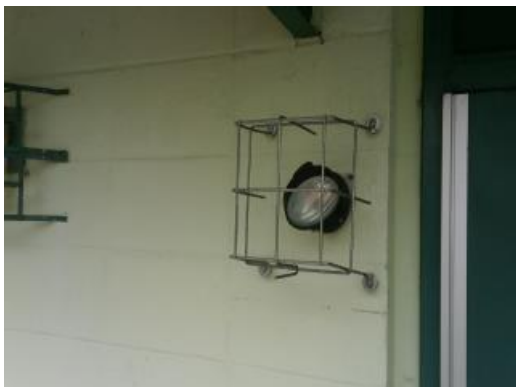
Aged Building Mounted Light

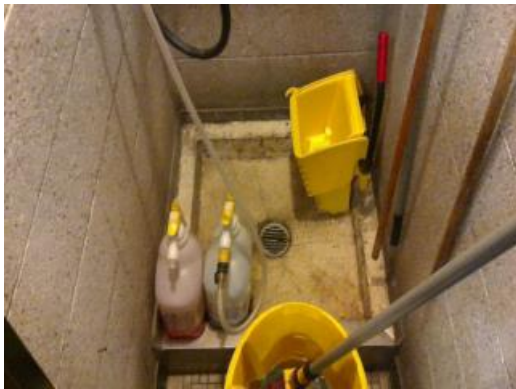
Corroded Service Sink

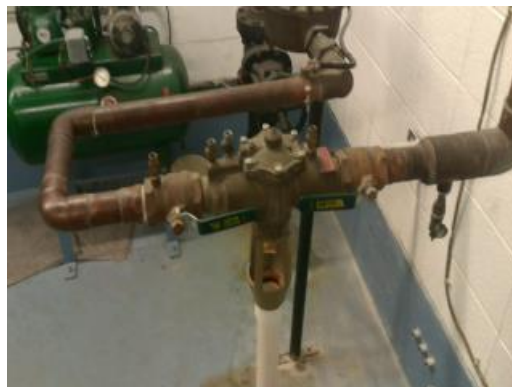
Corroded Backflow Preventer

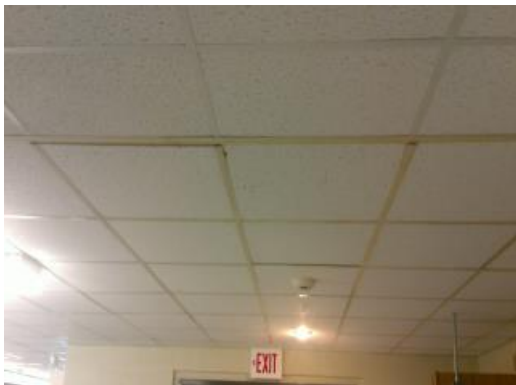
Stained And Broken Grid

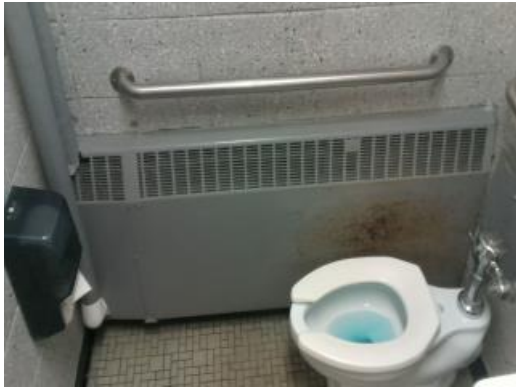
Rusted Radiant Heater

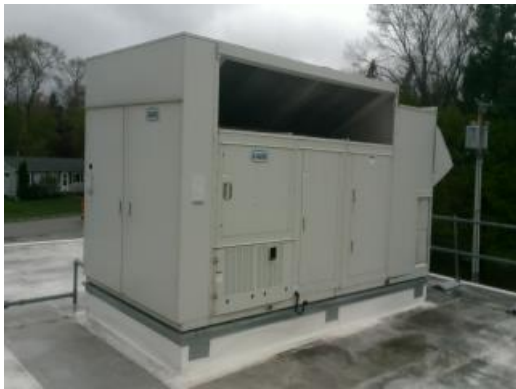
Large Energy Recovery Unit

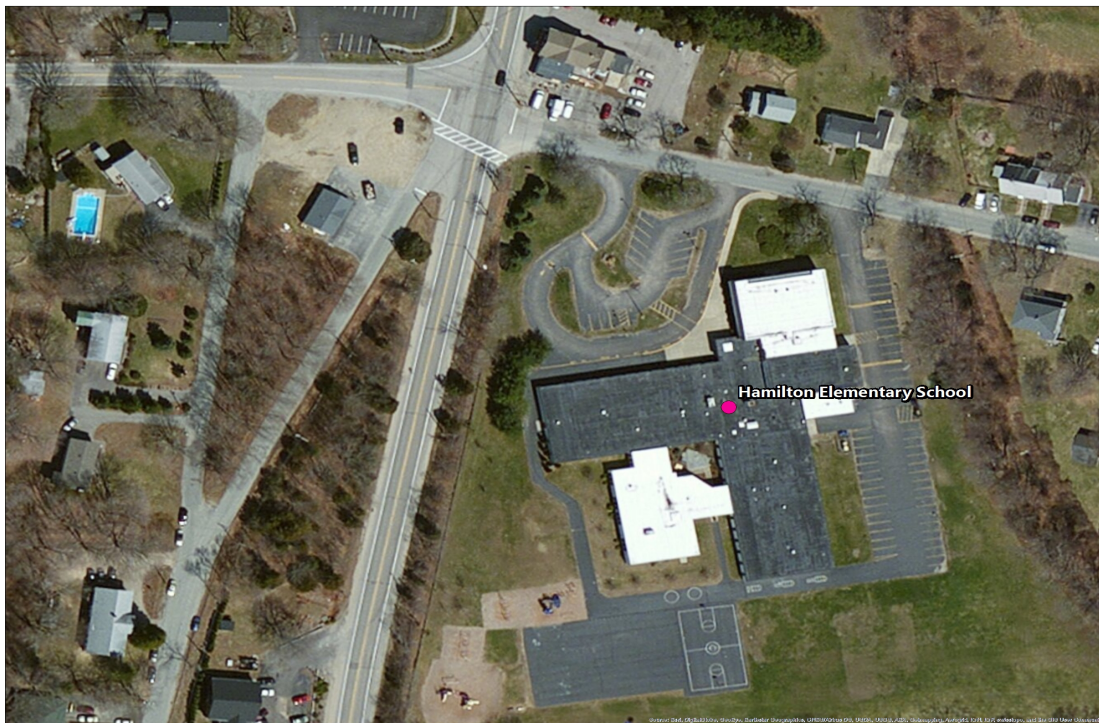
Figure 1: Aerial view of Hamilton Elementary School

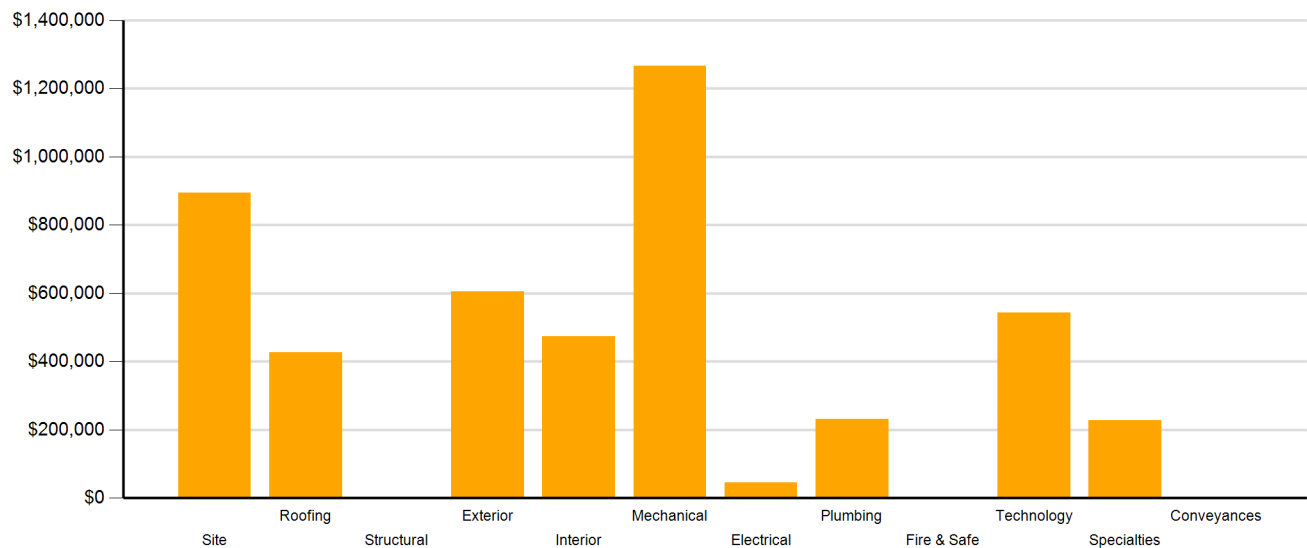
Figure 2: System Deficiencies

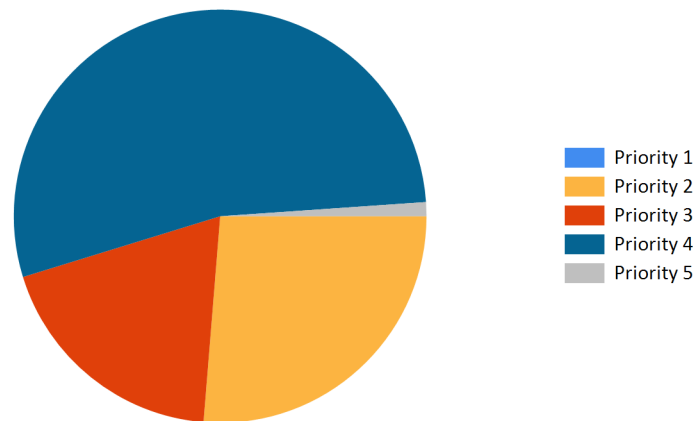
Figure 3: Current deficiencies by priority

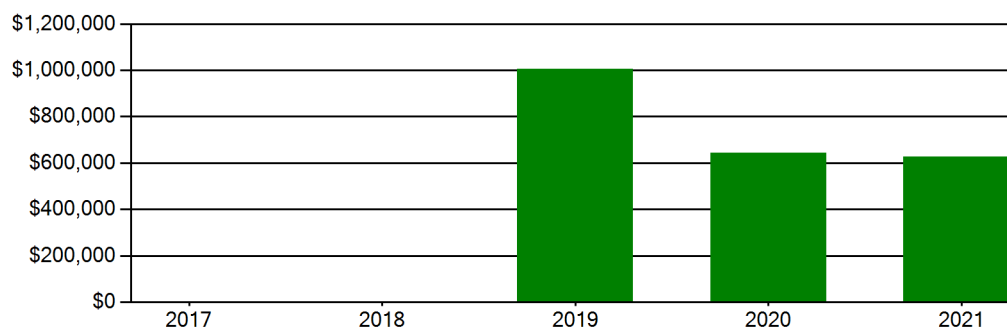
Figure 4: Life Cycle Capital Renewal Forecast

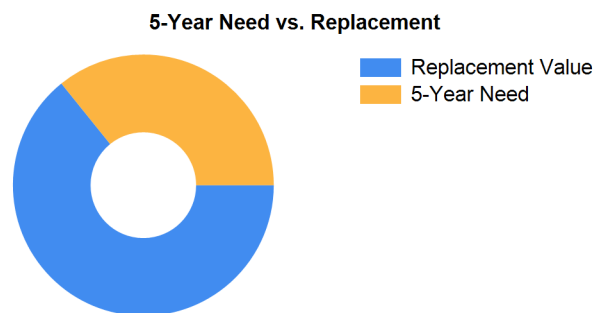
Figure 5: 5-Year FCI

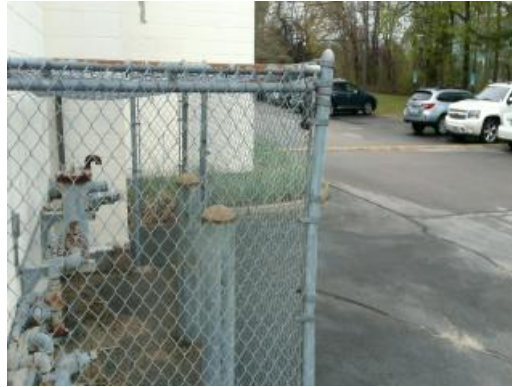
Damaged 8' Chain Link Fence

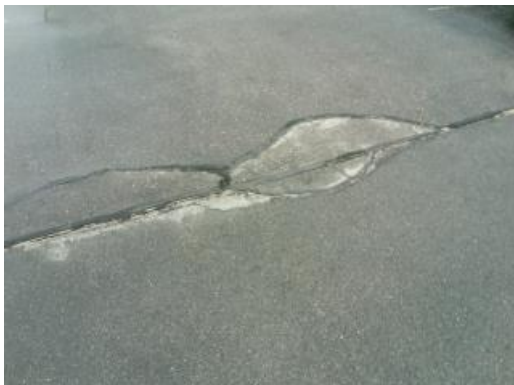
Cracked Asphalt At Parking Lot

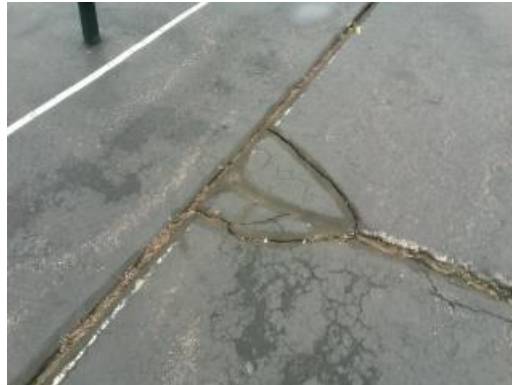
Cracking And Splitting At Play Area

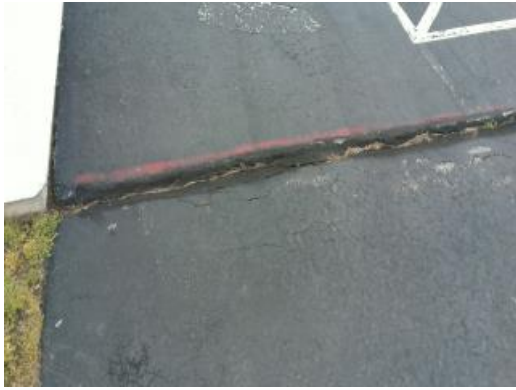
Splitting Asphalt Play Area

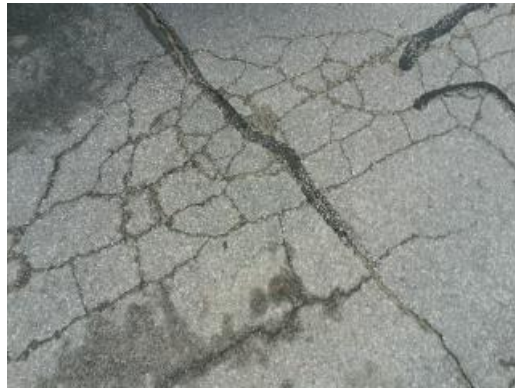
Cracked Asphalt At Roadway

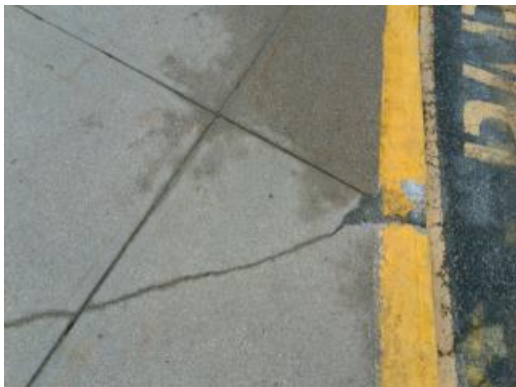
Cracking At Parking Lot
