School Type by Count

School Type	SqFt
Elementary School	210,625
Middle School	171,828
K-8	31,817
High School	259,720
Total:	673,990

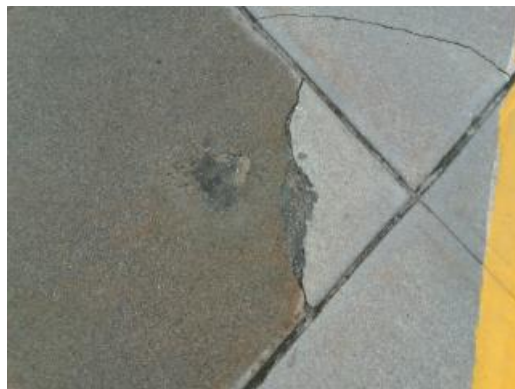
Cracking And Holes At Parking Lot

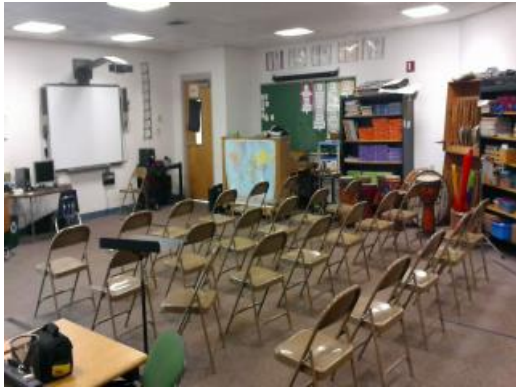
North Kingstown - Hamilton Elementary School

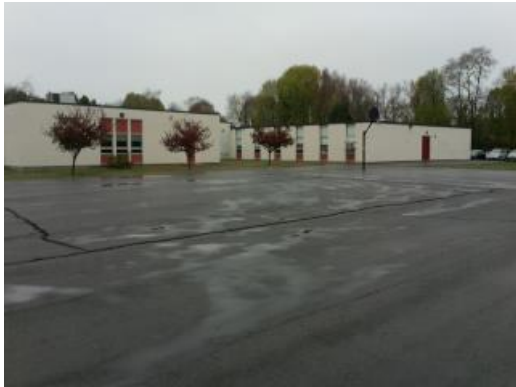
North Kingstown - Hamilton Elementary School

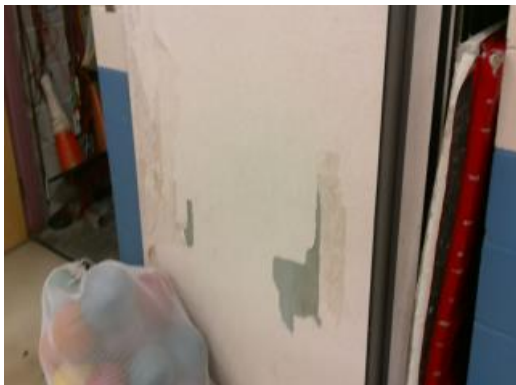
Damaged Movable Partition At Gymnasium

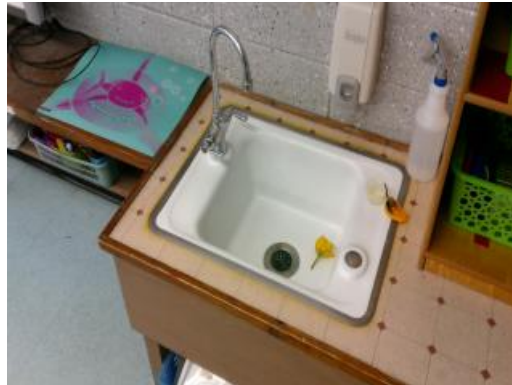
Damaged Classroom Lavatory

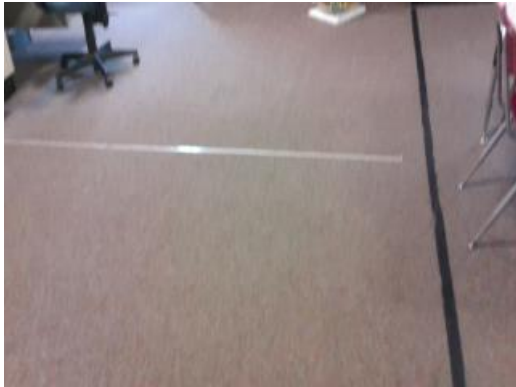
Damaged Carpet At Library

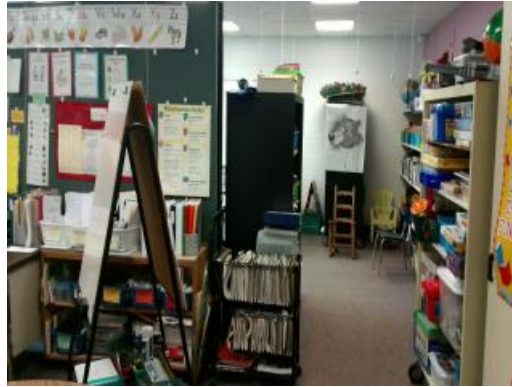
Damaged Carpet At Classroom 22

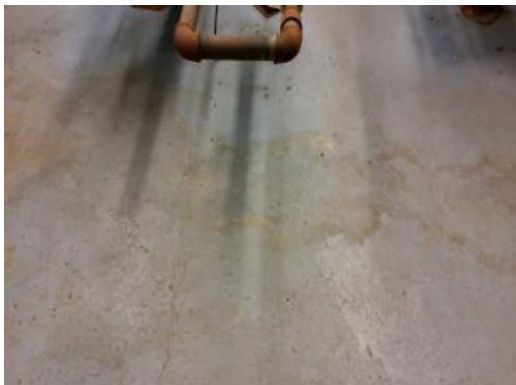
Concrete Finish Peeling At Boiler

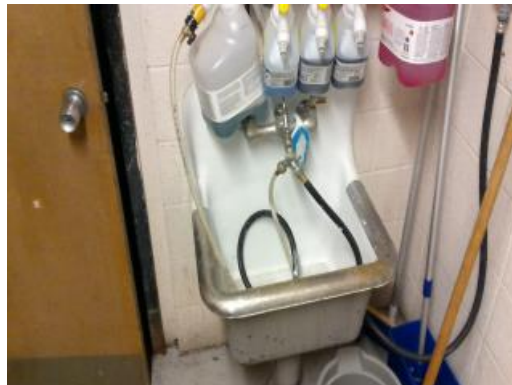
Stained And Rusted Mop/Service Sink

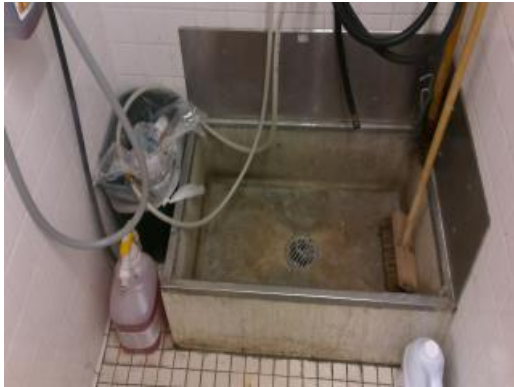
Rusted Mop/Service Sink

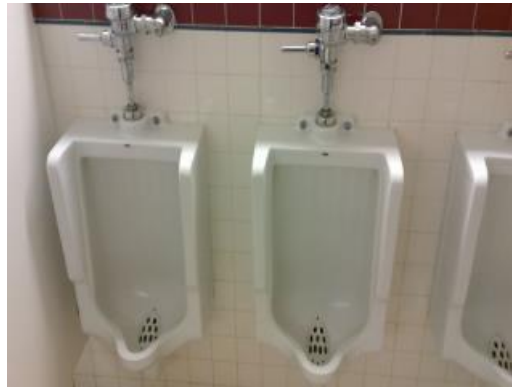
Stained And Corroded Flush Valves At Urinals

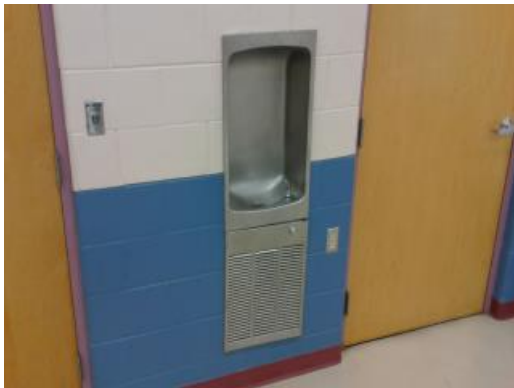
Refrigerated Drinking Fountain

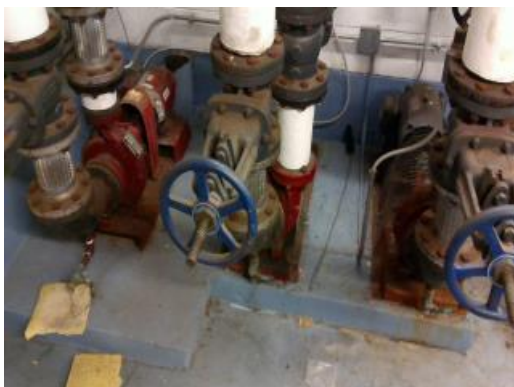
Rusted And Leaking Pump Seals

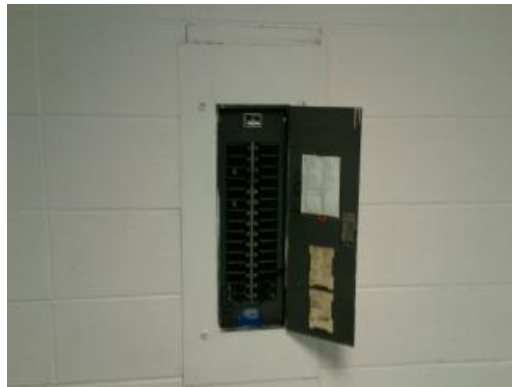
Electrical Panelboard

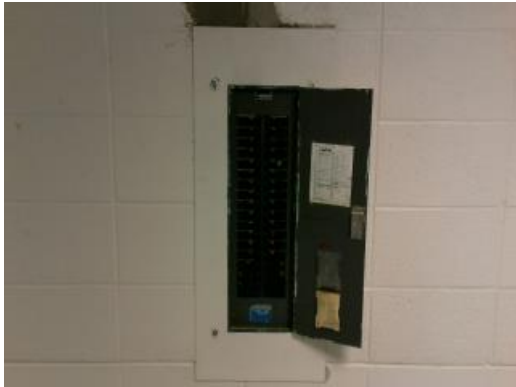
Electrical Panelboard

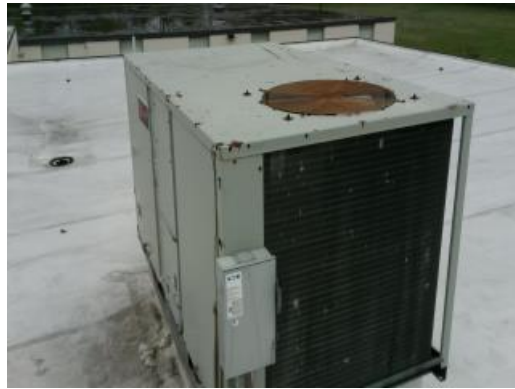
Rusted And Damaged Coils At Roof Top Unit

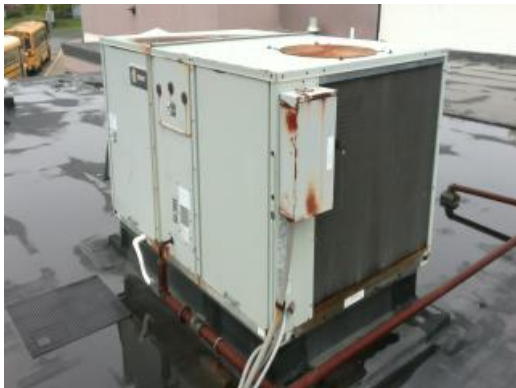
Rusted And Damaged Coils At Roof Top Unit

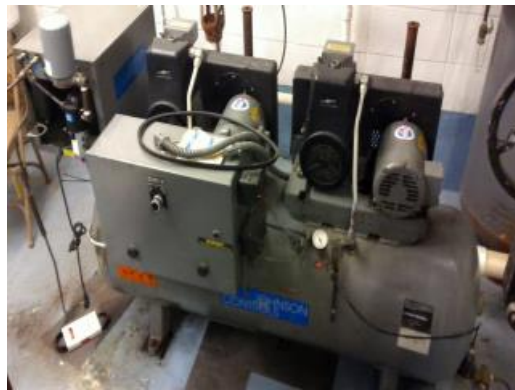
Inoperable Air Compressor

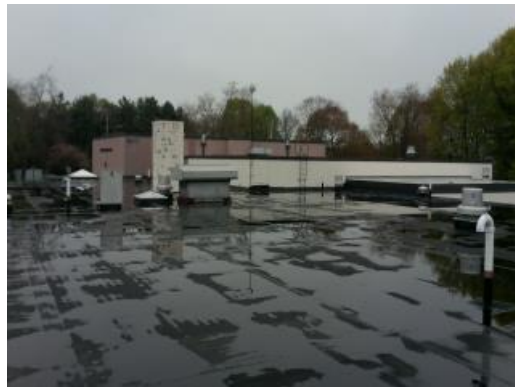
Peeling Paint At Exterior CMU Wall

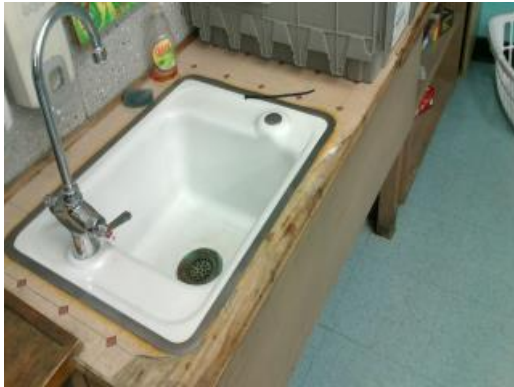
Damaged Classroom Cabinet

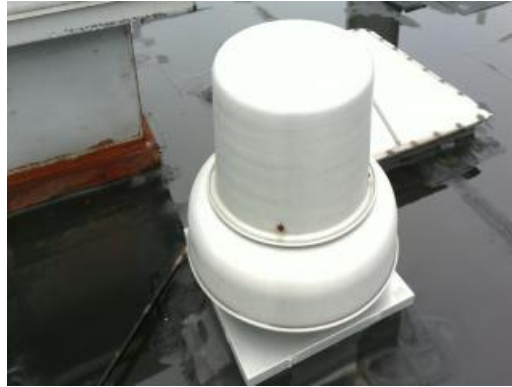
Rusted Exhaust Hood Casings

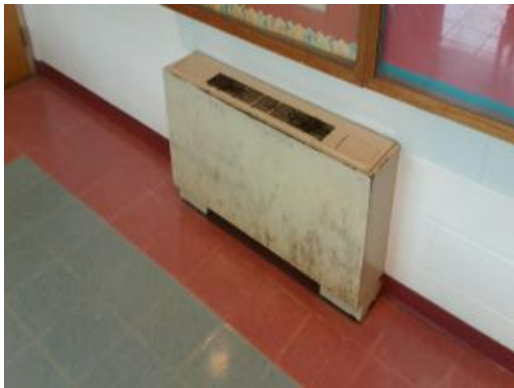
Clogged Coils And Rusted Casing At Unit Vent

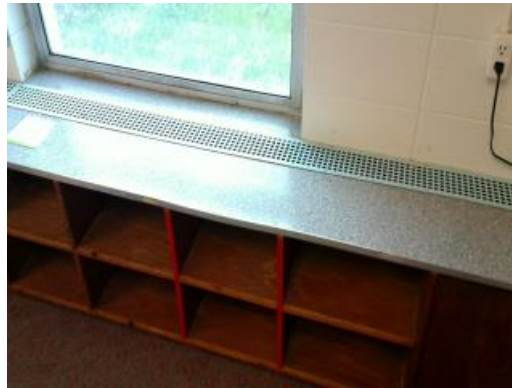
Clogged Coils And Rusted Casing At Fin Tube Heater

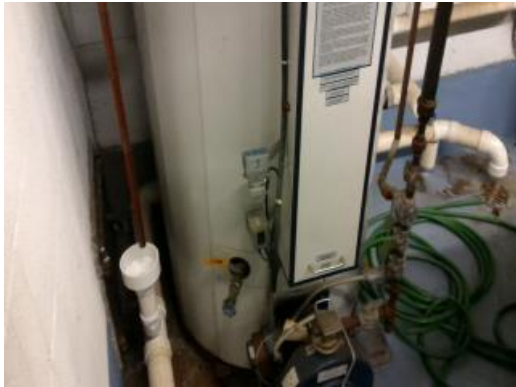
North Kingstown - Hamilton Elementary School

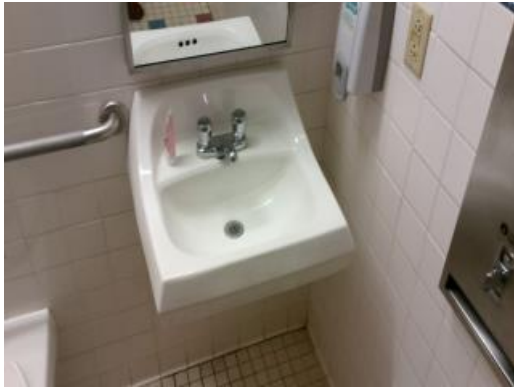
North Kingstown - Hamilton Elementary School

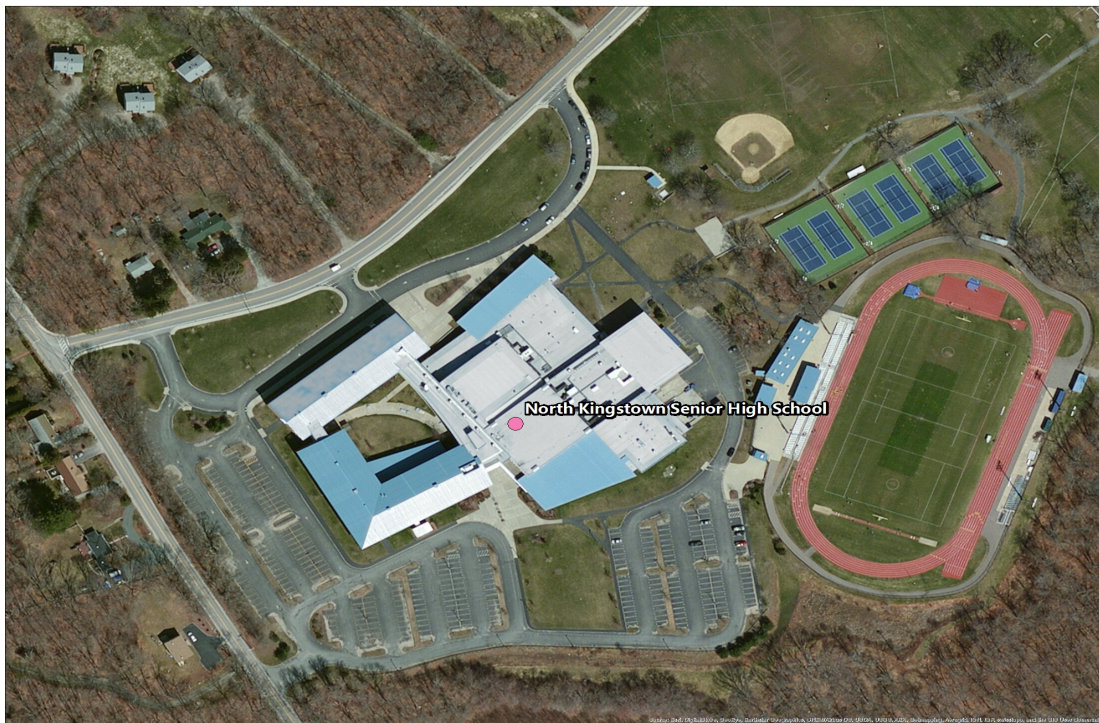
Figure 1: Aerial view of North Kingstown Senior High School

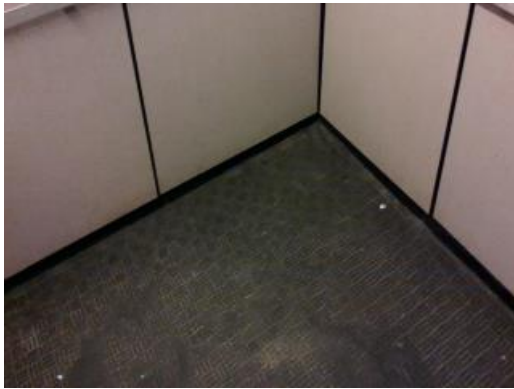
Elevator Floor Is Worn

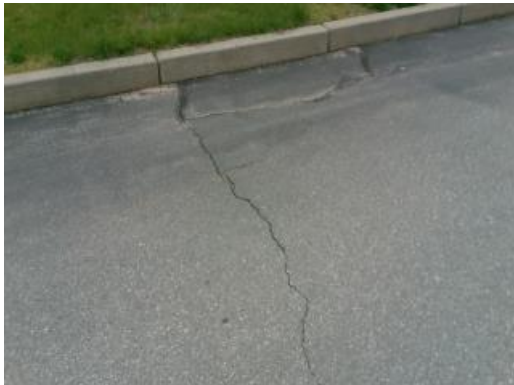
Worn Asphalt Roadway Pavement

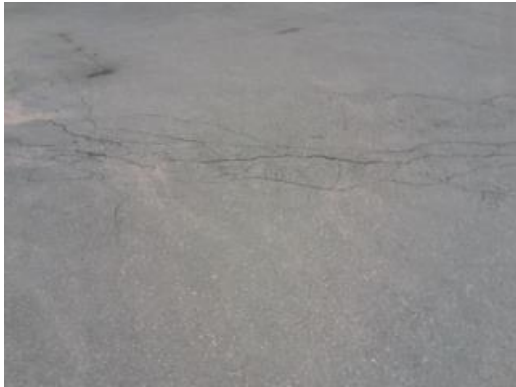
Worn Asphalt Parking Lot Pavement

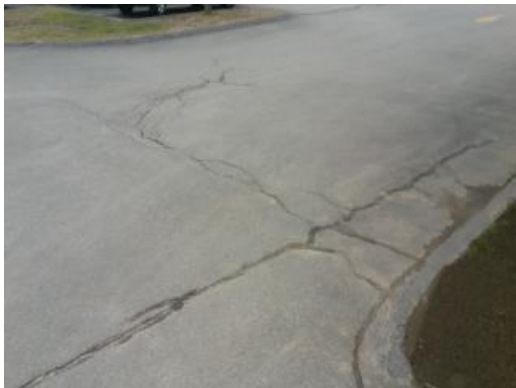
Damaged Asphalt Walks

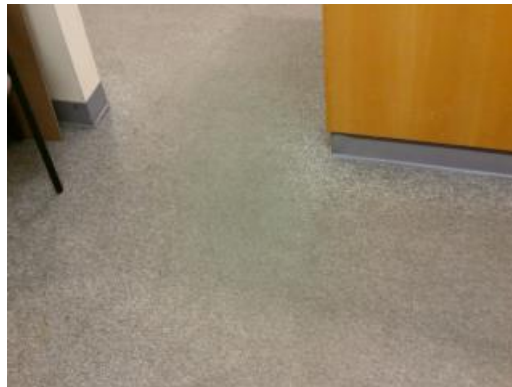
Worn Carpet At Main Office

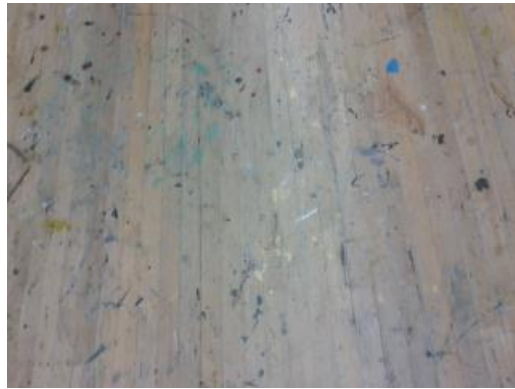
Damaged Wood Flooring At Stage

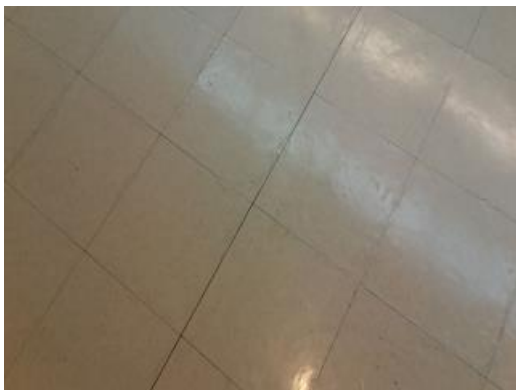
Damaged VCT By The Entrance Outside Gym 2

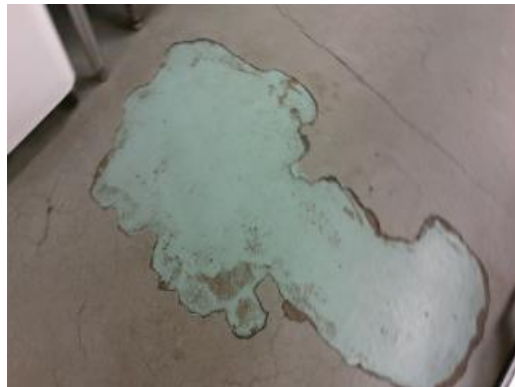
Damaged Epoxy Flooring In The Kitchen

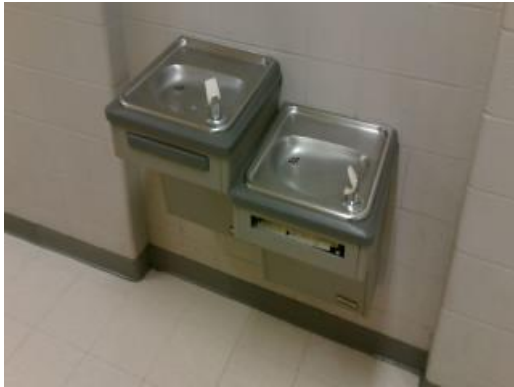
Non-Functional Refrigerated Water Fountains

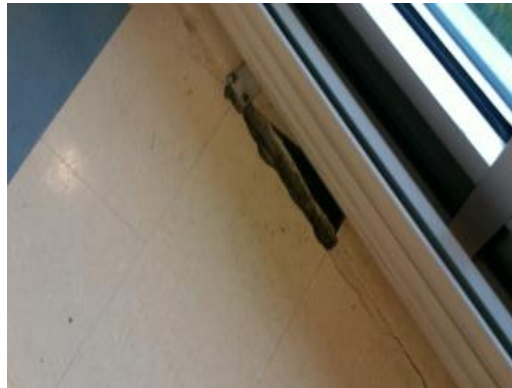
Cracked Flooring at Cafeteria

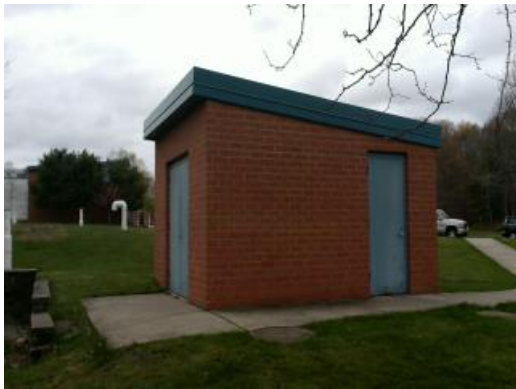
Utility Building Exterior

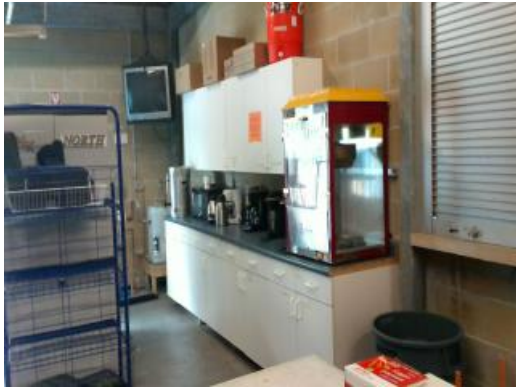
Concession Stand Interior

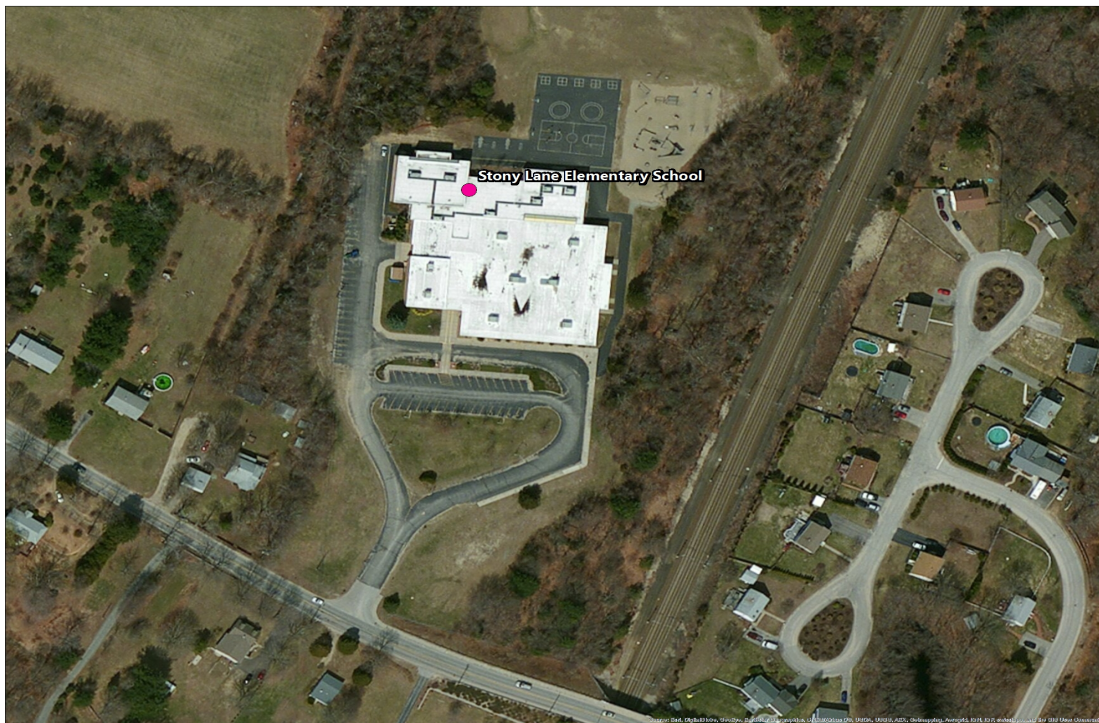
Figure 1: Aerial view of Stony Lane Elementary School

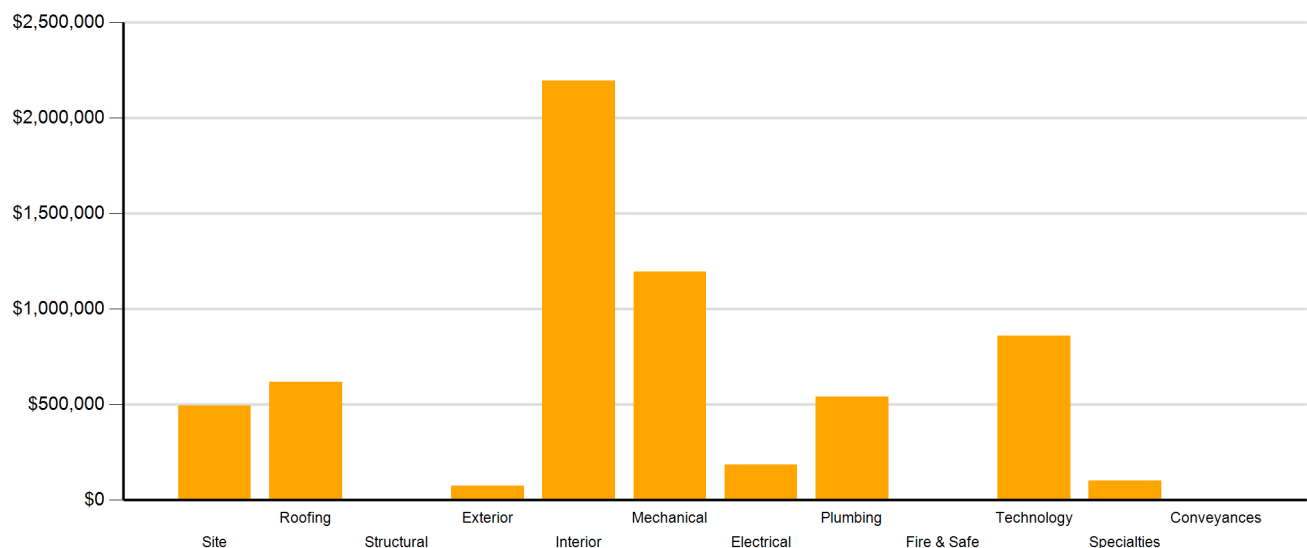
Figure 2: System Deficiencies

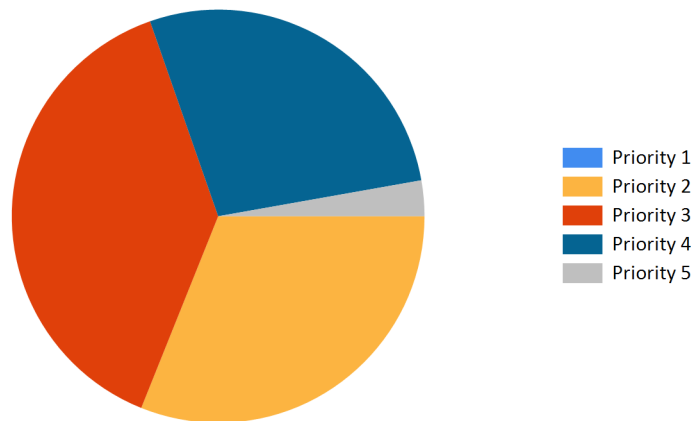
Figure 3: Current deficiencies by priority

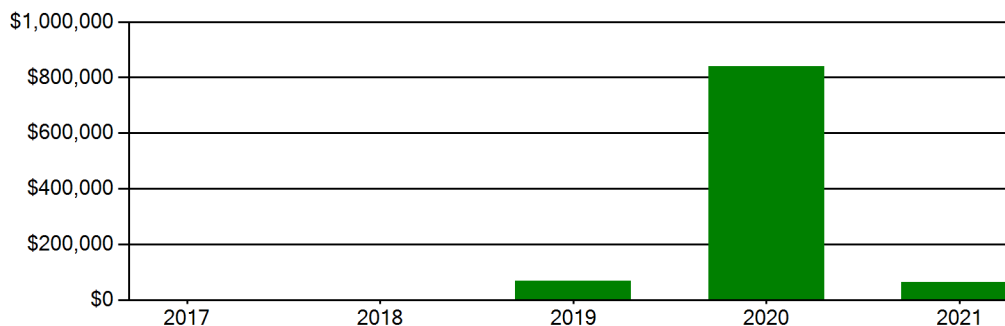
Figure 4: Life Cycle Capital Renewal Forecast

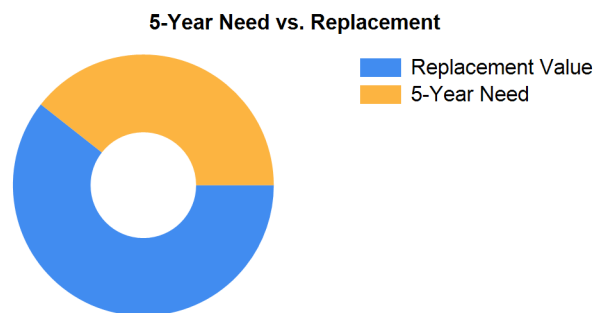
Figure 5: 5-Year FCI

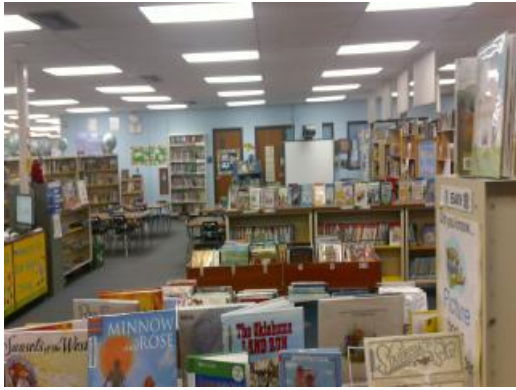
North Kingstown - Stony Lane Elementary School

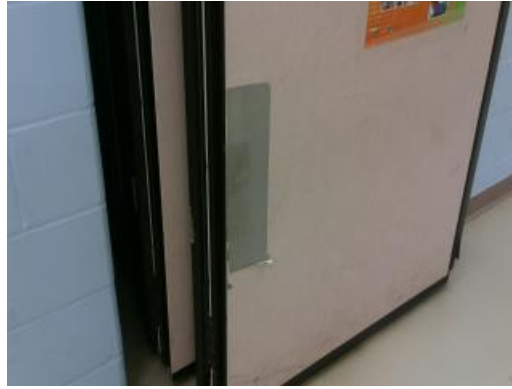
Damaged Partition Wall

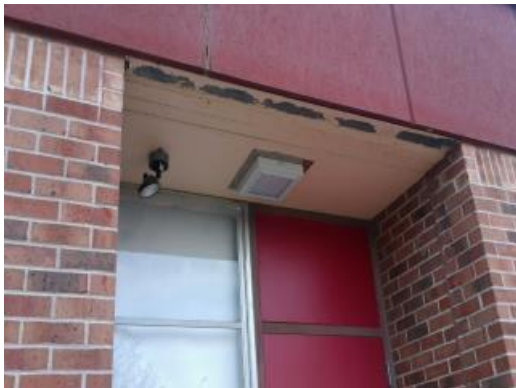
Peeling Soffit Paint

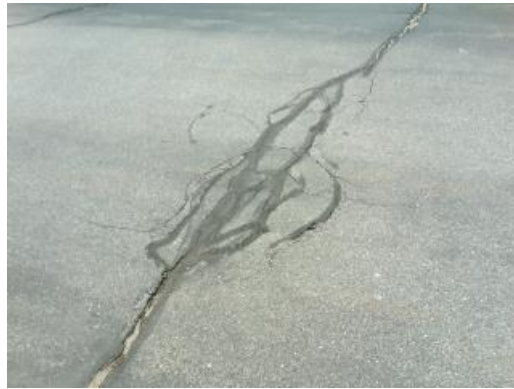
Cracked Asphalt Roadway

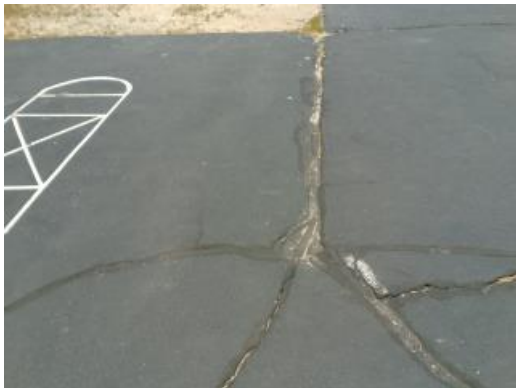
Cracked Play Area Asphalt

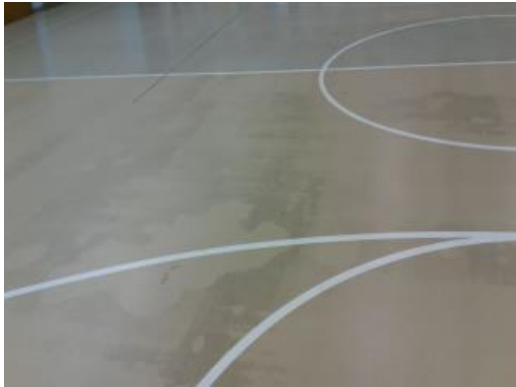
Gymnasium Sport Flooring

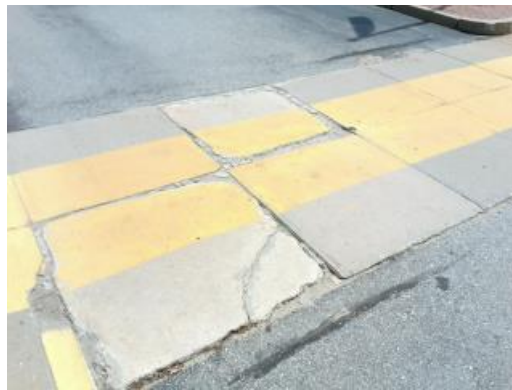
Concrete Walkway At Entrance

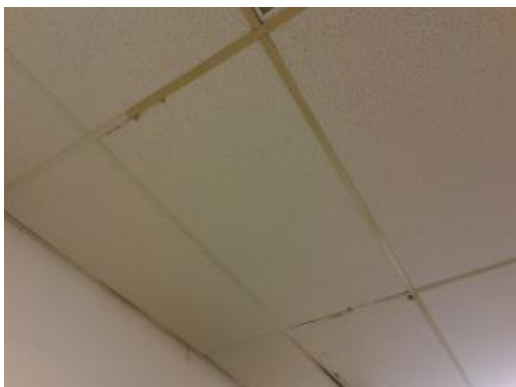
Stained Ceiling Grid

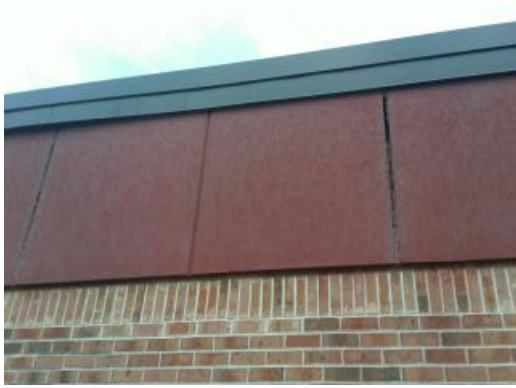
Failing Caulking At EIFS Panels

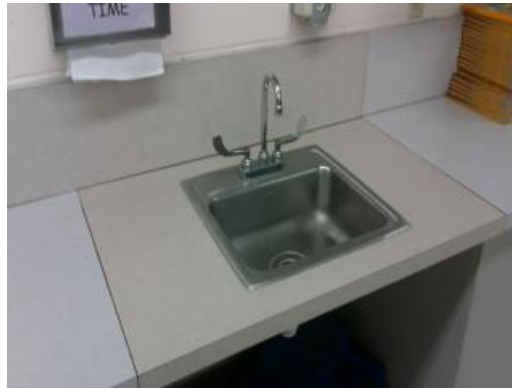
Aged Laminate Casework

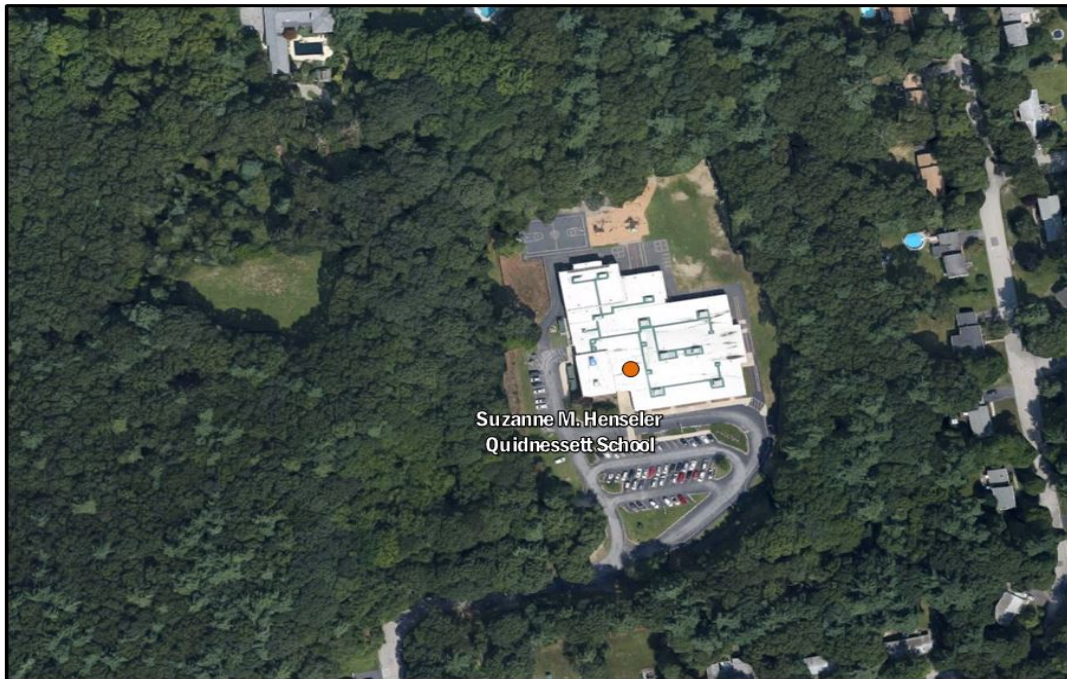
Figure 1: Aerial view of Suzanne M. Henseler Quidnessett Elementary School

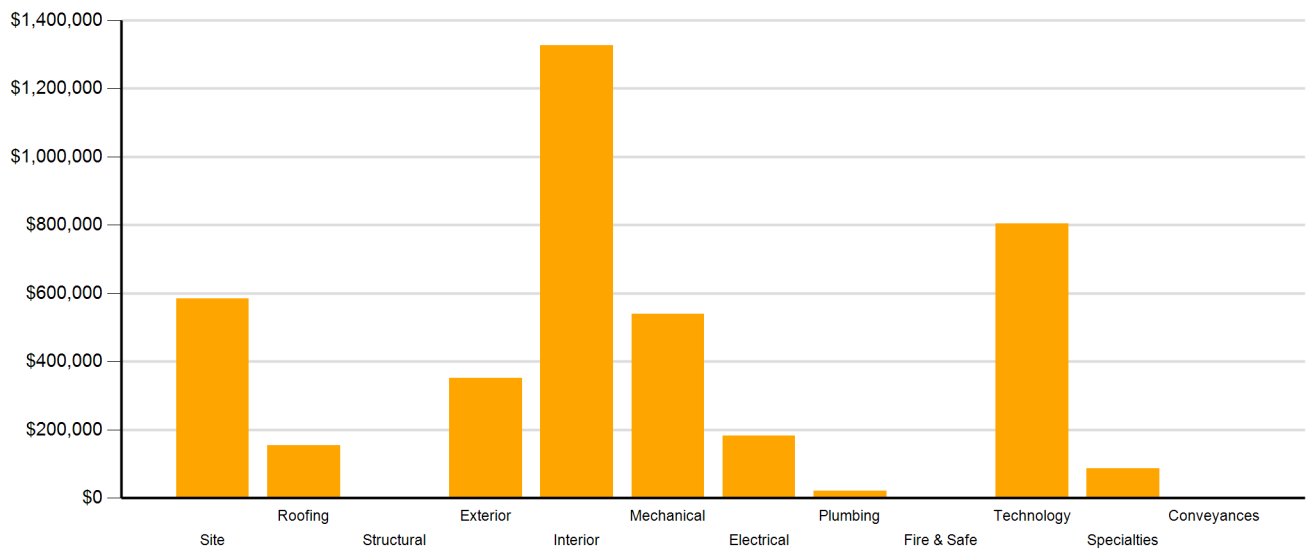
Figure 2: System Deficiencies

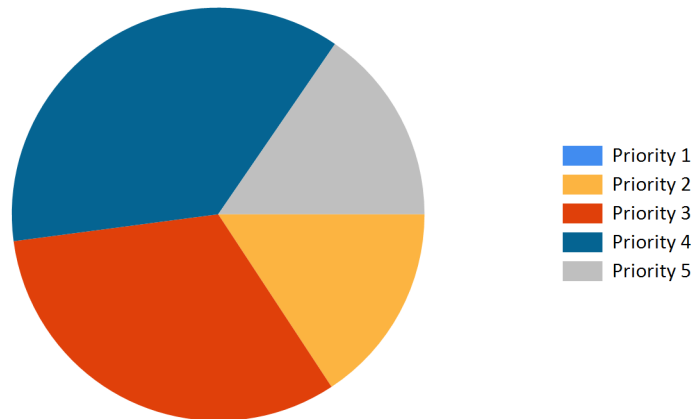
Figure 3: Current deficiencies by priority

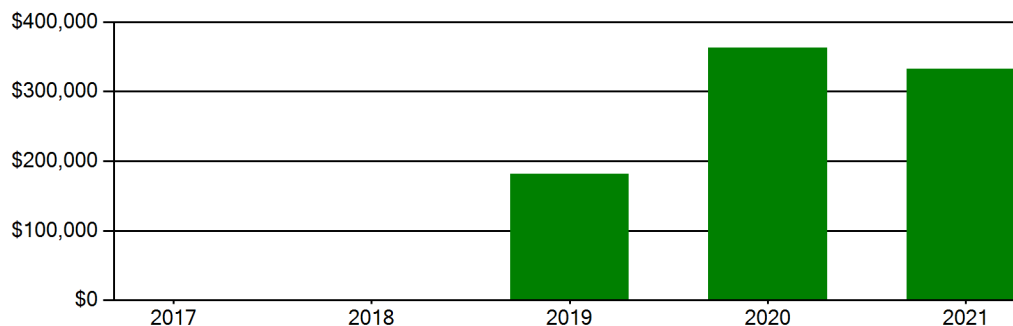
Figure 4: Life Cycle Capital Renewal Forecast

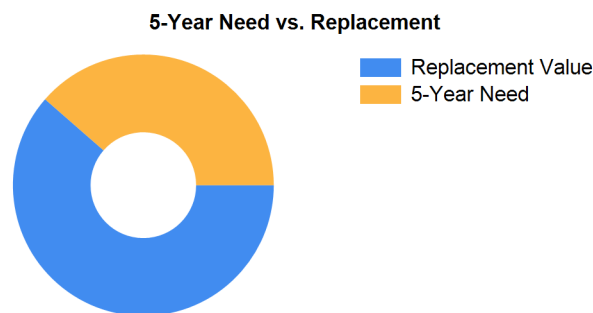
Figure 5: 5-Year FCI

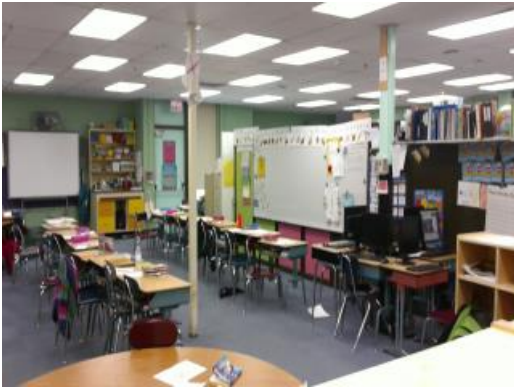
Open Concept Classroom

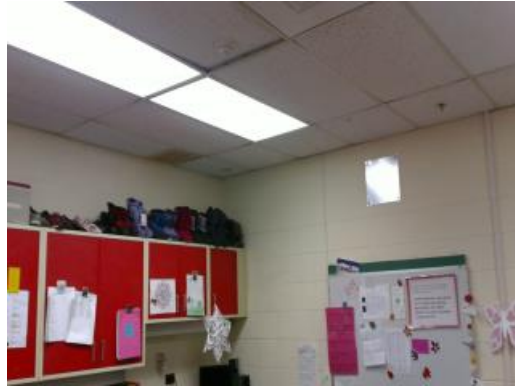
Stained And Sagging Ceiling Tiles

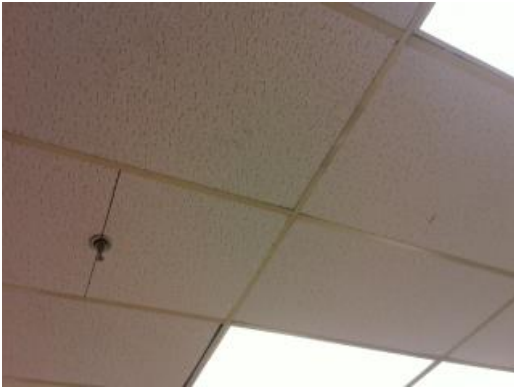
Stained Ceiling Grid

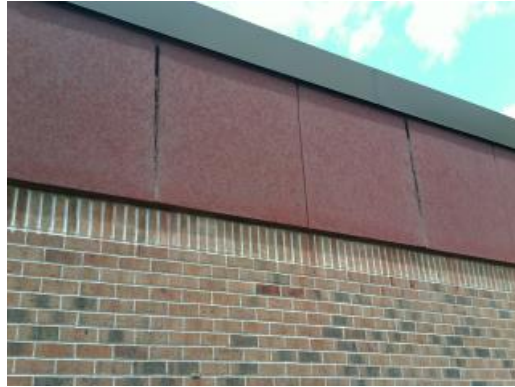
Weathered Caulking At EIFS

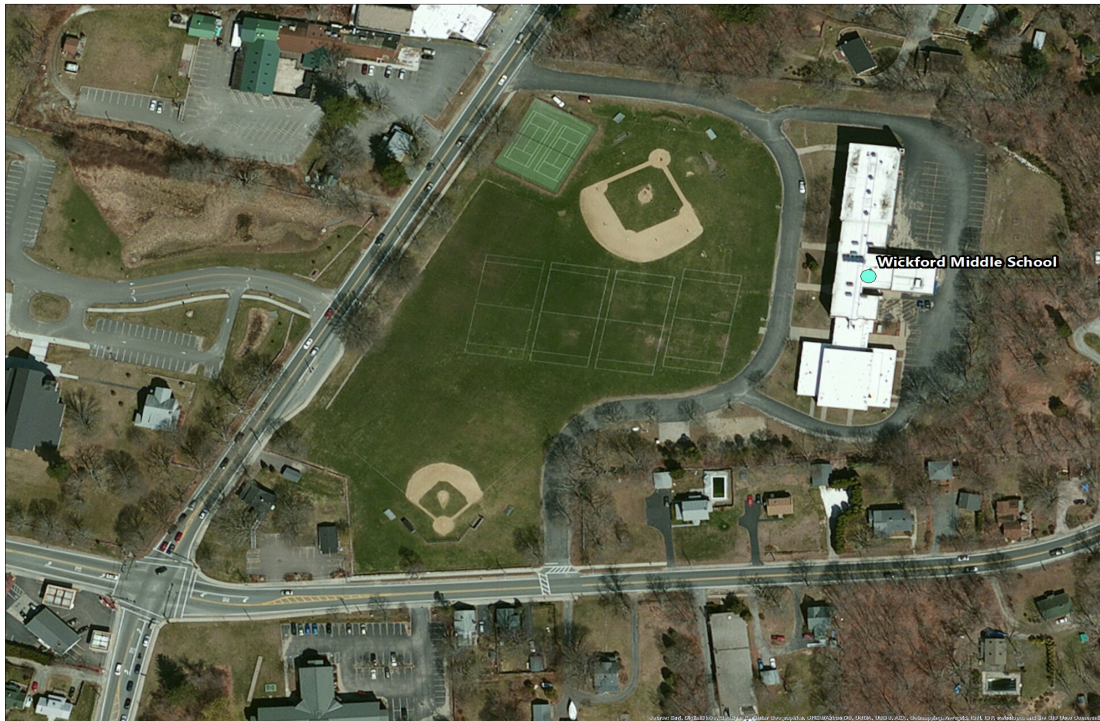
Figure 1: Aerial view of Wickford Middle School

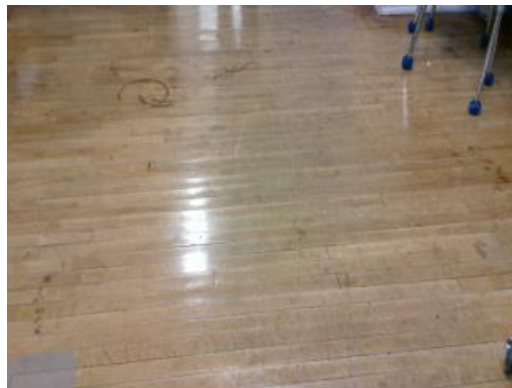
Worn And Scratched Wood Floor

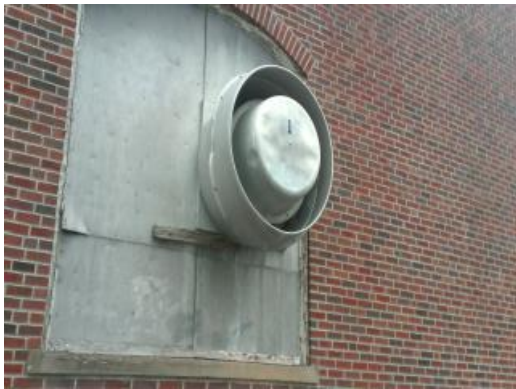
Exhaust Fan Ventilation

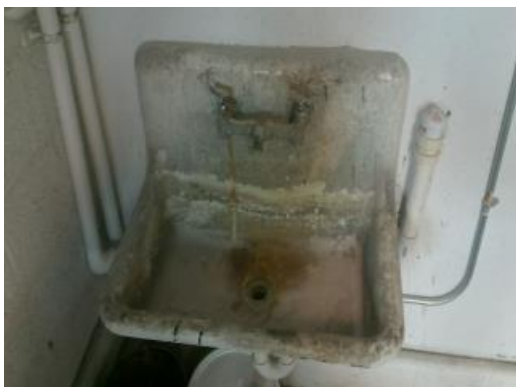
Corroded Service Sink

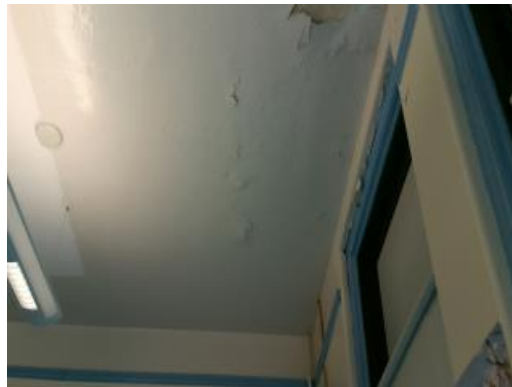
Peeling Ceiling Paint

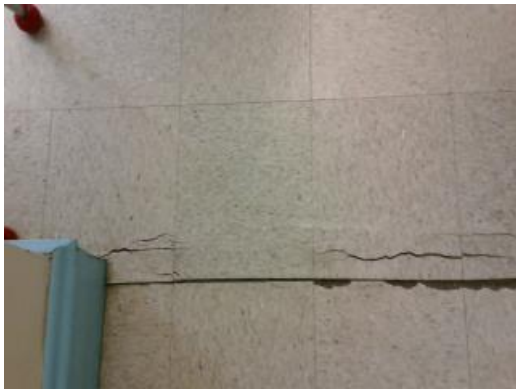
Cracked Flooring at Second Floor

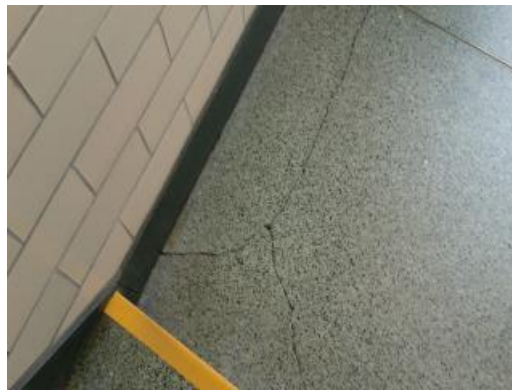
Cracked Flooring at Stairs

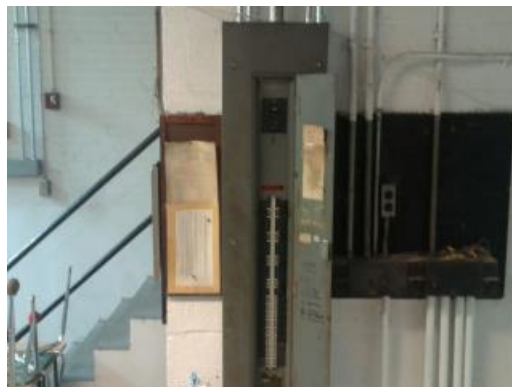
Federal Pacific Panelboard

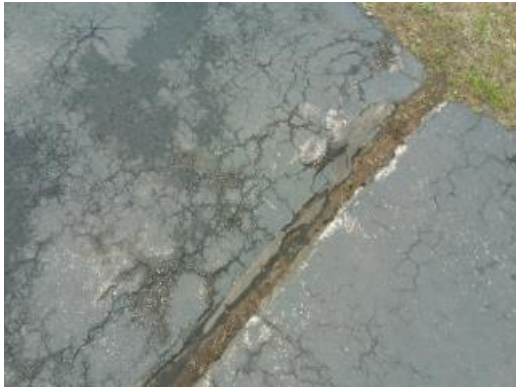
North Kingstown - Wickford Middle School

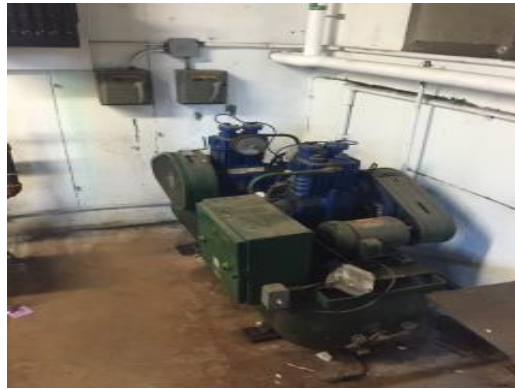
Leaking Air Compressor

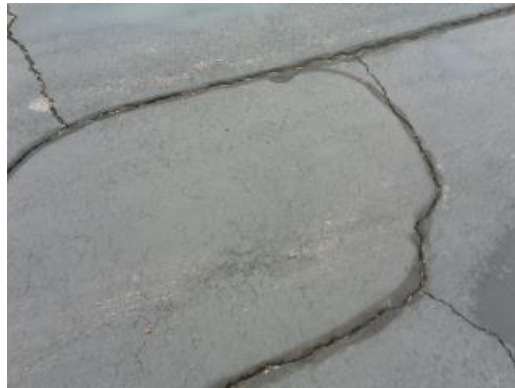
Roadway Asphalt Cracks

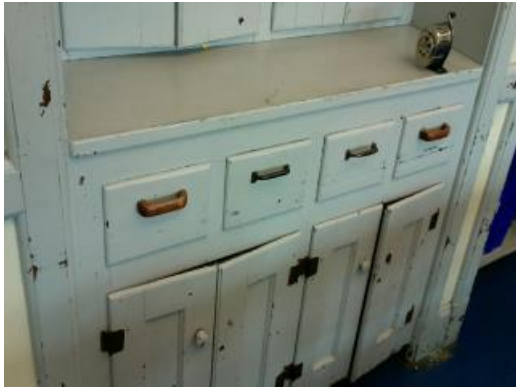
North Kingstown - Wickford Middle School

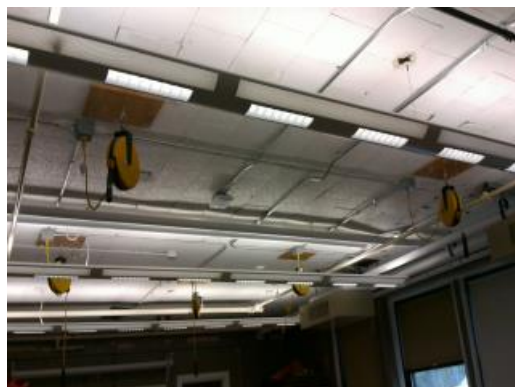
Falling Adhered Acoustic Ceiling Tiles

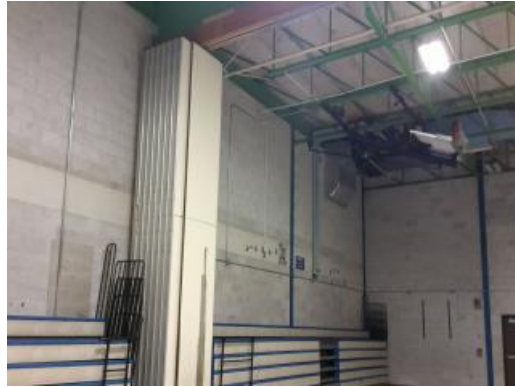
Damaged Gym Partition
