Report of Findings

**Brayton Elementary School**

**20 Brayton Hill Terrace**

Job No: 24-1041

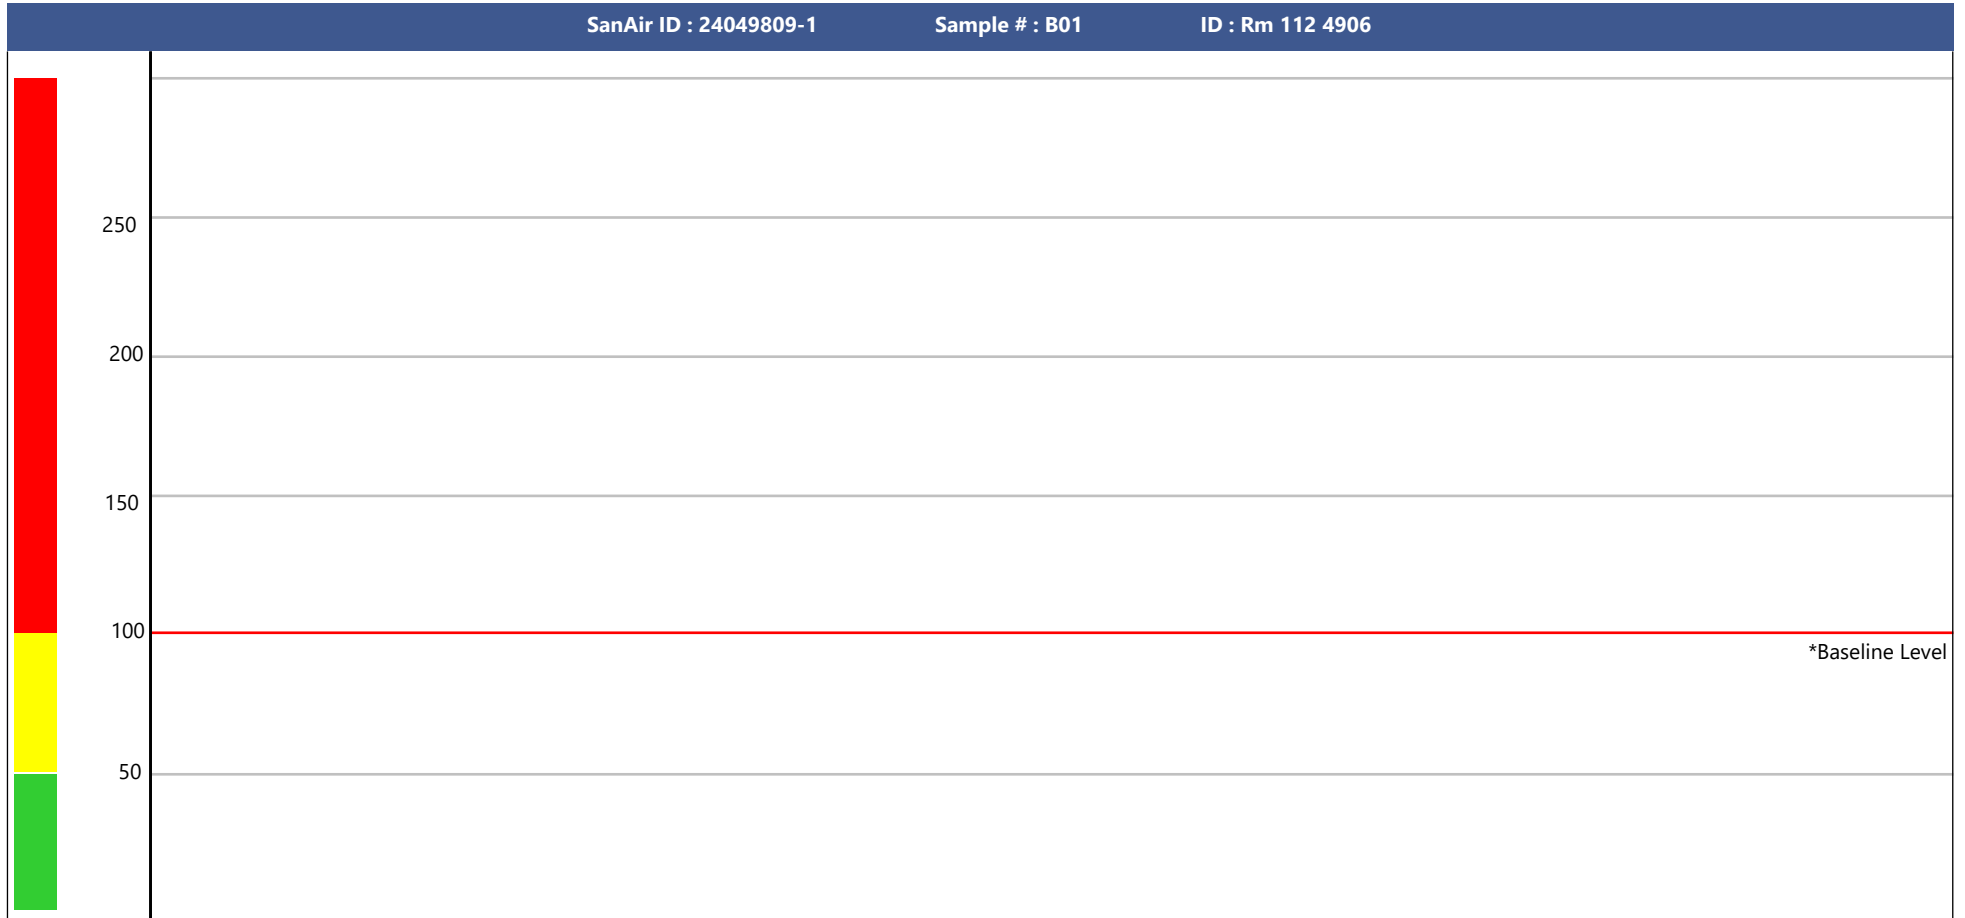
## Air Cassette Analysis - Spores % of Outside Air

| | Count/m <sup>3</sup> higher than Baseline |
| | Count/m <sup>3</sup> comparable to Baseline |

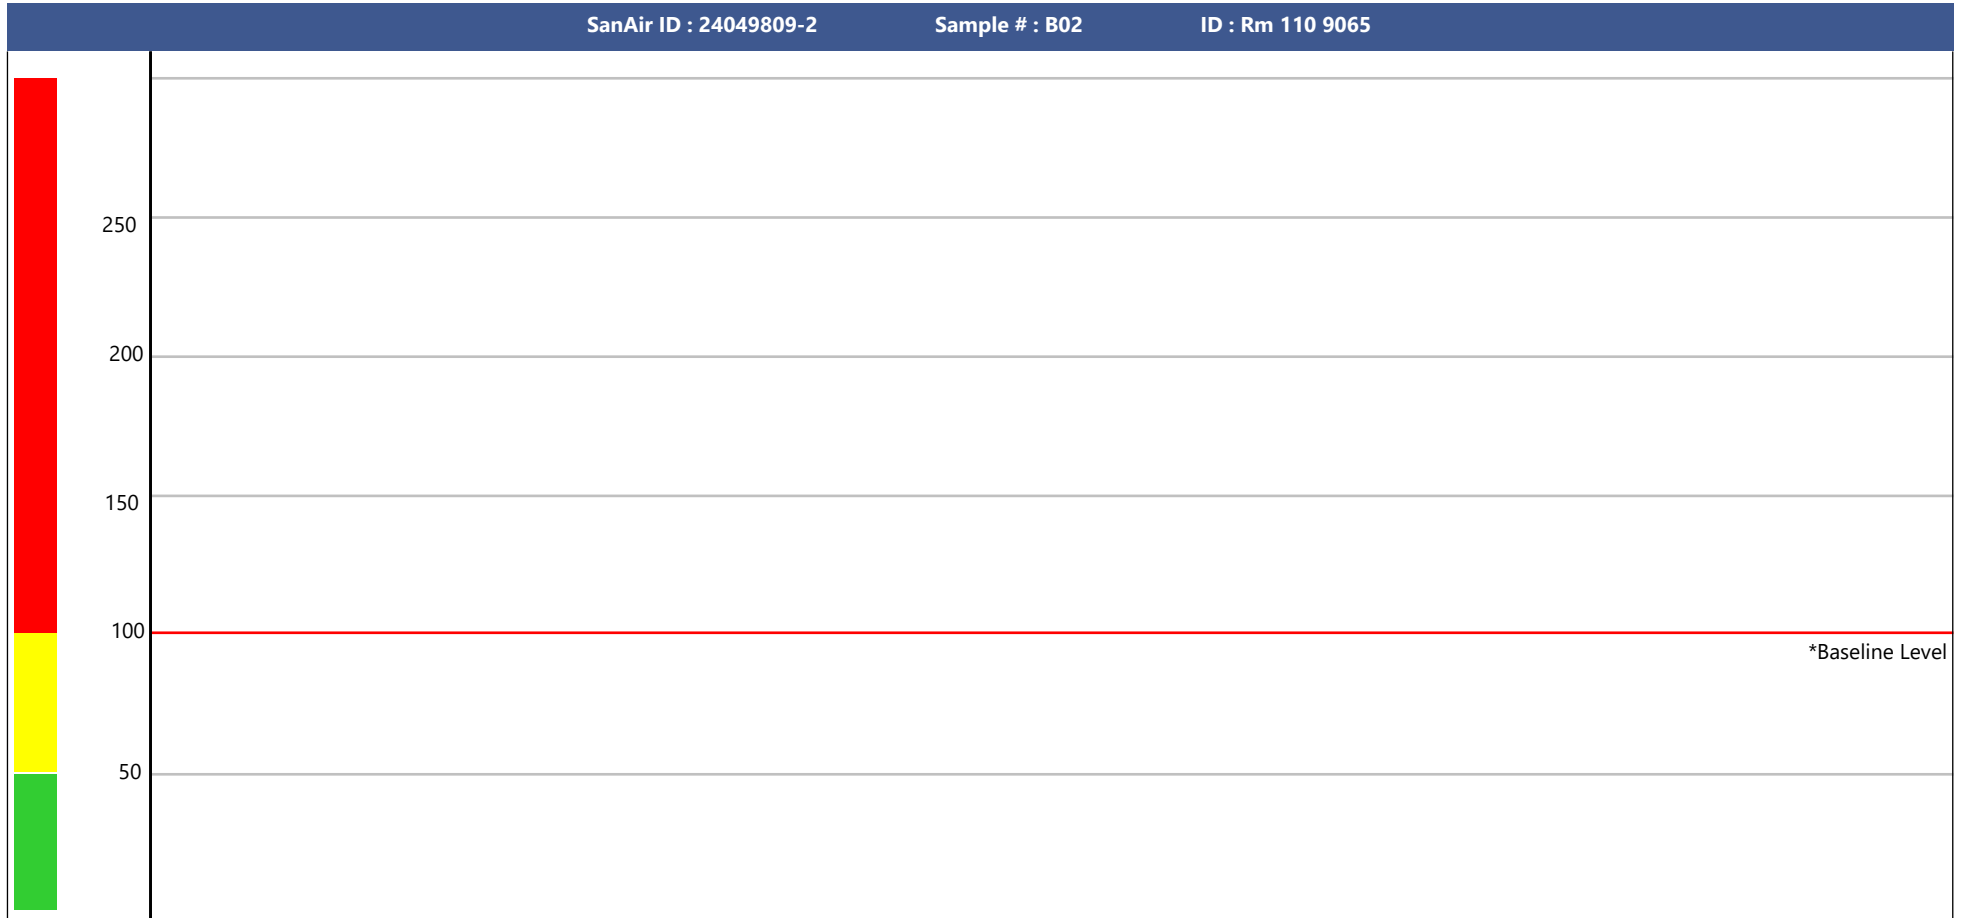
## Air Cassette Analysis - Spores % of Outside Air

| | Count/m <sup>3</sup> higher than Baseline |
| | Count/m <sup>3</sup> comparable to Baseline |

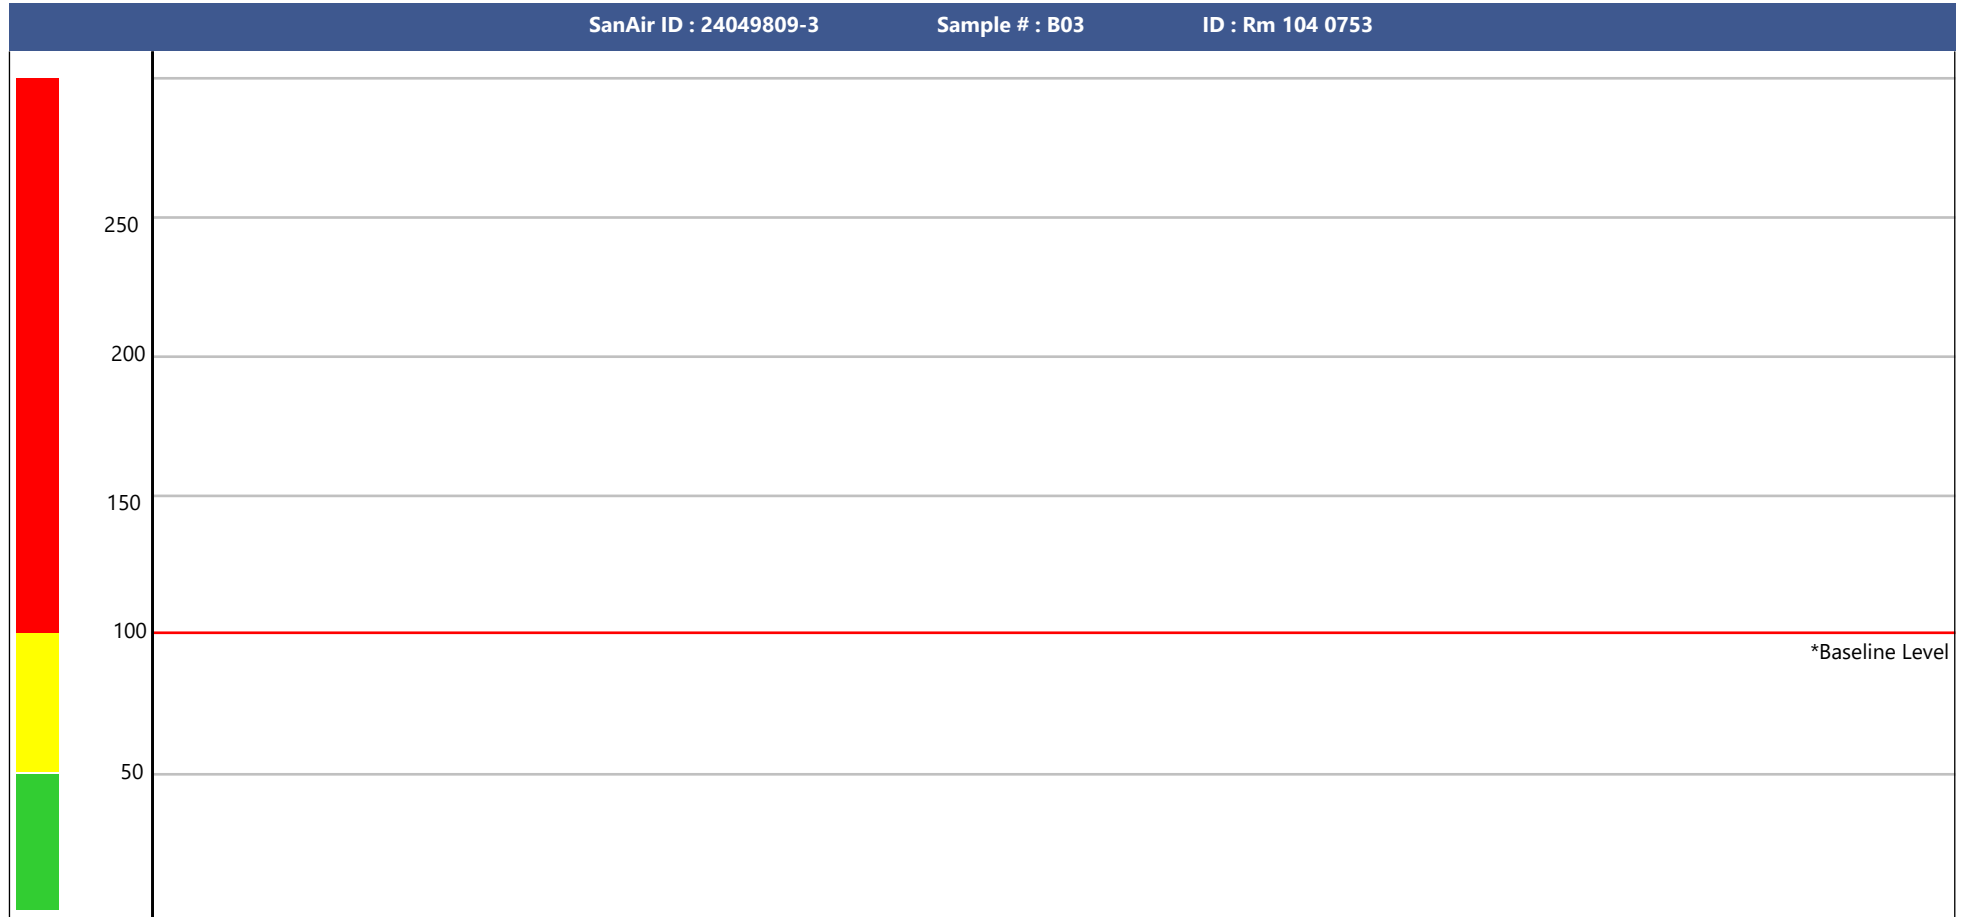
## Air Cassette Analysis - Spores % of Outside Air

| | Count/m <sup>3</sup> higher than Baseline |
| | Count/m <sup>3</sup> comparable to Baseline |

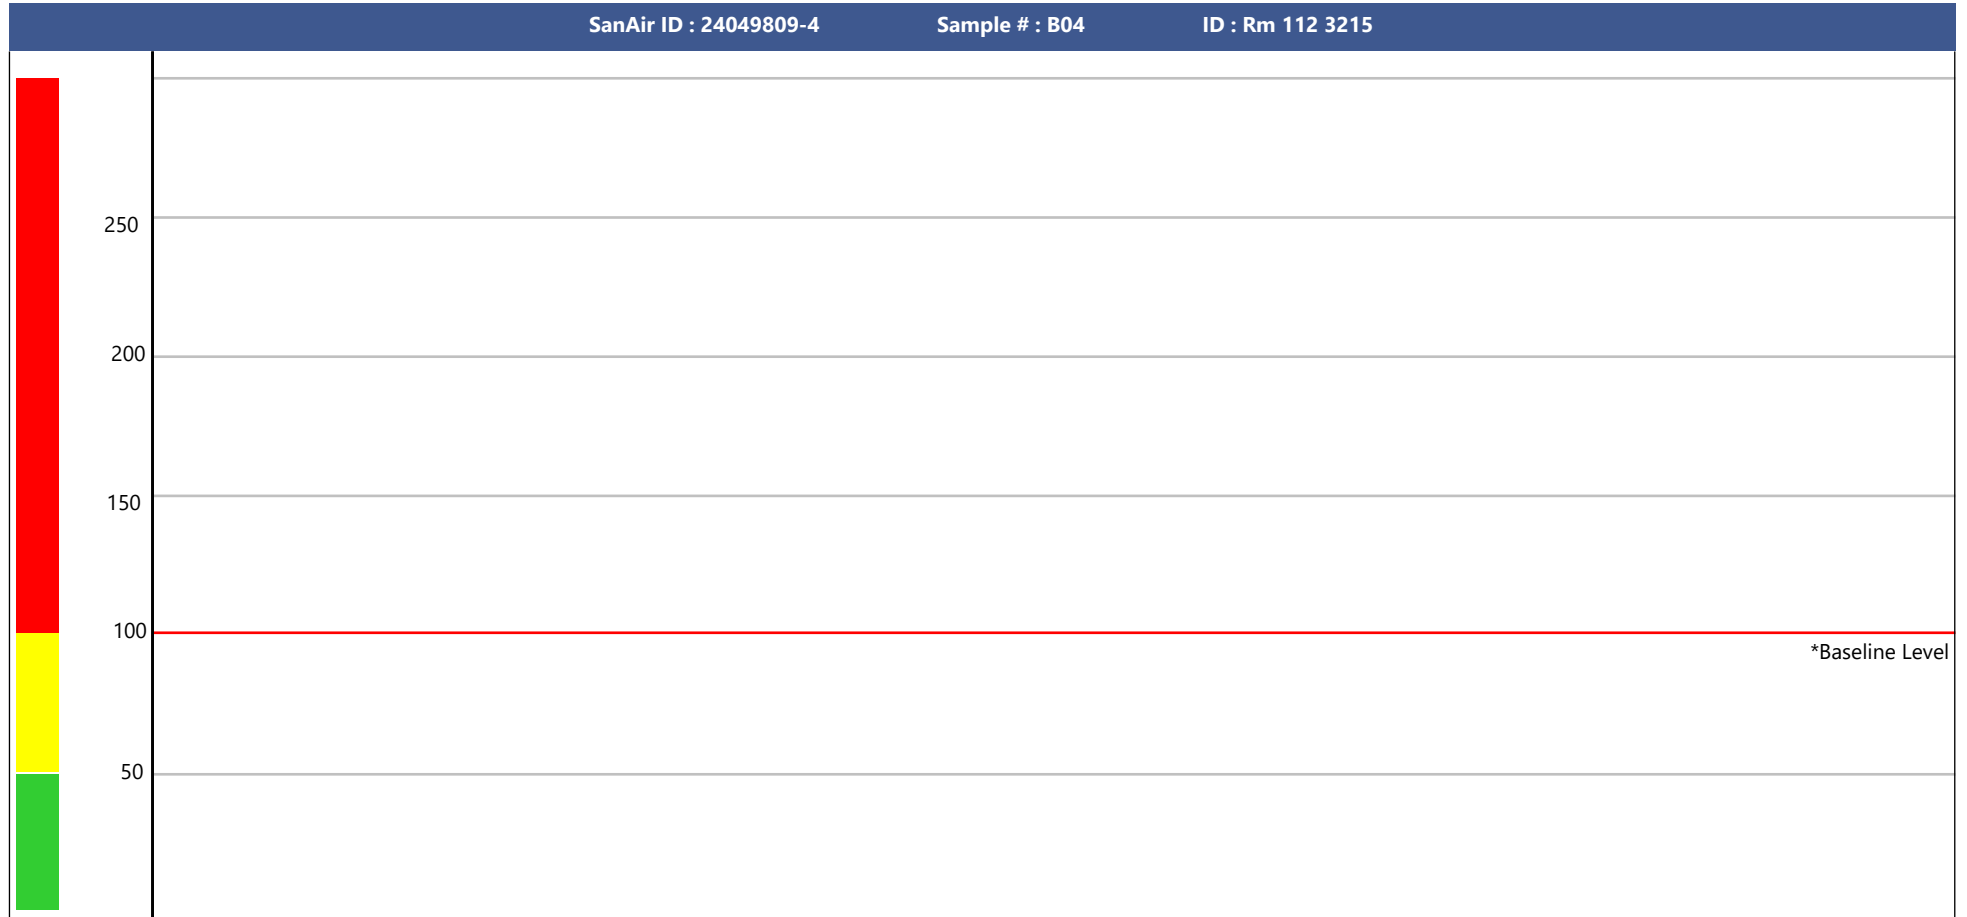
## Air Cassette Analysis - Spores % of Outside Air

No organisms to graph. Normalized organism counts may not have exceeded the organism thresholds, or there were no organism counts for this sample. Please refer to the analysis report.

\*The Baseline Level (100%) represents the average baseline sample counts. Counts above the baseline may indicate higher than expected levels of a given result.

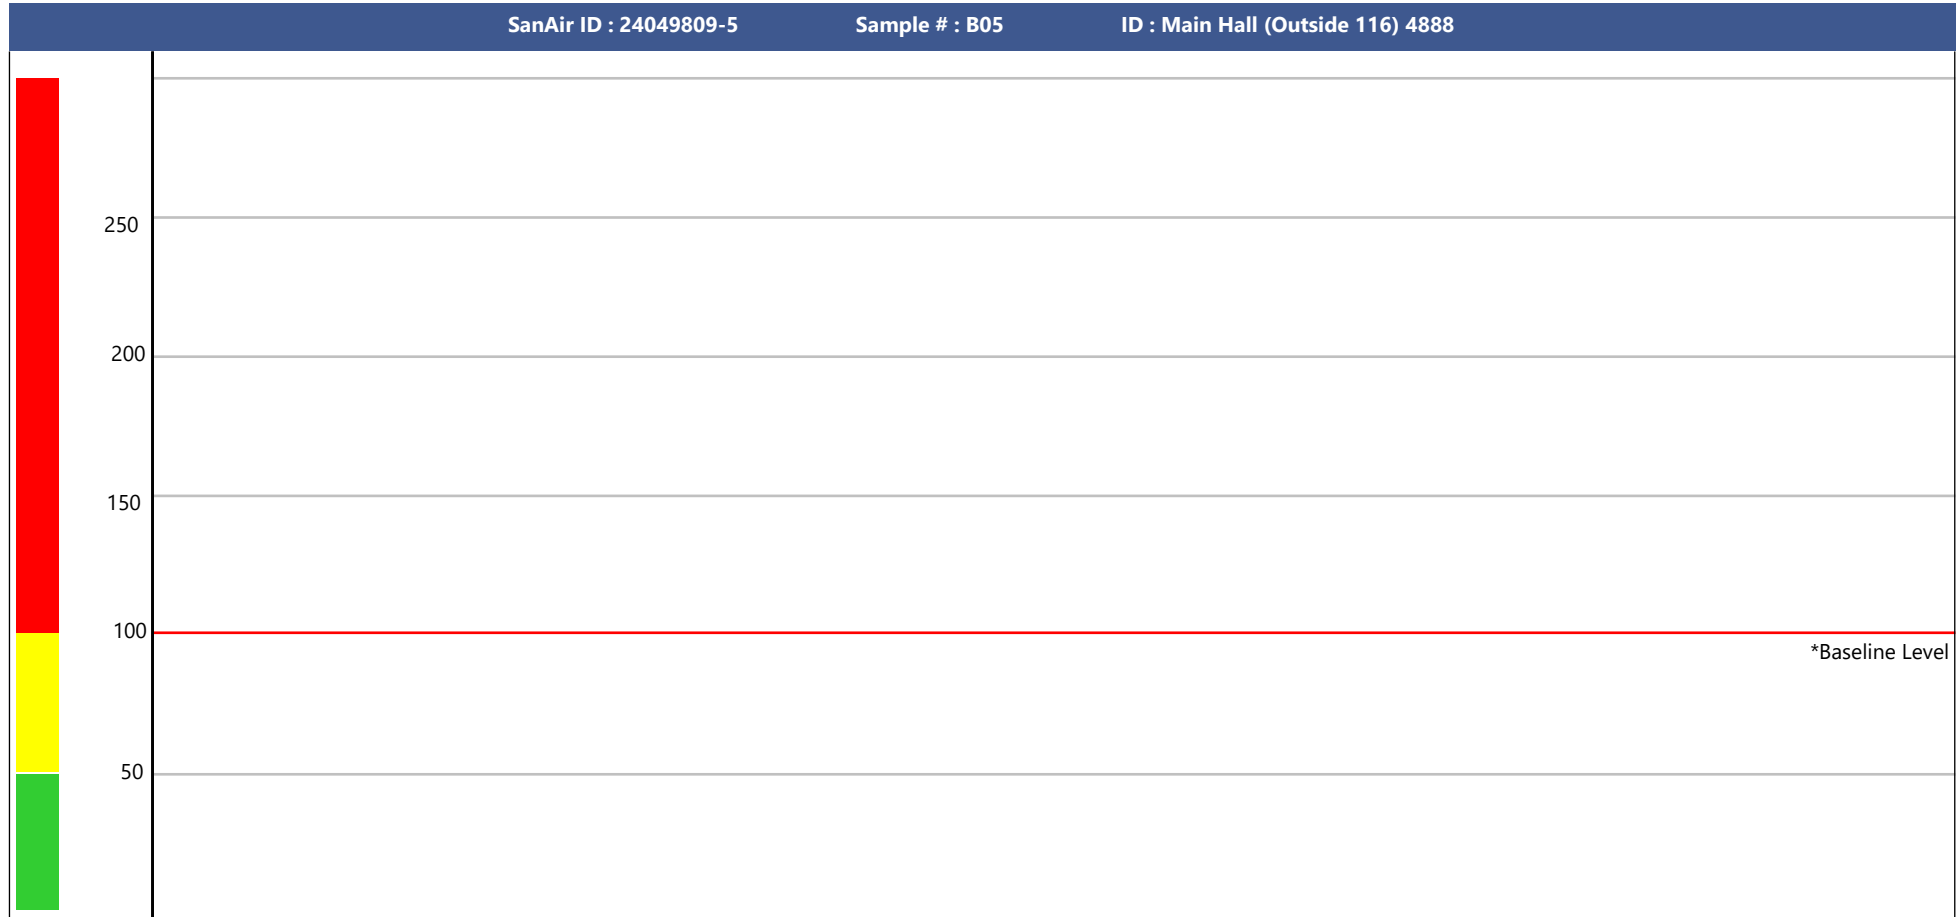
## Air Cassette Analysis - Spores % of Outside Air

No organisms to graph. Normalized organism counts may not have exceeded the organism thresholds, or there were no organism counts for this sample. Please refer to the analysis report.

\*The Baseline Level (100%) represents the average baseline sample counts. Counts above the baseline may indicate higher than expected levels of a given result.

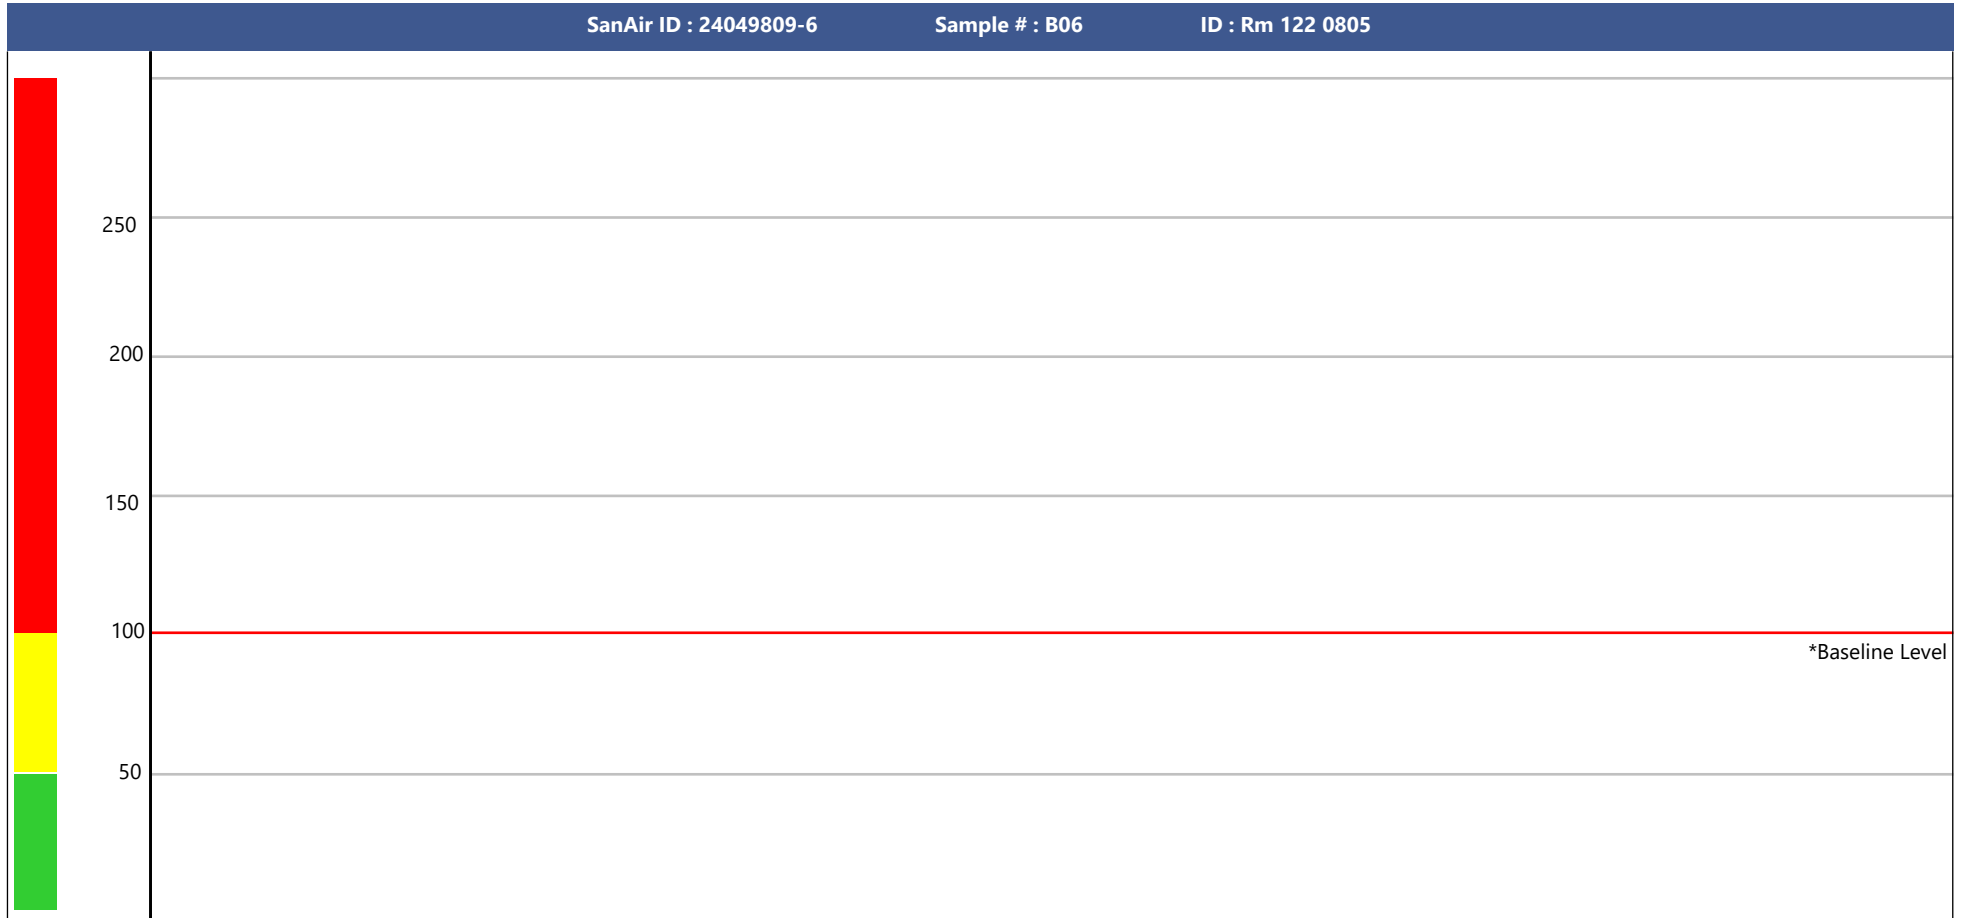
## Air Cassette Analysis - Spores % of Outside Air

| | Count/m <sup>3</sup> higher than Baseline |
| | Count/m <sup>3</sup> comparable to Baseline |

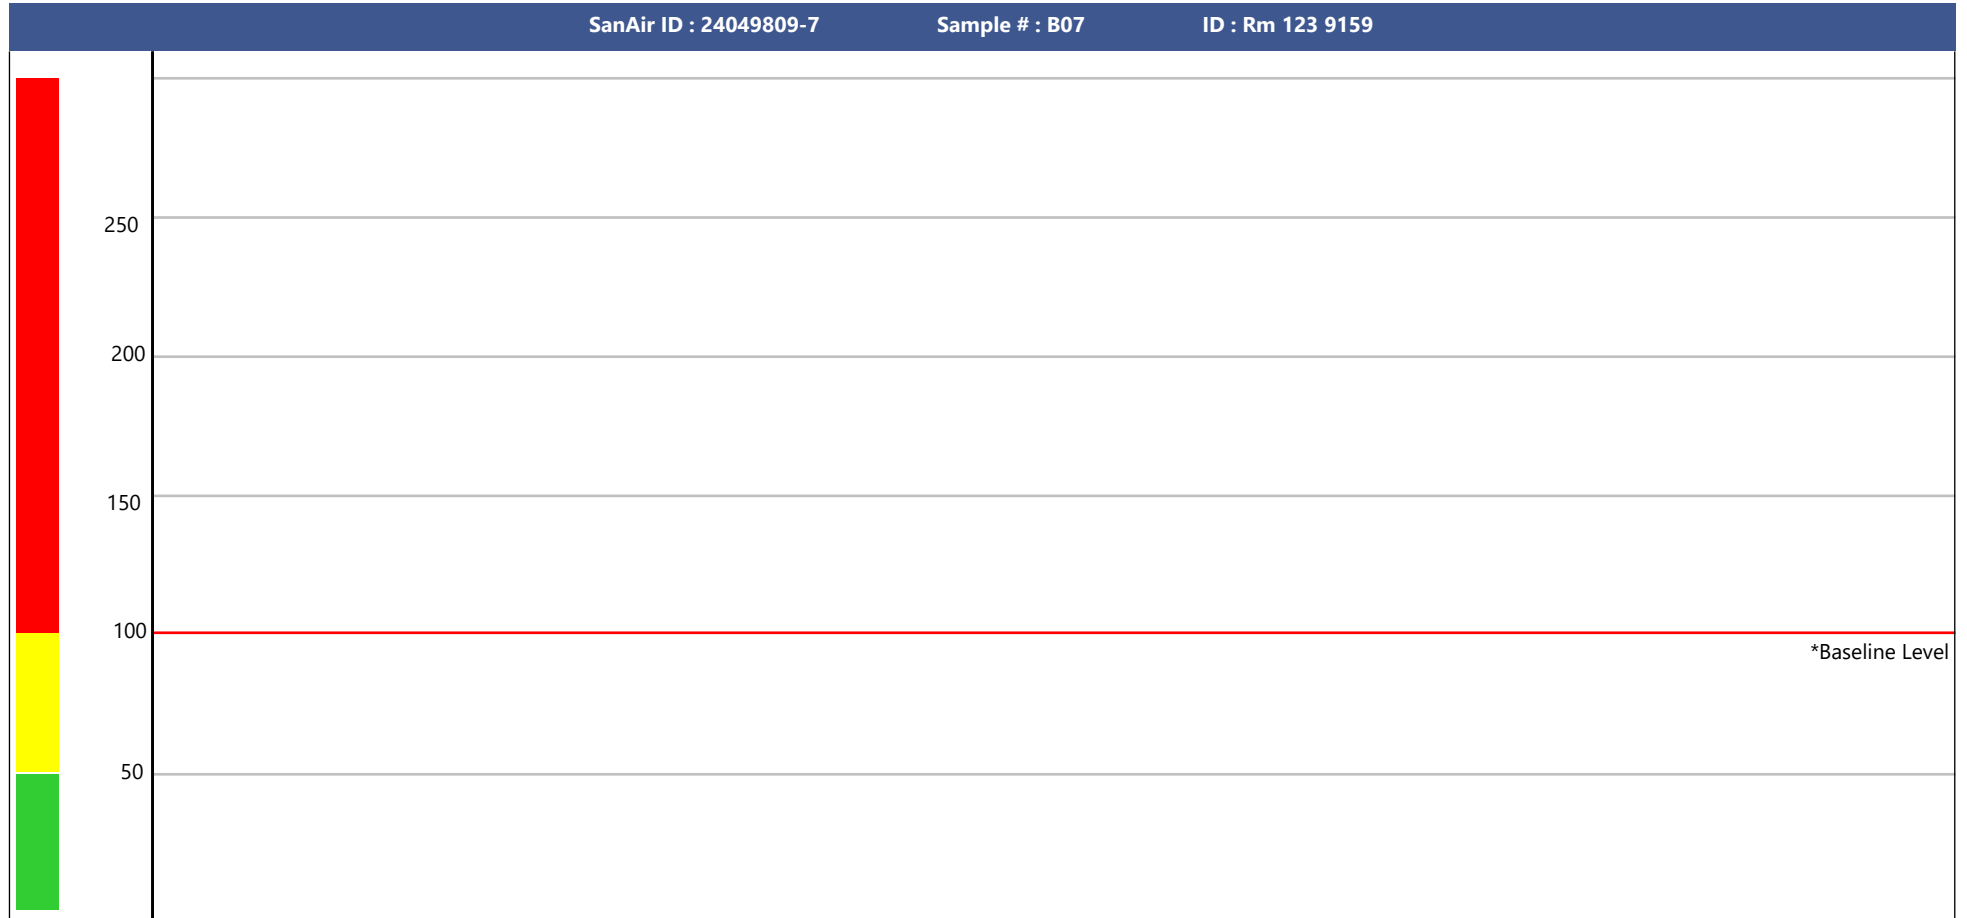
## Air Cassette Analysis - Spores % of Outside Air

| | Count/m <sup>3</sup> higher than Baseline |
| | Count/m <sup>3</sup> comparable to Baseline |

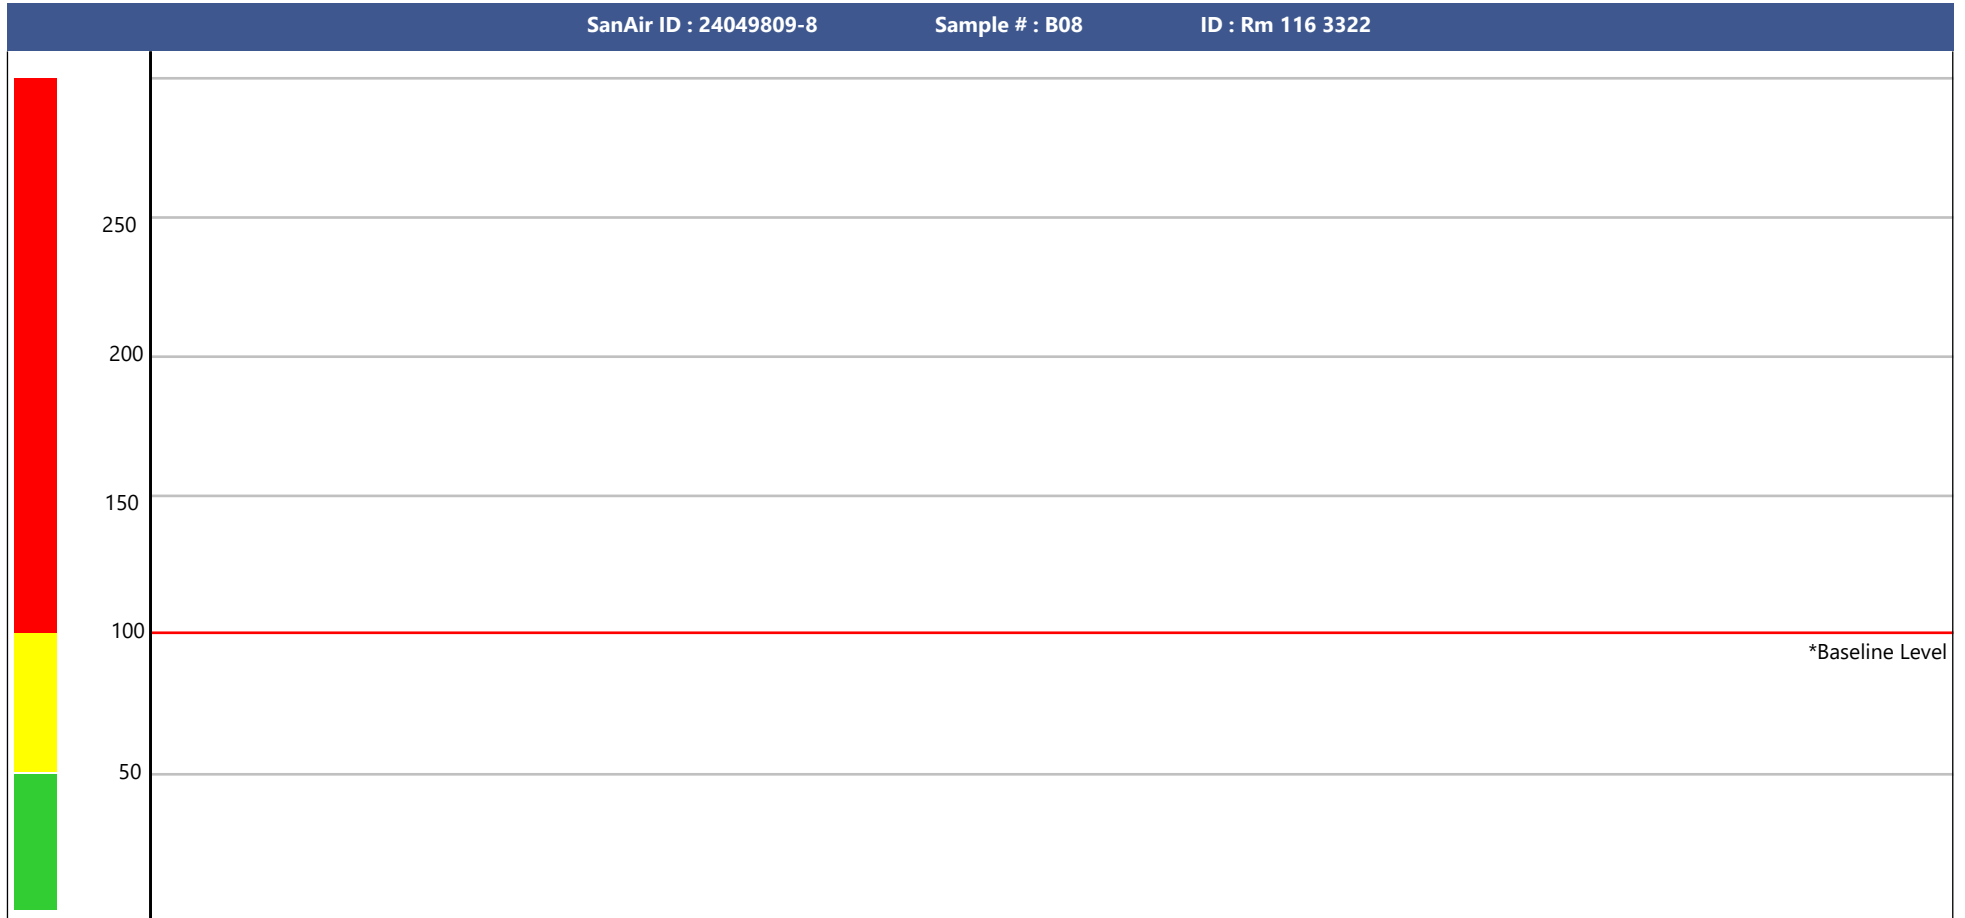
## Air Cassette Analysis - Spores % of Outside Air

| | Count/m <sup>3</sup> higher than Baseline |
| | Count/m <sup>3</sup> comparable to Baseline |
