GLADSTONE SCHOOL DISTRICT

Facilities Assessment Report

BRIC ARCHITECTURE, INC. JULY 2024

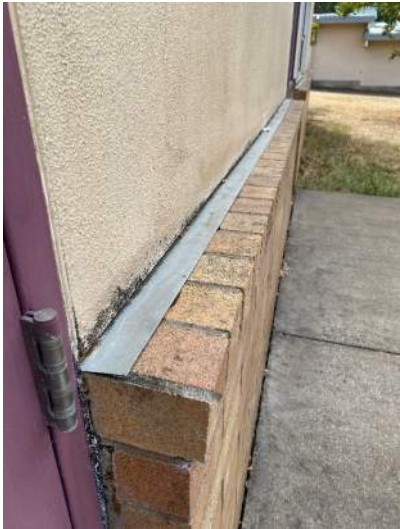
Figure 3

ITEM	FINDING	COMMENTS
B2010 Exterior Walls	<ul style="list-style-type: none"> → The flashing between exterior materials shows signs of water exposure. See figure 3. → The exterior painted walls are in fair condition. → Tall masonry walls show signs of water damage. See figure 4. 	<ul style="list-style-type: none"> → Walls include an exterior insulated finishing system (EIFS), brick masonry and concrete masonry (painted). → There is metal flashing between the EIFS and the masonry. To determine any issues, a more invasive assessment would be necessary. It is not known the cause of the water damage to the masonry walls. See roofing report for additional information.
B2020 Exterior Windows	<ul style="list-style-type: none"> → One window in classroom 16 has a broken seal; condensation is visible. See figure 5. → Windowsills in the cafeteria are in fair condition. 	<ul style="list-style-type: none"> → Windows are a combination of newer insulated window systems and older single pane assemblies. → Although no issues were observed at the time of the assessment, it was observed that library windows are heavily caulked on the interior side. These older windows are a candidate for replacement for efficiency. → One of the gymnasiums has translucent panel window assemblies on two sides. → A skylight is present in room 27.

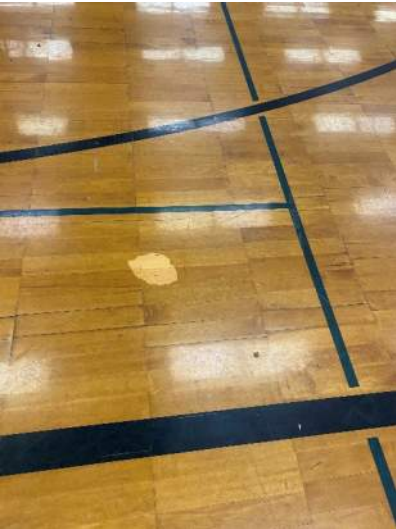
Figure 6

ITEM	FINDING	COMMENTS
C3020 Floor Finishes	<ul style="list-style-type: none"> → Select exterior doors lack entry mat flooring. → The flooring in the hallway adjacent to the main gymnasium is damaged. → The main gymnasium flooring is in fair condition. See figure 6. → The stage floor is fair condition; the stage edge is in poor condition. → There are several locations throughout this facility where the resilient flooring (VCT) appears to separate (larger joint gaps than usual) or does not appear to be lying flush on the floor slab. See figure 7. 	<ul style="list-style-type: none"> → The lack of entry (walk-off) mats can pose a safety issue. → Carpeting occurs in office areas and in the library and is in good condition. → Most of the flooring in this facility is vinyl composition tile (VCT). → The observed cracking could be the result of building settlement or deterioration of flooring material (due to the material's age). A more invasive study is needed to correctly determine the issues. → Both gymnasiums have wood flooring and rubber base (no vented). Both spaces have court striping. → Both the band and choir classrooms have VCT flooring. The ramp within the space has a rubber flooring surface. → Kitchen flooring is ceramic tile.

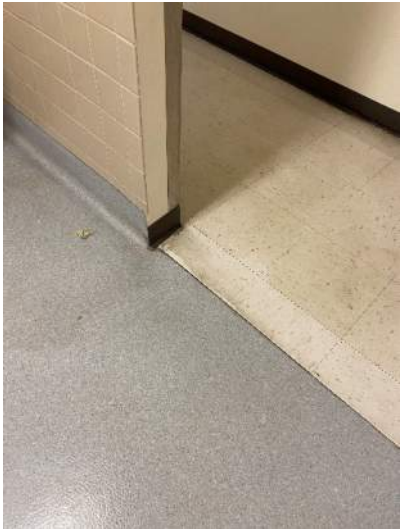
Figure 8

C40 Toilet Room Facilities		
C4010 Ceiling Finishes	→ No issues observed.	→ Ceilings in restrooms are painted gypsum board.
C4020 Floor Finishes	→ Transition between flooring types at select multi-user restrooms is in poor condition. See figure 8.	<ul style="list-style-type: none"> → The restrooms near classrooms 12 and 25 do not have a transition strip between the resilient flooring. → The flooring in the multi-user restrooms is ceramic tile. One set of student restrooms has a resilient flooring (linoleum) with a coved base. → Single user/all-user restrooms have sheet vinyl flooring with a coved base.
C4030 Wall Finishes	→ No issues observed.	<ul style="list-style-type: none"> → Multi-user restrooms have ceramic tile walls and painted gypsum above the tile. Some fiber reinforced panels (FRP) were observed. → Single user restrooms have painted gypsum board walls and/or FRP panels.
C4040 Accessories	→ No issues observed.	<ul style="list-style-type: none"> → Both locker rooms have been retrofitted with private changing stalls. → Wash sinks in the multi-user restrooms are an older model (original to construction). See Plumbing for additional information.

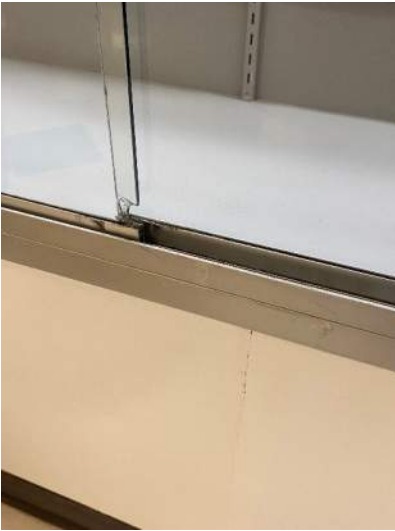
Figure 9

ITEM		FINDING	COMMENTS
C50 Specialties			
C5010	Equipment	<ul style="list-style-type: none"> → One of the glass display case doors is damaged. See figure 9. → Masonry seats/benches in both locker rooms need to be painted. 	<ul style="list-style-type: none"> → Classrooms are equipped with a variety of instructional equipment including markerboards, projectors and screens, Smartboards, and display areas (tackboards or tackable panels). → The choir classroom has a markerboard with staff lines. → Display cases are present in multiple areas. A flat panel television was also observed. → Both gymnasiums have wall padding. → The main gymnasium has both wood and plastic bleachers. It also houses a scoreboard, projection screen and six basketball backstops. → The second gymnasium also has 6 basketball backstops and a scoreboard. → The girl's locker room has 4-tier metal lockers (Superior), both at the perimeter and in the middle (Island). There are fixed wood benches. → The boy's locker room has single tier and 4-tier lockers (Superior), both at perimeter walls and in island configurations. Fixed wood benches are also present. → Hallways lockers are 2-tier lockers both by Lyon and Superior. They vary in overall height.

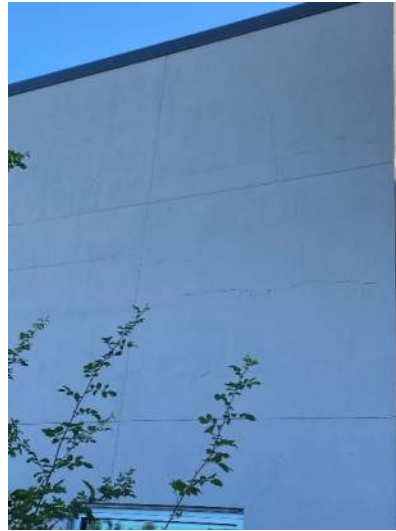
Figure 2

ITEM	FINDING	COMMENTS
B2010 Exterior Walls	<ul style="list-style-type: none"> → There are numerous cracks in the walls (at the auditorium). See figure 2. → There is some damage to masonry wall, several holes were observed. → The masonry wall at the boys' locker room hallway has visible water damage. See figure 3. 	<ul style="list-style-type: none"> → The cracks could be the result of settlement or panel joints could be spaced too far apart. → It is not known the cause of the water damage to the masonry walls. → Exterior wall materials include painted masonry, exterior insulated finishing systems (EIFS) and metal siding. Painted tilt-up concrete walls are present at the auditorium. → The freestanding shop building is clad in metal siding.
B2020 Exterior Windows	<ul style="list-style-type: none"> → Exterior wood window trim in the art room (classroom C123) is in fair condition. → The exterior windows are classroom F111 are in poor condition. See figure 4. 	<ul style="list-style-type: none"> → Window systems vary in age and style on this building. Aluminum storefront assemblies are present on newer portions of the building, while the older portion have single pane glazing in metal frames. The older window styles are not energy efficient. → The exterior windows at classroom F111 appear to be glazing in a wood frame without glazing stops. → There are painted metal sunshades on portions of the building. → Tubular skylights are present in several hallways. Skylights are also present in the cafeteria.

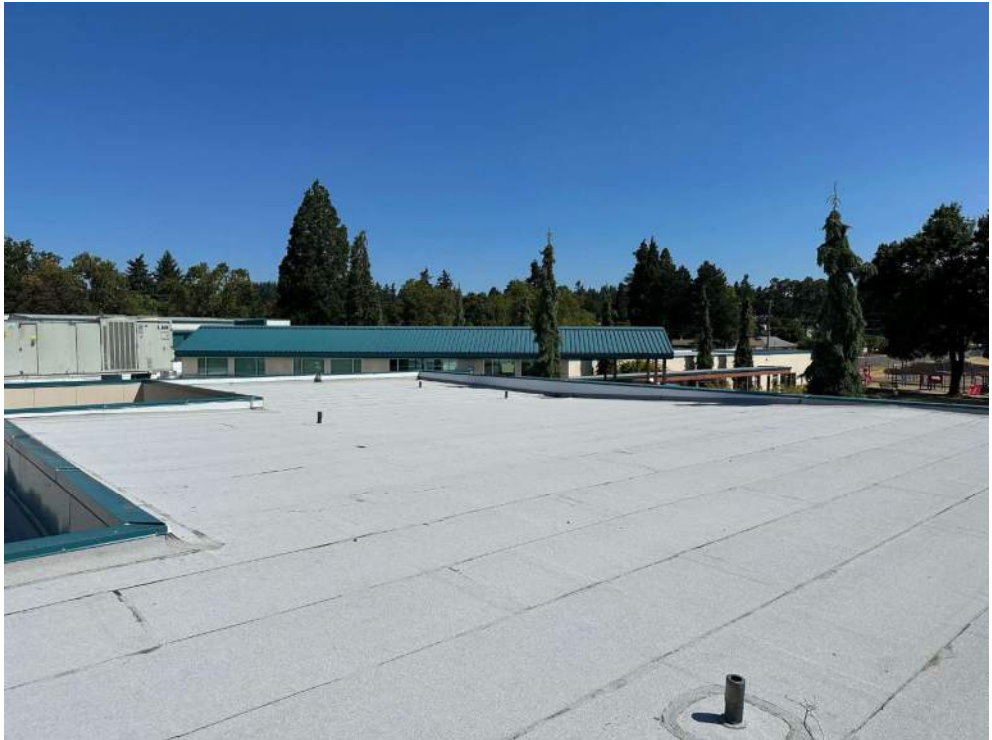
ROOF AREA RESTORED IN 2019

- Budget for roof replacement of the area restored with the AlphaGuard in 10-15 years and continue roof maintenance. Budget should include sheet metal and flashing replacement.
- Replace roof drains which are leaking in the area restored with the aluminum restoration product and repair blisters immediately and budget for roof replacement within 5 years. Budget should include sheet metal and flashing replacement.
- The older BUR roof should be replaced as soon as possible. We recommend complete replacement within the next 1-2 years.
- Continue roof maintenance and drain cleaning on a regular basis.

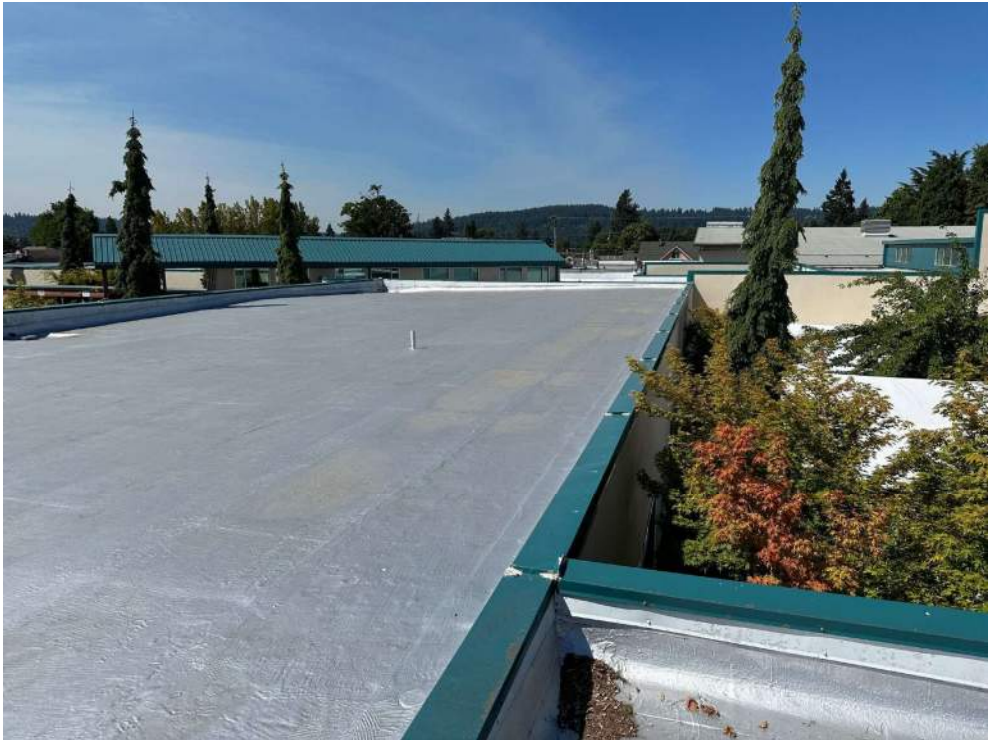
ALUMINUM EMULSION RESTORATION IN 2020

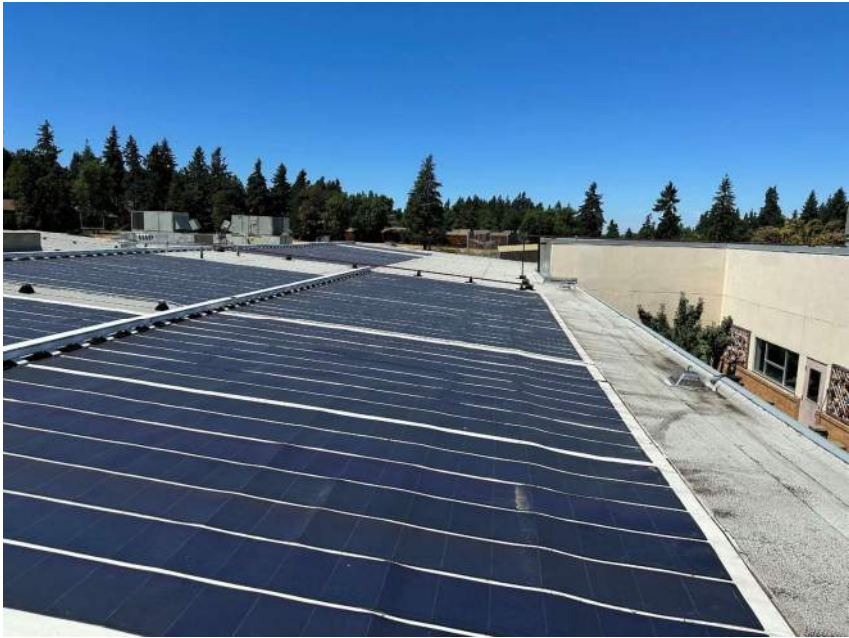
ROLLABLE SOLAR PANELS COVER MUCH OF THE ROOF

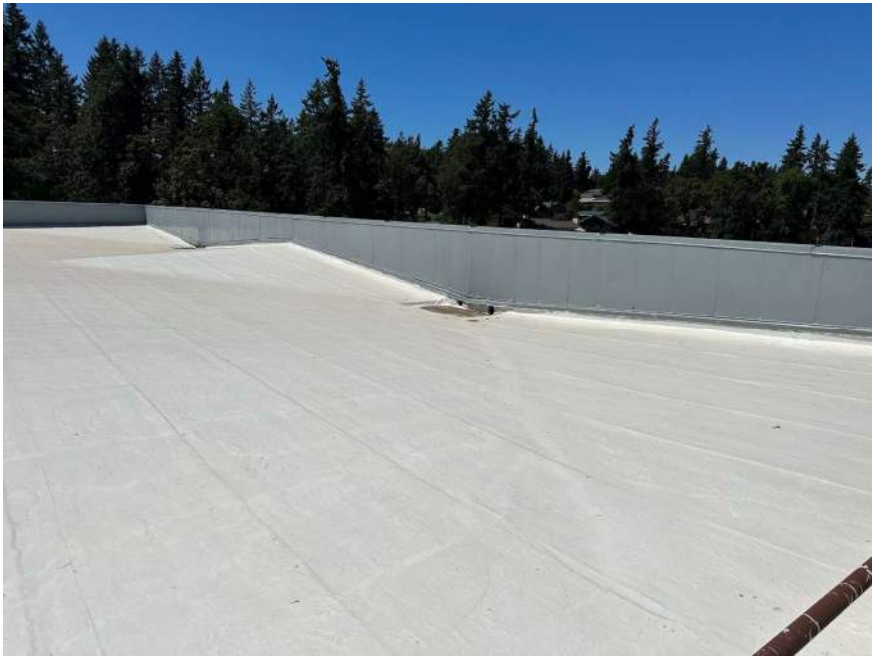
GYM ROOF RESTORED IN 2022 WITH ALPHA GUARD COATING

- Budget for gym roof replacement in 10-15 years.
- Budget for areas of BUR with aluminum emulsion at edges and wall transitions in 5 years and continue with roof maintenance.
- If older modulars are to remain, replace roofs immediately or within 1 year. Shingles at northern modular should be replaced in approximately 10 years.
- Budget for BUR replacement in majority of the roof in a bond issue within the next 2 years.
- Repair blisters immediately.
- Repair/Replace expansion joints in EFIS to CMU wall immediately, along with an elastomeric paint at the exposed CMU and a sealer at the exposed brick masonry.
- Determine impacts of rollout solar panels on re-roofing.

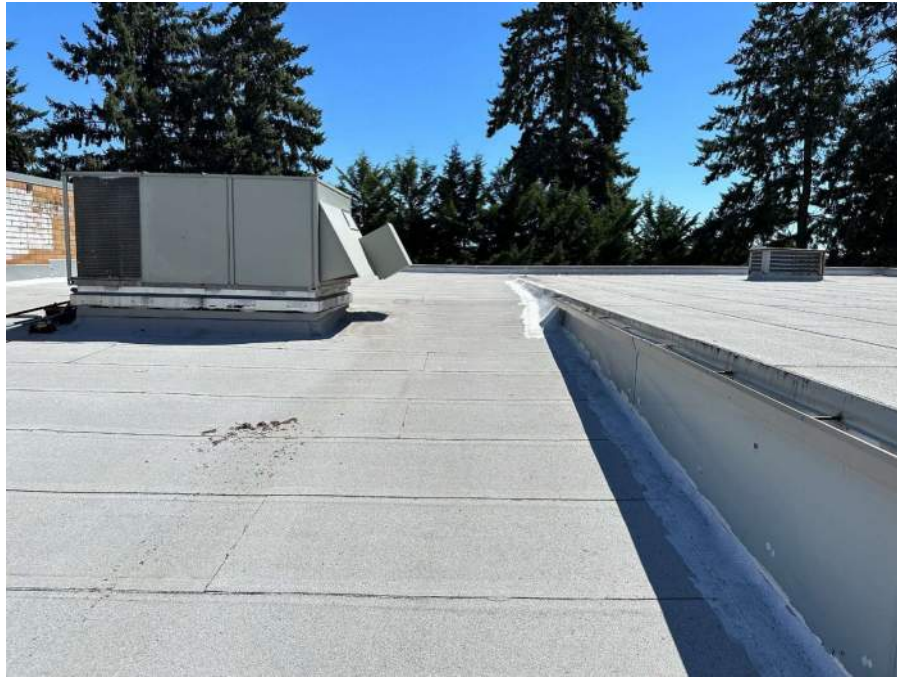
2006 BUR WITH ALUMINIUM EMULSION ON EDGES

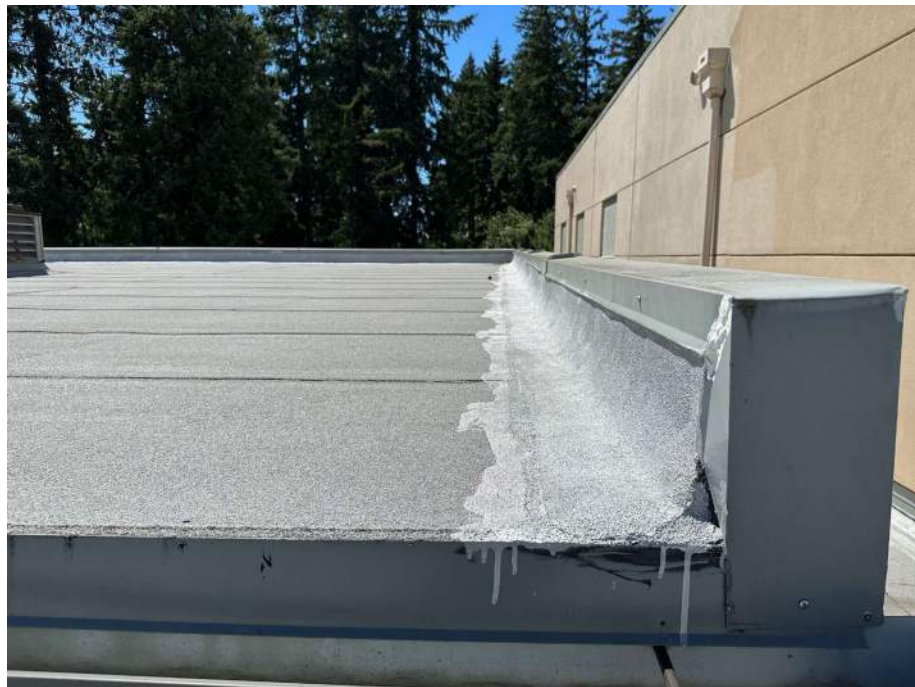
2006 BUR WITH ALUMINIUM EMULSION ON EDGES

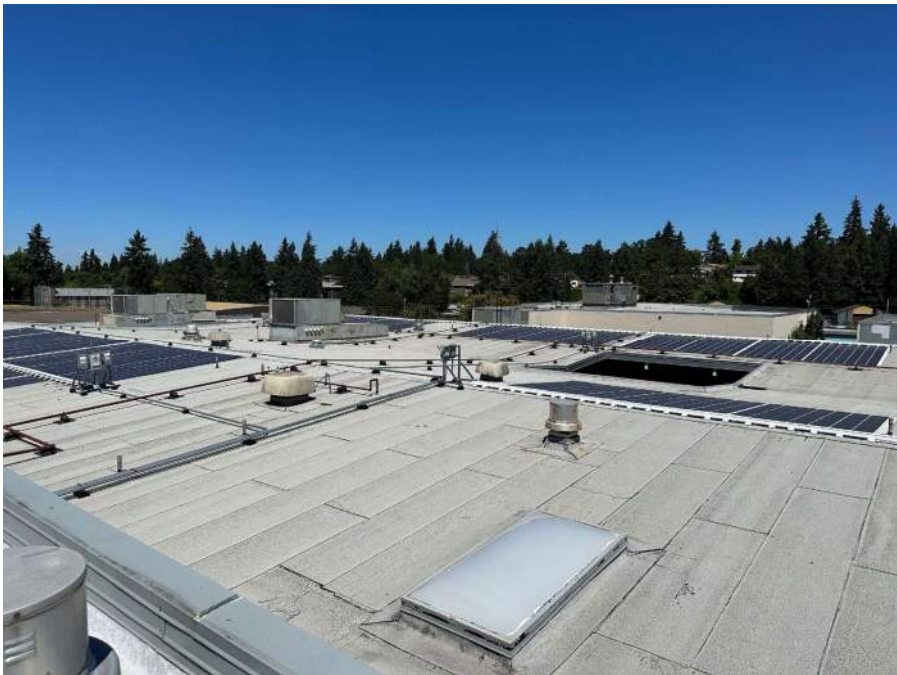
OLDER BUR WITH ROLLABLE SOLAR PANELS

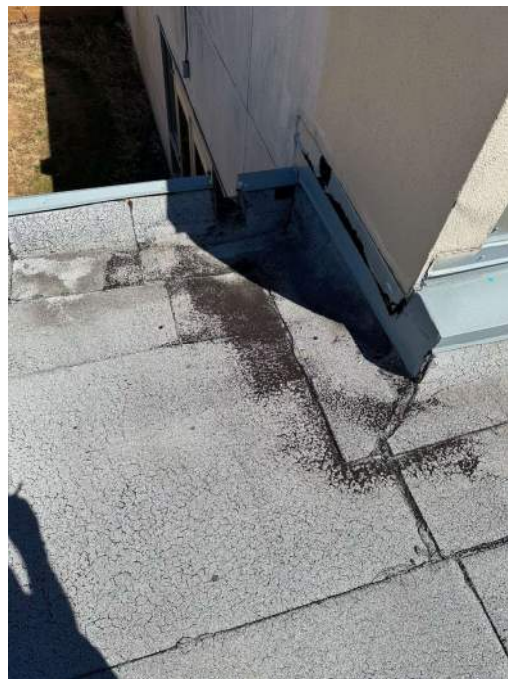
PONDING, GRANULE LOSS & NEED FOR SEALANT AT FLASHINGS

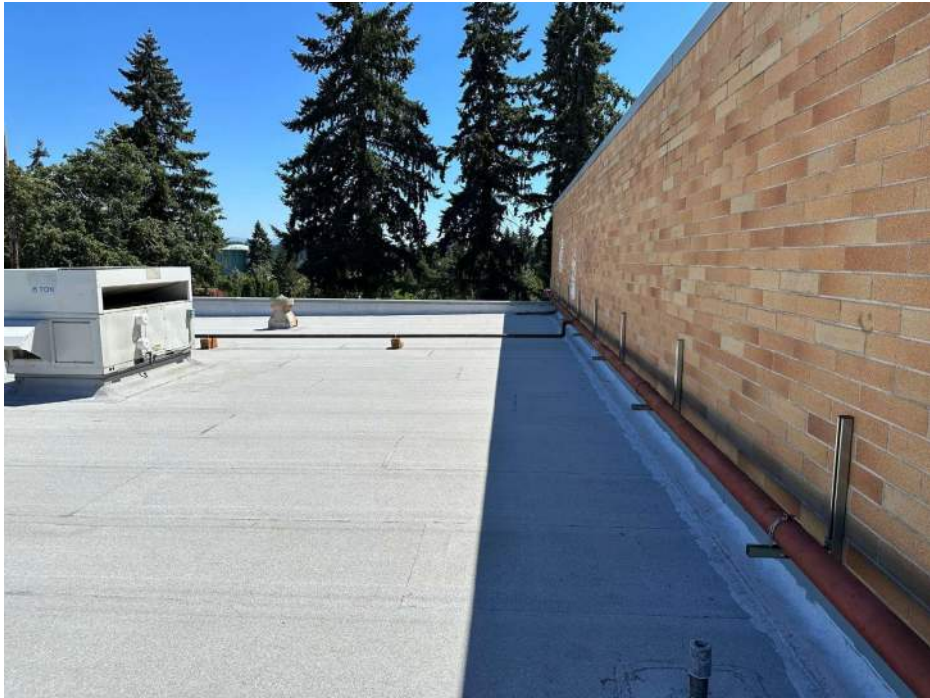
NEWER BUR 2021

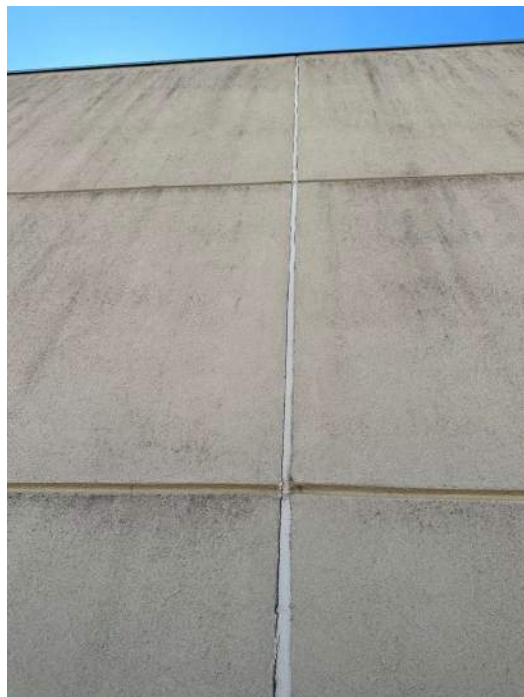
In addition we noted a few envelope/roofing issues such as the CMU wall near the back gym could really use an elastomeric paint to seal the block. The sealants in the EFIS and the EFIS to CMU appear to be worn and worthy of replacement as well. The exposed brick in the same area should be sealed and some flashings around sealants should be reviewed. There was some minor moss noted on one roof area.

EFIS JOINT NEEDS TO BE RESEALED

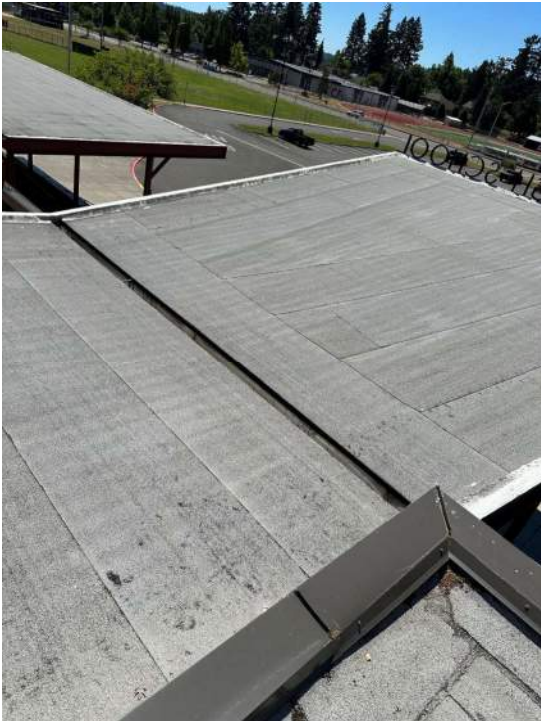
INTERNAL GUTTER AT MAIN ENTRY

- Budget for BUR Replacement over the entire school within 5 years. Consider redesigning edge and interior gutter at main entry for better drainage. Continue annual maintenance.
- Remove trees near NE corner or cutback.
- Apply aluminum emulsion at areas where granule loss is significant or replace roof immediately.
- Replace sealant at all scuppers where sealant has lost elasticity, is missing, or in need of repair.
- Replace shingles and repair gutter at structure south of main building in 1-2 years.
- Replace oldest BUR of approximately 8,293 SF ASAP.
