Fire Safety Inspection

Main Building

Downsville Central School District

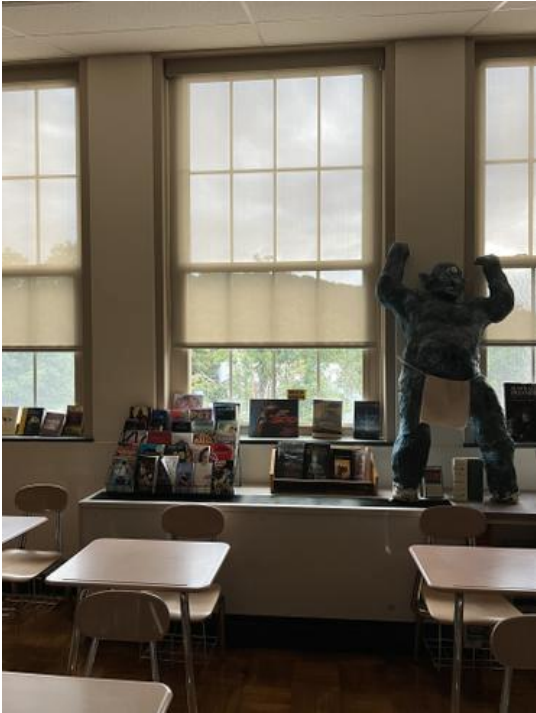
Photo 1

2 E-2 Emergency rescue windows are free from obstructing bars, screens, grilles or classroom equipment, or if so equipped, windows must be releasable or removable from the inside without the use of a key, tool, or force greater than that needed for normal operation.

Non-Compliant

Rooms B-104, 106, 213, 220

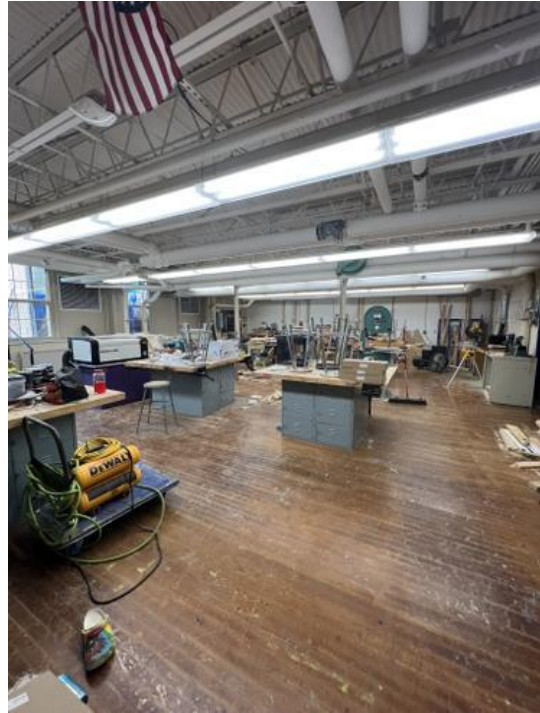
Photo 2

6 F-1 Storage in storerooms and classroom areas is orderly and restricted to items of obvious value and usefulness.

Non-Compliant

Wood shop

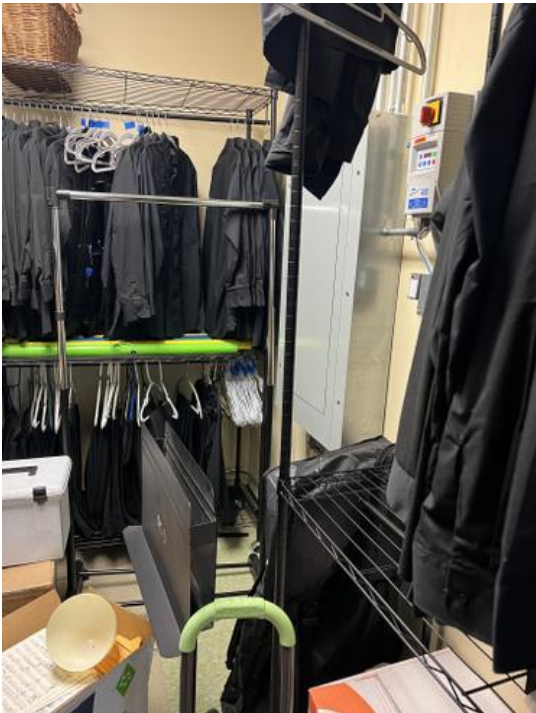
Photo 3

12 G-1 Electrical service and branch equipment working space is unobstructed. - F604

Non-Compliant

Band/Choir store room

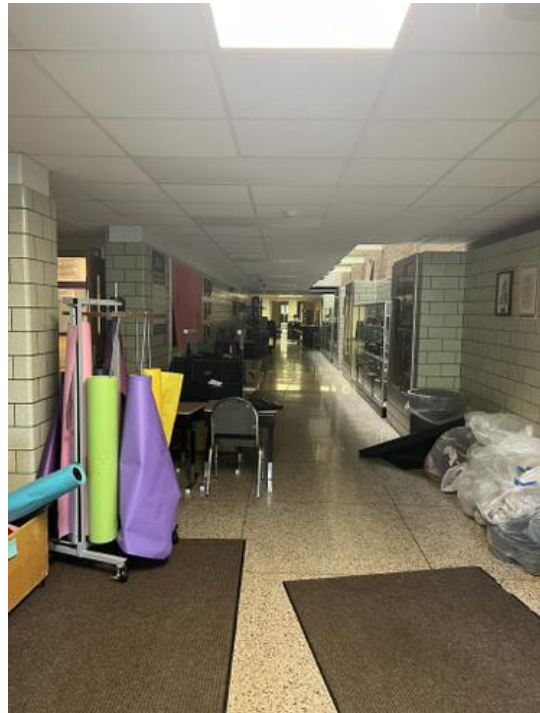
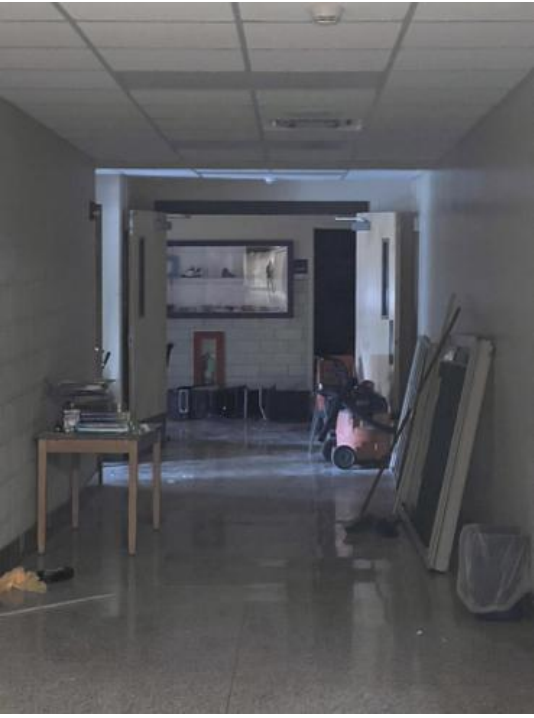
Photo 4

15 A-2 Furnishings do not obstruct or obscure exits. - F807

Non-Compliant

Basement corridors
